Joseph R. Polenzani Battalion Chief Franklin (TN) Fire Department

Why Mobile Homes?

Volunteer Lieutenant and a Fire Fighter Die While Combating a Mobile Home Fire - West Virginia

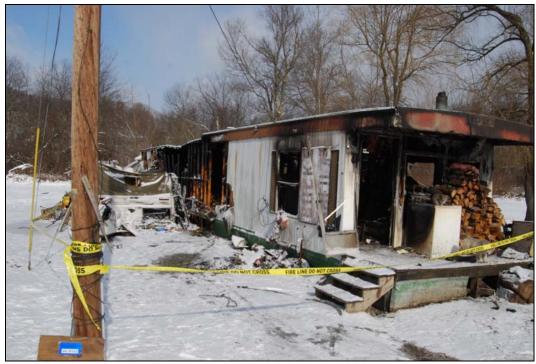
Incident Scene (Photo courtesy of fire marshal)

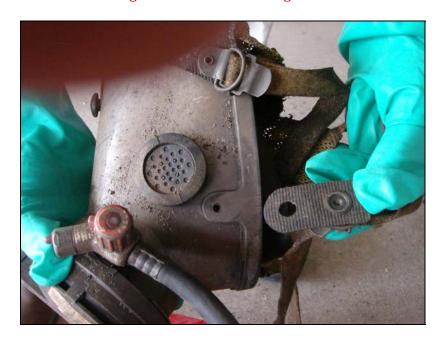
Photo 1. Facepiece missing a harness fastener. (NIOSH photo)

The victims' facepieces had not been flow tested since 2002, and the SCBAs did not meet the current edition of NFPA 1981. The face piece used by victim #2 was missing a harness anchor screw which could affect the seal of the mask. Also, the victims' air packs did not contain an integrated or standalone PASS device. Fire fighters need to know and officers need to reinforce that a SCBA is an integral part of fire fighters' protective clothing, and without it they cannot safely enter hazardous environments requiring respiratory protection. Preventative maintenance programs are designed to extend the life of a product and catch potentially life-threatening problems.

Recommendation #13: Fire departments should ensure that policies and procedures for proper inspection, use, and maintenance of self-contained breathing apparatus (SCBA) are implemented to ensure they function properly when needed.

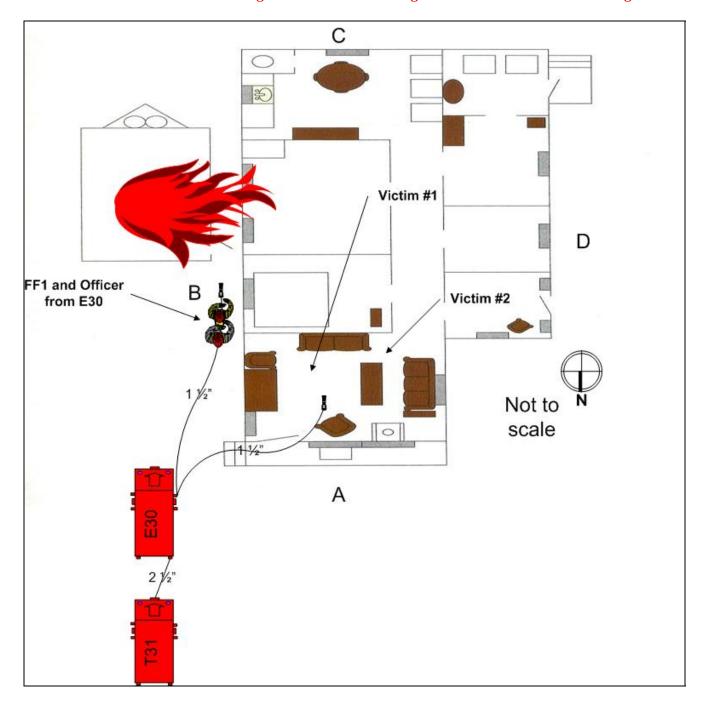
Victim #1 was found 9 ft 10 in and Victim #2 was found 15 ft 11 in from the A-side door they entered through. *Note: These measurements were taken from the doorway to the victims' closest extremities.* Victim #1 was face down with his arms by his side and legs straight. His regulator was connected to his facepiece and was discovered under him at waist level. His body was positioned toward the C-side of the mobile home. His helmet was found sitting upright on a couch several feet away from him as if he had taken it off and laid it on the couch. Victim #2 was found 1 ft 10 in ahead of Victim #1, also face down. His left leg was bent under his right leg, right arm under his body, and left arm facing up. His regulator and facepiece were also connected and discovered under his body at waist level. His body was also pointing toward the C-side of the mobile home. Both victims had their Nomex® hoods rolled down on their necks. Also, both victims were found without an integrated or stand-alone PASS device.

Diagram 2. Incident scene when evacuation alarm sounded and location of victims when found.

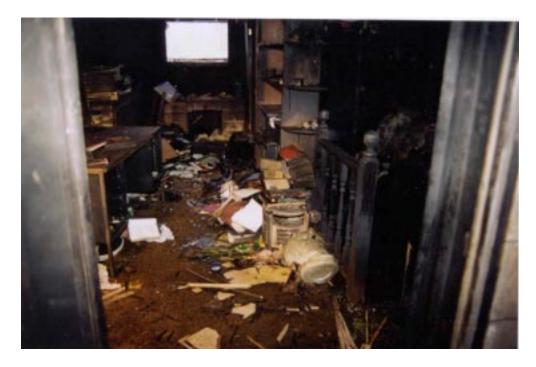
several times, and the two fire fighters became disoriented, got off the line, and crawled into an addition (12 ft x 12 ft) to the mobile home. The fire fighter from Engine 19 found a window, broke through it, and fell outside the mobile home. Other fire fighters assisted him, and he was transported to the local hospital, at 1202 hours.

Photo 3. Addition to Mobile Home (12 ft x 12 ft)
