Case Study

Drone Inspection of a Culvert for the Environment Agency

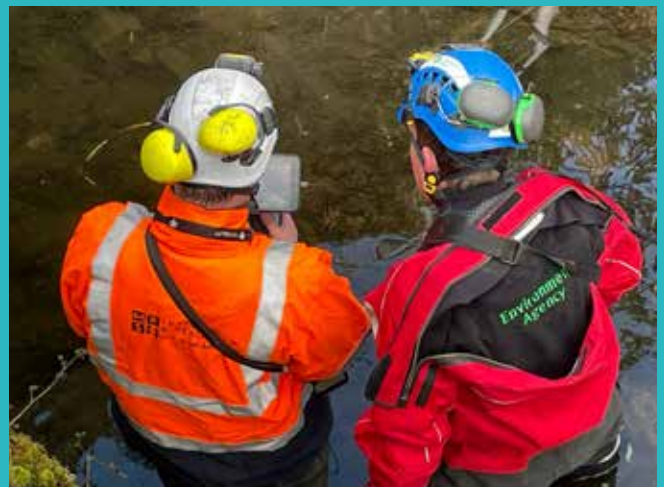
These photos and videos identified that the incoming entrance was blocked with debris washed in by the river that had collected in the entrance and built up over time. If this debris were dislodged, it could travel down the culvert and cause serious harm to anyone working in there.

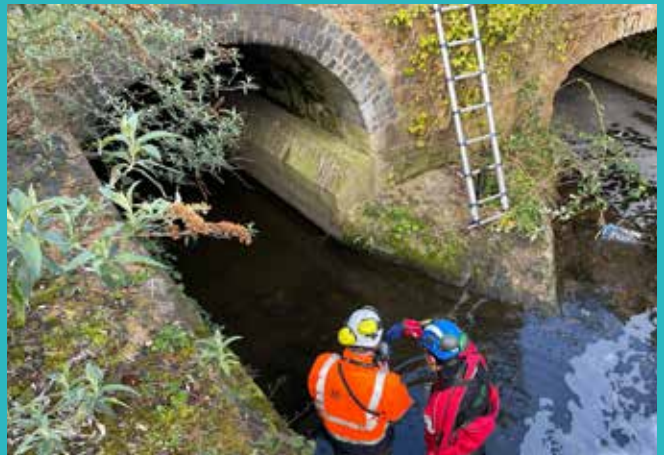
The images also found deterioration in the concrete roof with exposed metal reinforcing apparent – which could fall and cause injury at any time.
