3D REHABILITATION

3D electrical resistivity tomography is proving to be a fundamental tool in the identification of the effective causes of settlement of a structure for the planning, control and verification of expansive resin injections.

3D electrical resistivity tomography has been one of the main tools used in the works carried out in the Ciudad de Los Ángeles Integral Rehabilitation Area (ARI) in Madrid.

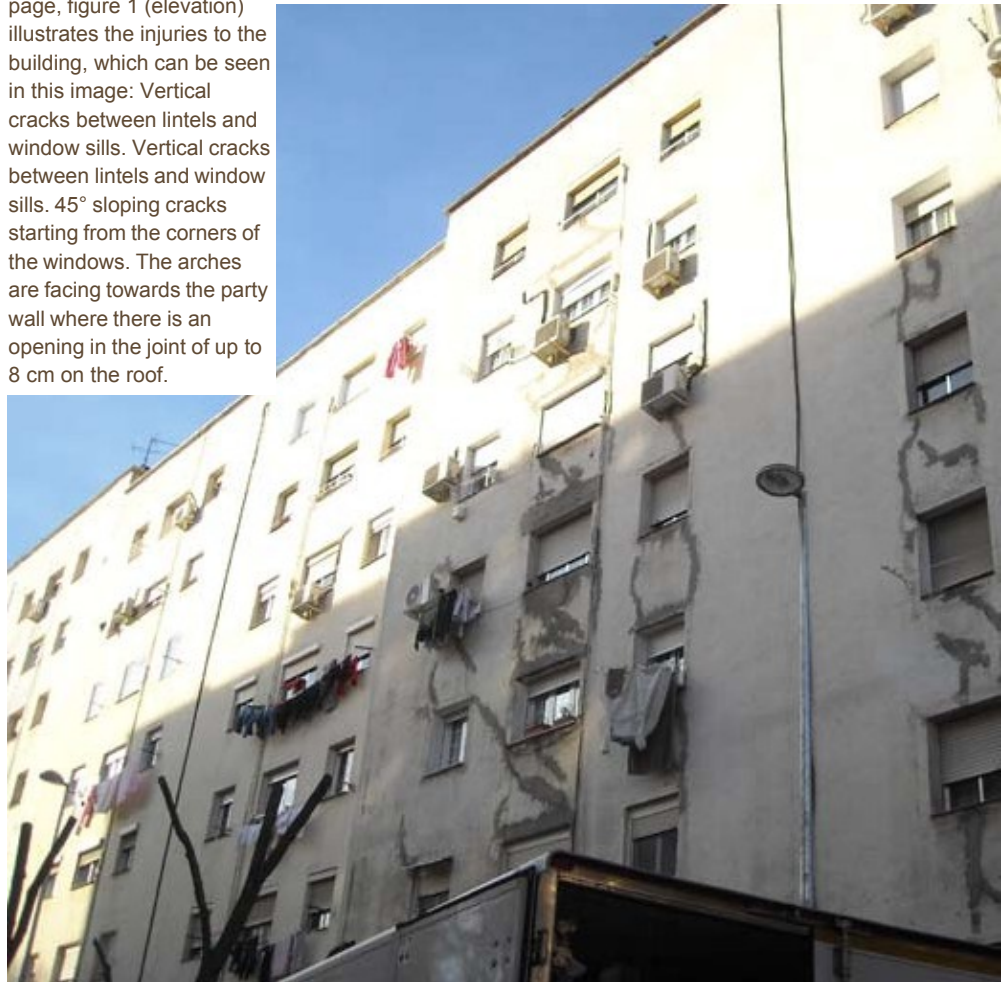
On the right, on the other page, figure 1 (elevation) illustrates the injuries to the building, which can be seen in this image: Vertical cracks between lintels and window sills. Vertical cracks between lintels and window sills. 45° sloping cracks starting from the corners of the windows. The arches are facing towards the party wall where there is an opening in the joint of up to 8 cm on the roof.

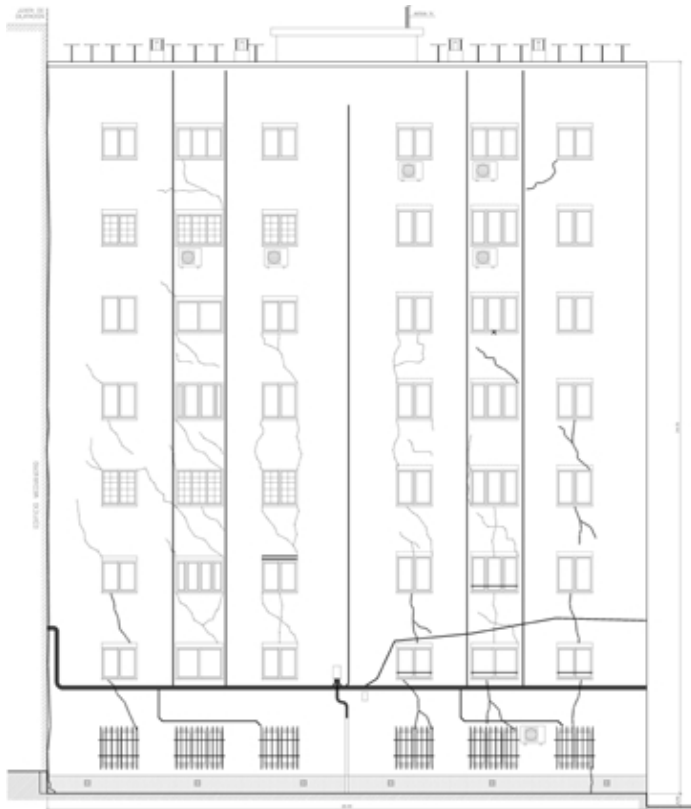
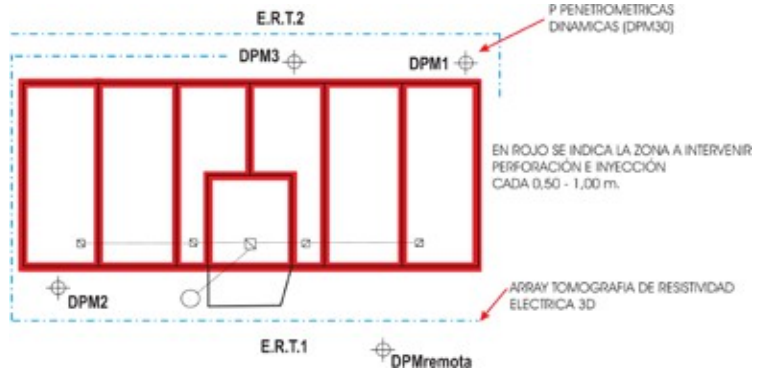
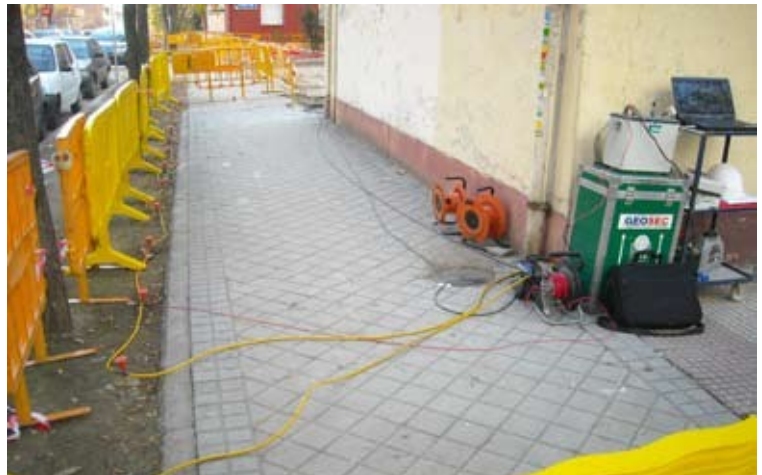
Figure 2: Test plan;
test projection, E.R.T.
3D and D.P.M. 30.

Once the deadlines and execution procedure had been agreed with the project management, the soil was characterised according to protocol by means of dynamic penetration tests and 3D ERT (see figures 2 and 3). The 3D electrical resistivity record shows the level of the building foundations.

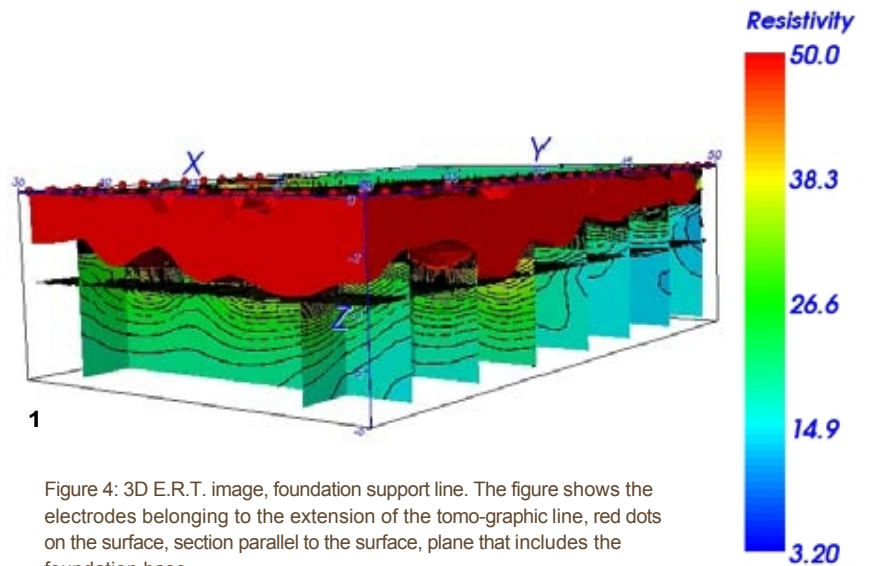
Figure 4: 3D E.R.T. image, foundation support line. The figure shows the electrodes belonging to the extension of the tomo-graphic line, red dots on the surface, section parallel to the surface, plane that includes the foundation base.

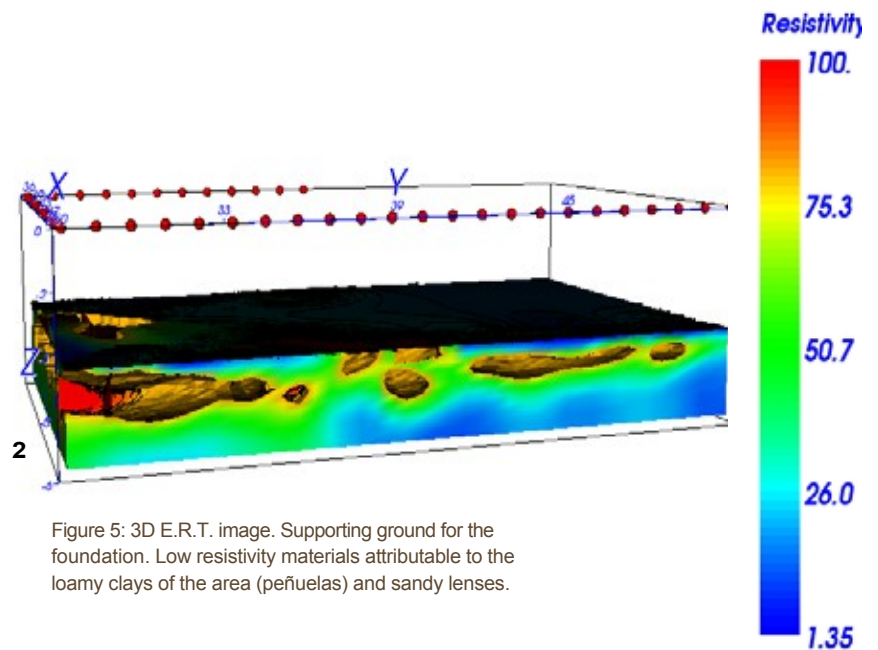
Figure 5: 3D E.R.T. image. Supporting ground for the foundation. Low resistivity materials attributable to the loamy clays of the area (peñuelas) and sandy lenses.

and the underlying materials composed of clays and sand lenses (identifiable in figure 5).

Tests were carried out on the expansivity of the samples collected, showing moderate to high expansivity. The lack of homogeneity of the soil, its expansivity and the possible washing of the sands, as shown by the high electrical resistance records, are considered to be effective causes of the destabilisation of the structure. The injections of expansive resin at two depths, four and five metres, allowed the homogenisation of the terrain, decreasing the presence of

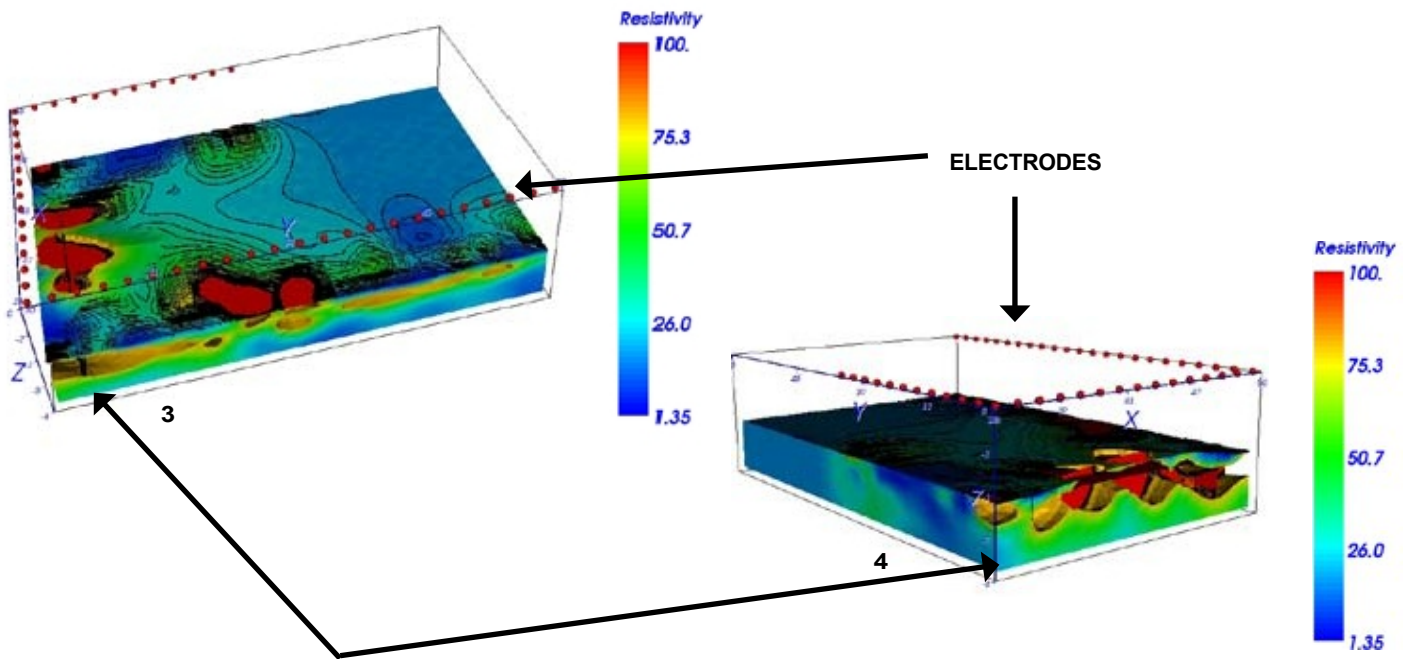
Above, figure 6: 3D E.R.T. image at foundation level showing high resistivity records attributable to lava in the sand lenses detected.

AREAS OF HIGH RESISTIVITY WITHIN THE SANDS ATTRIBUTABLE TO POINT WASHES

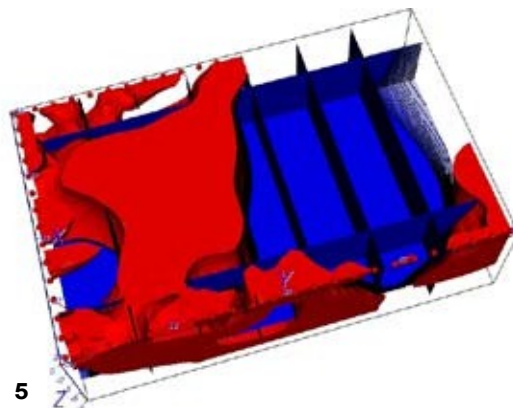
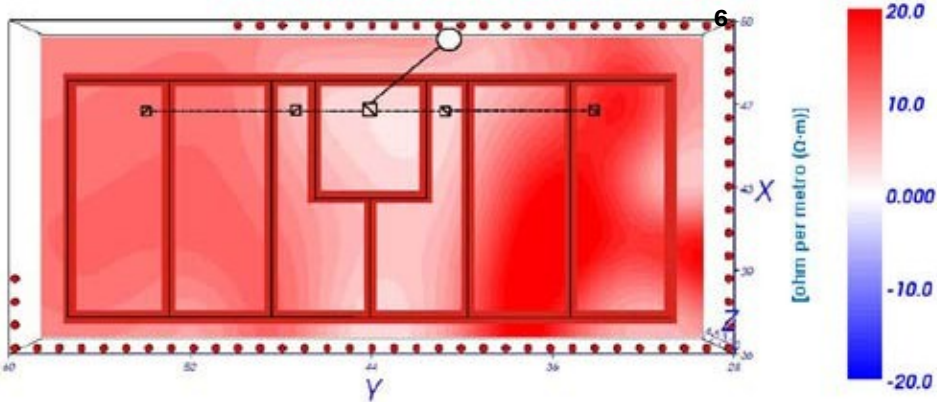
Figure 7. Below, 3D E.R.T. image of the soil below the foundation at level $h=3.50$ m, showing the homogenisation and 25% increase in electrical resistivity of the soil.

Right, intermediate 3D E.R.T. image, during the execution of the injections, showing the interaction of resin with the treated soil, allowing for modifications/repetition of the injections if the results obtained are not as expected.

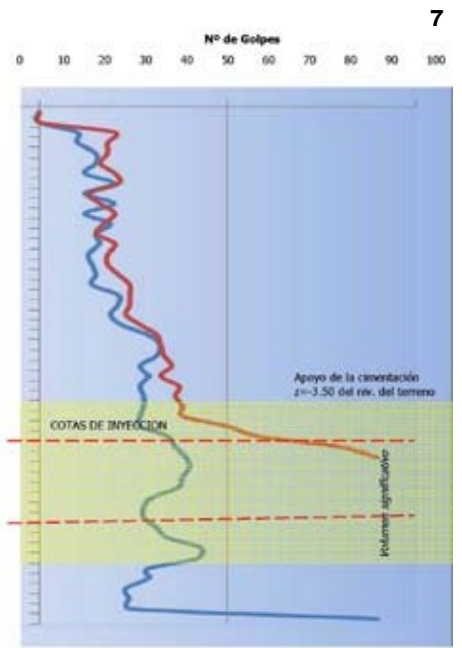
The comparison between the pre- and post-intervention geophysical and geotechnical study of the ground under the footprint of the target building, carried out using the 4D electrical resistivity tomography method $f(x,y,z,t)$ in near real time and dynamic penetration tests, confirms this, allowing a significant increase in resistivity and tip resistance to be verified compared to the initial values measured before the injections (see figure 8).

Figure 8: Tapping record of one of the DPM 30 dynamic penetration tests performed before (blue) and after the intervention (red). There is a clear increase in mechanical strength at the tip with rejection at almost the first injection level.
