# The Undeniable Value of Inspection

POND & COMPANY

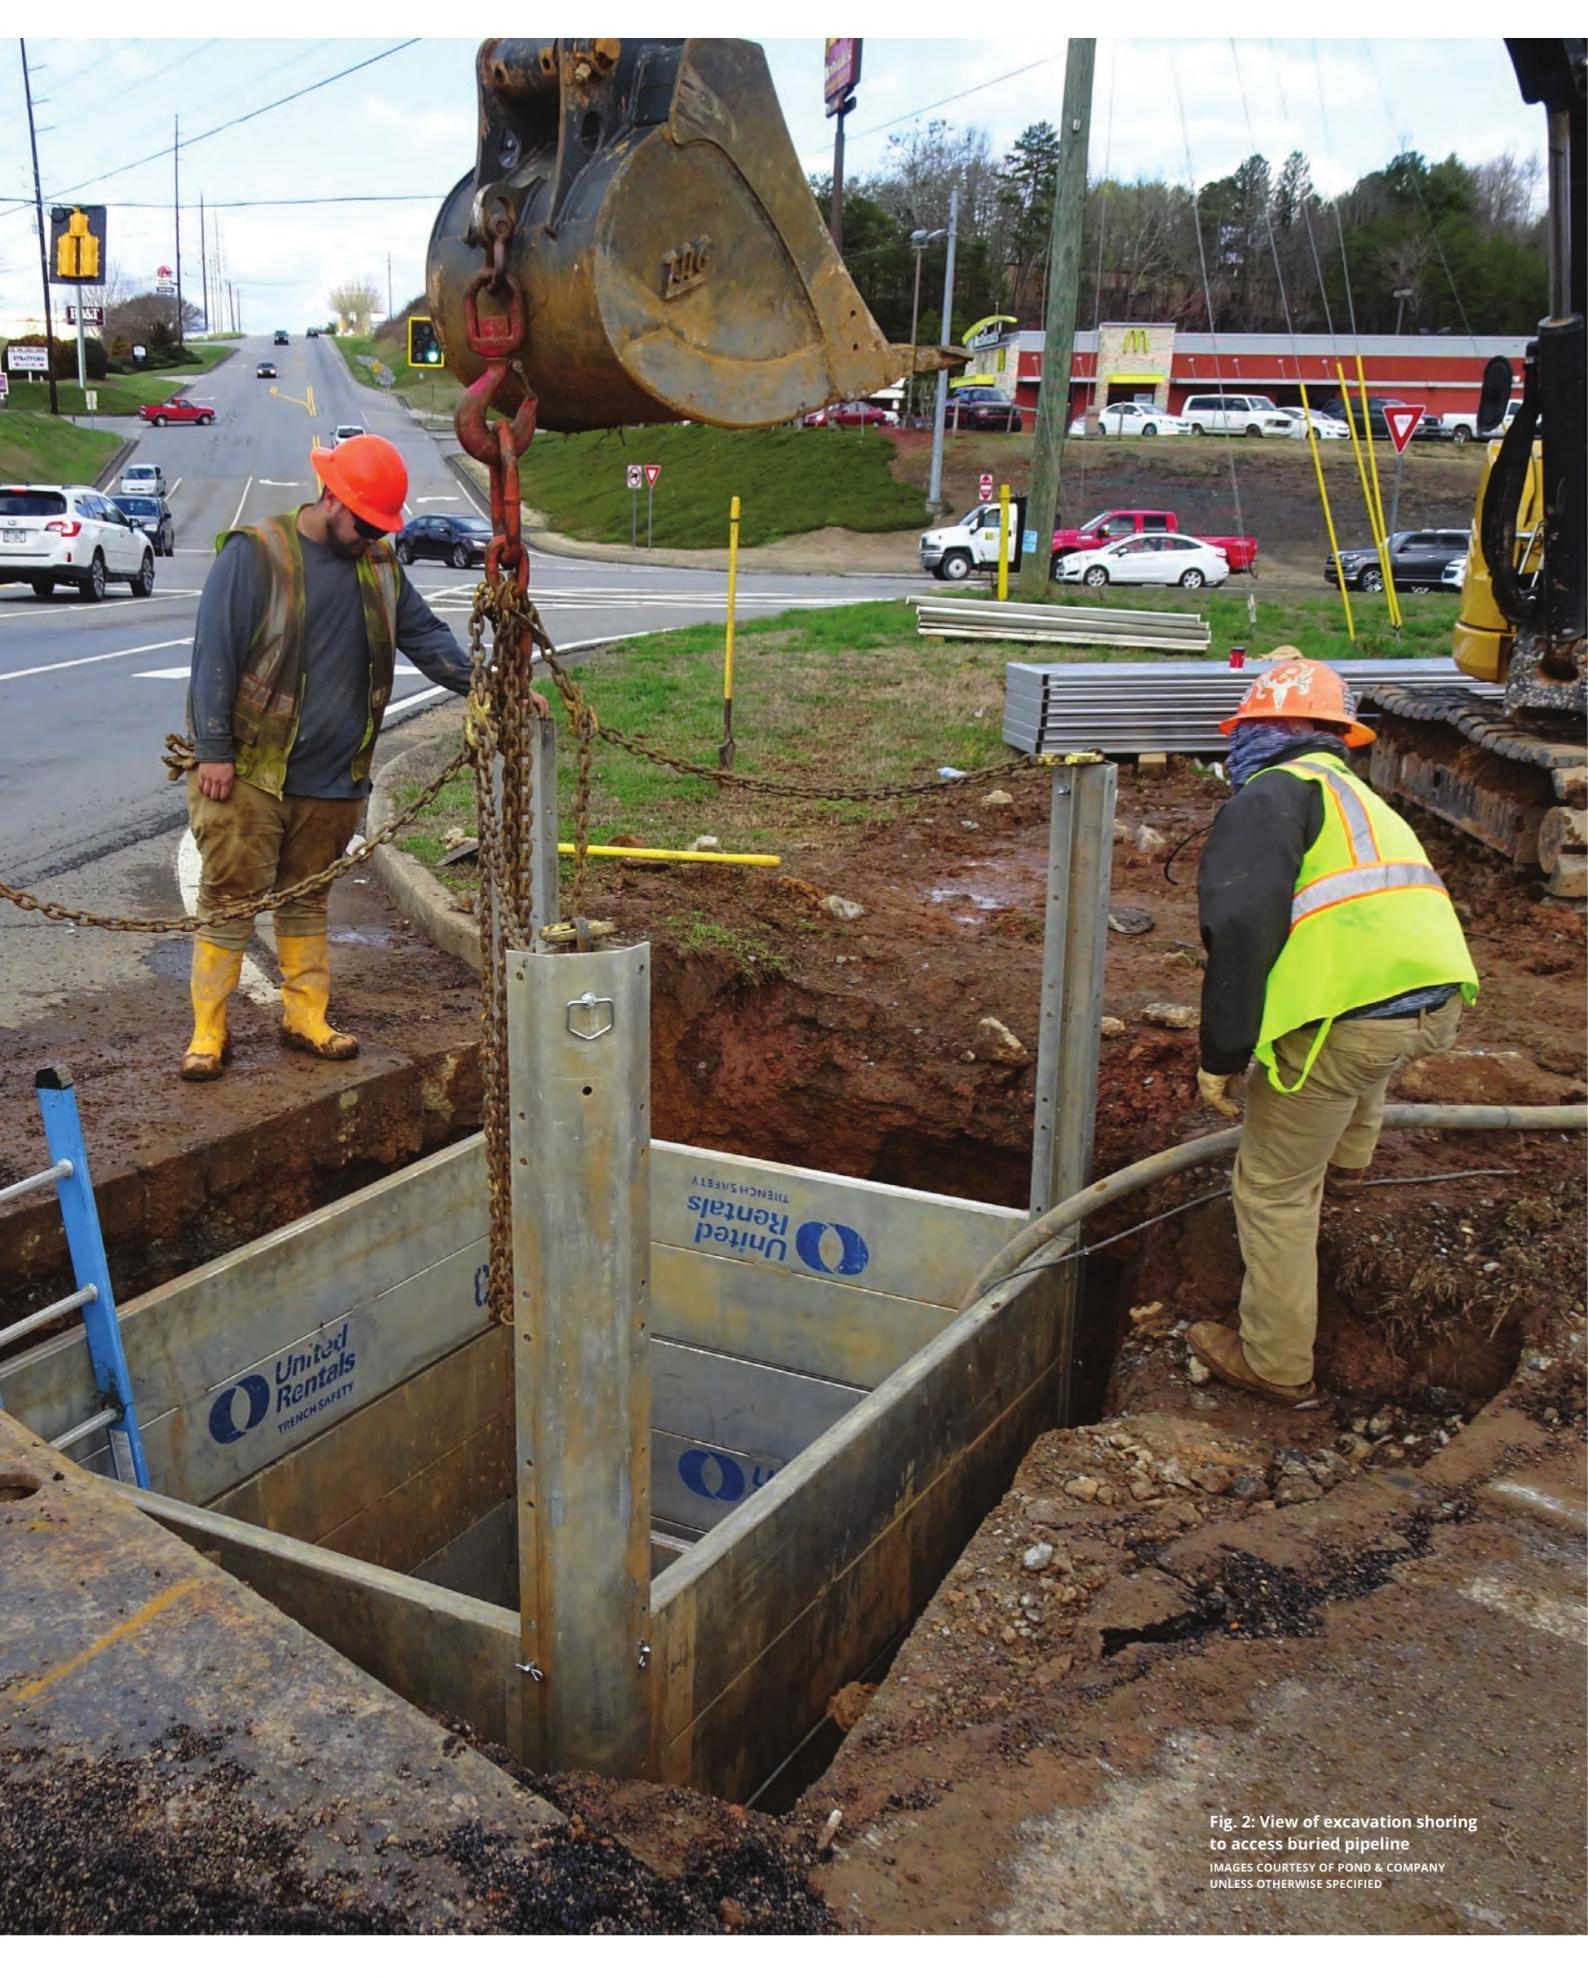
Digging these trenches and putting up (shoring) walls to prevent collapse is a tedious, costly endeavor (Fig. 2). Not only does the process run up to \$500,000 per excavation, the egregious cost of performing these O&M remediations and the risk associated with them is a challenging model to follow. What if we could prevent these defects from arising in the first place?

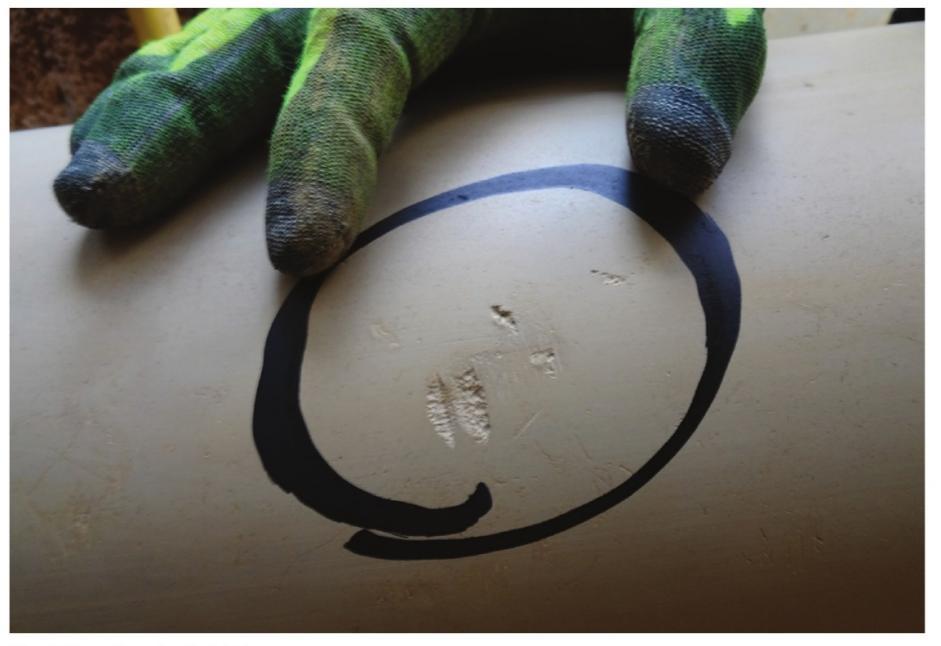
Fig. 4: View of mechanical defect

After a pipeline is placed into service, the corrosion system performance is monitored. A DCVG investigation identified locations of coating defects from the coating process or from mechanical damage of the pipeline coating. Locations identified with coating defects were identified, and confirmatory digs were scheduled. Several different defects were identified. One area exhibited mechanical damage that was coated over at the plant, as shown in Fig. 4.

The mechanical damage occurred prior to the coating process and appeared to have been missed during inspection. Another location exhibited coating damage during the installation process, as show in Fig. 5.

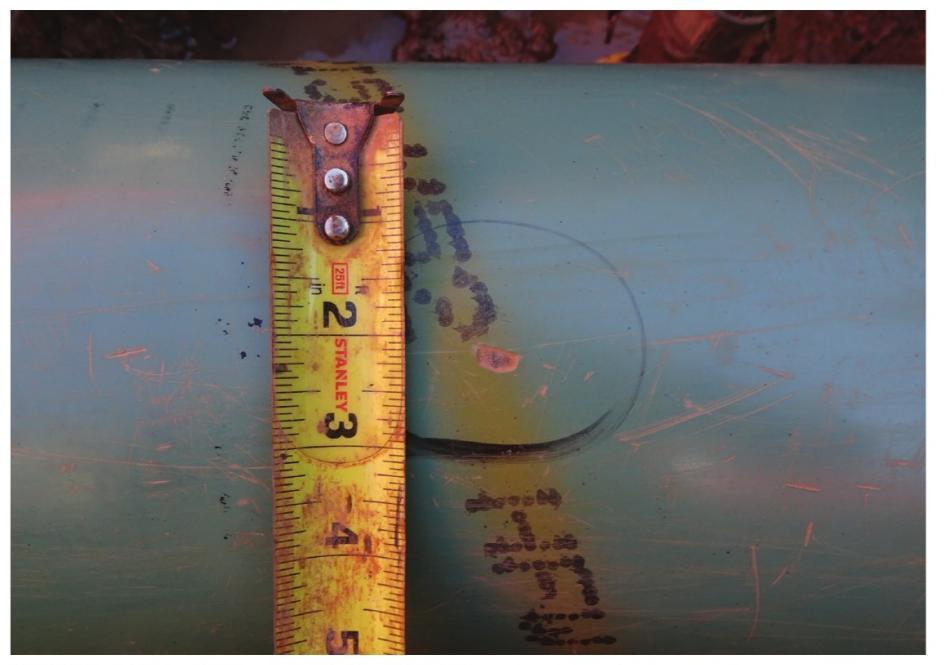
Fig. 5: View of coating defect produced during installation

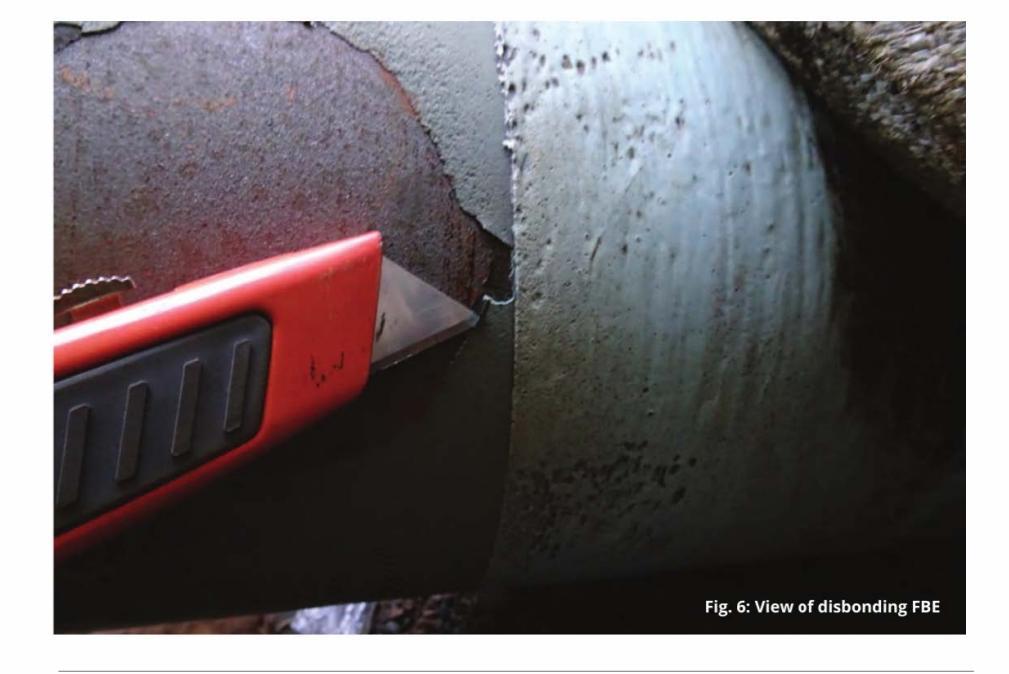
A properly applied FBE system would be tightly adherent and should resist delamination. It should only be scratched by probing with a knife. This investigation showed that the FBE was lifted by knife probing with the surface beneath the FBE exhibiting mill scale and surface corrosion, as shown in Fig. 6.

After the field investigation, it was discovered that client did, indeed, have a third-party inspection at the plant during the coating application process. A cursory review of the inspection records showed that the inspection team onsite did not reject a single section of pipe during the entire run of over 35,000 linear feet.

In any manufacturing process, a certain percentage of defects are found. The fact that no defects were found, and that the coatings were all identified as applied within the specified range of dry film thickness, without a single section being rejected, called into question the skills of the inspection personnel assigned to the project. Further investigation revealed that the inspectors had no formalized training in coatings inspection. If there are no identified discrepancies with any of the materials, it is likely that they did not undergo meticulous inspection.
