Welcome to the second of our occasional newsletters featuring one or two interesting restoration jobs undertaken here at CIWS in recent times, combined with news about our company too.

In late summer, we carried out work on the famous **Fowler 13310 K7 Ploughing Engine - The Steam Sapper**

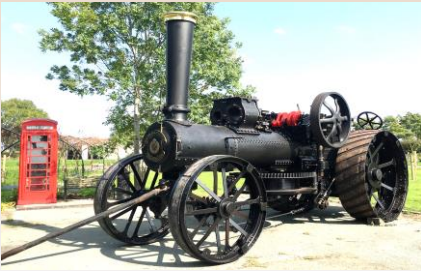
CIWS were able to repair a broken valve guide on this very interesting engine, thus helping to maintain the integrity of the wonderful restoration

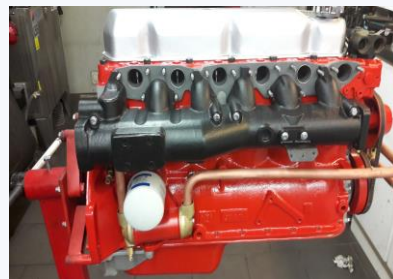
The manifold came to us with obvious damage, but after dye penetrant testing, we discovered there were more issues than first thought. The marinized engine manifold is water cooled (since there is little airflow around it during operation). That means its internal arrangement is a little more complex, so great care was called for during the repair process.

A gentle pressure test at just 2 bar(g), was enough to reassure us that the cracks are fixed, and the manifold is ready for use on the engine once more
