HRSG DEEP CLEANING™

**Thermal Insulation
Case Study**

OVERVIEW

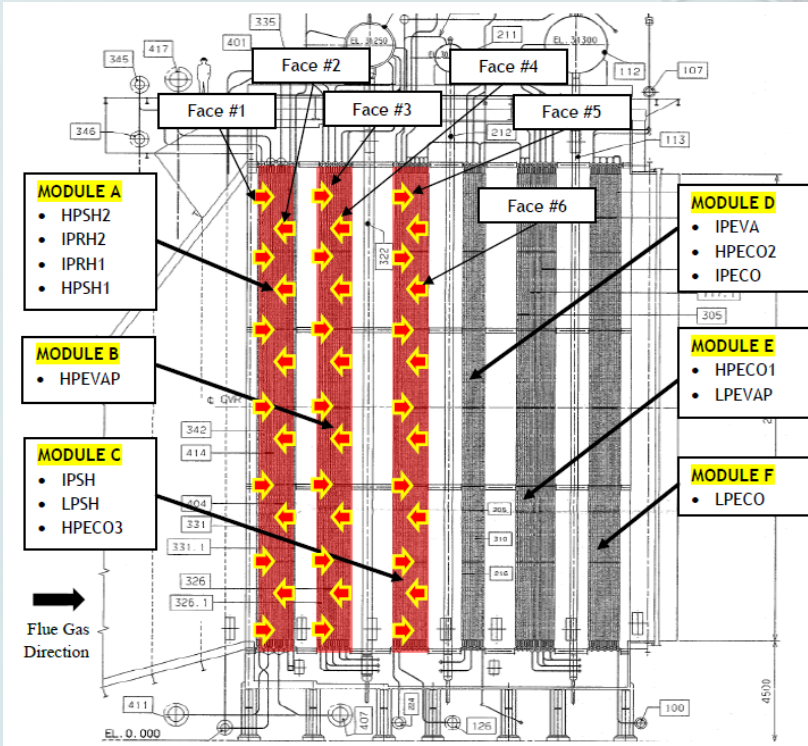
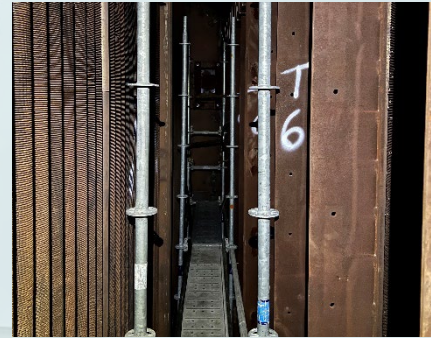
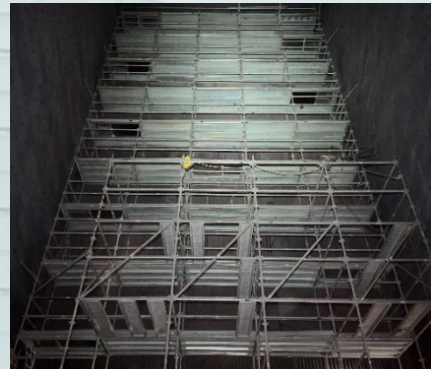
MODULES WHERE THE HRSG DEEP CLEANING™ PROCEDURE WAS APPLIED

Height: 21 mt; 68 ft / Width: 7 mt; 22 ft

Scaffolding System

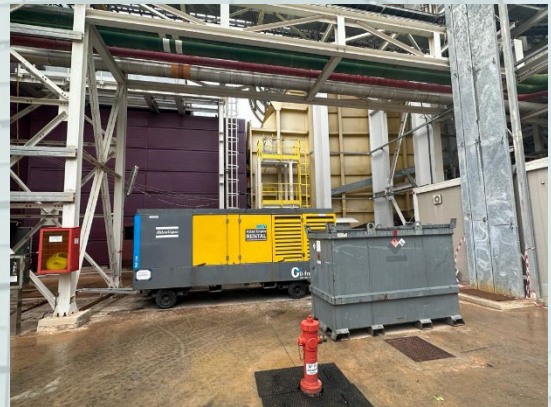
HIGH PRESSURE COMPRESSOR

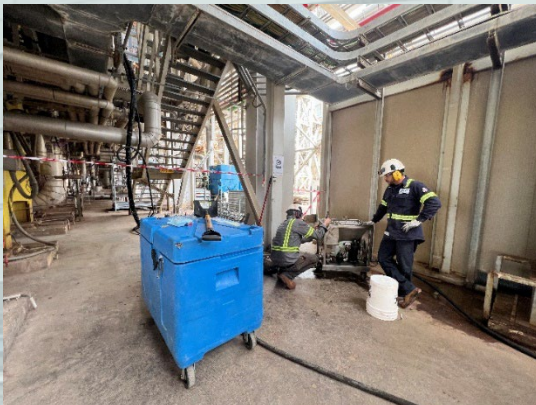
BLASTING MACHINE AND ICE TUBES

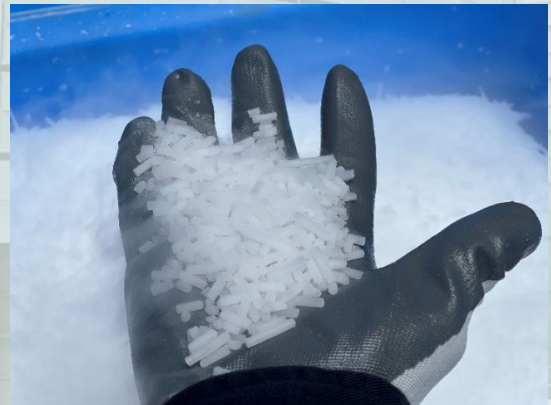
DRY ICE PELLETS - 3MM

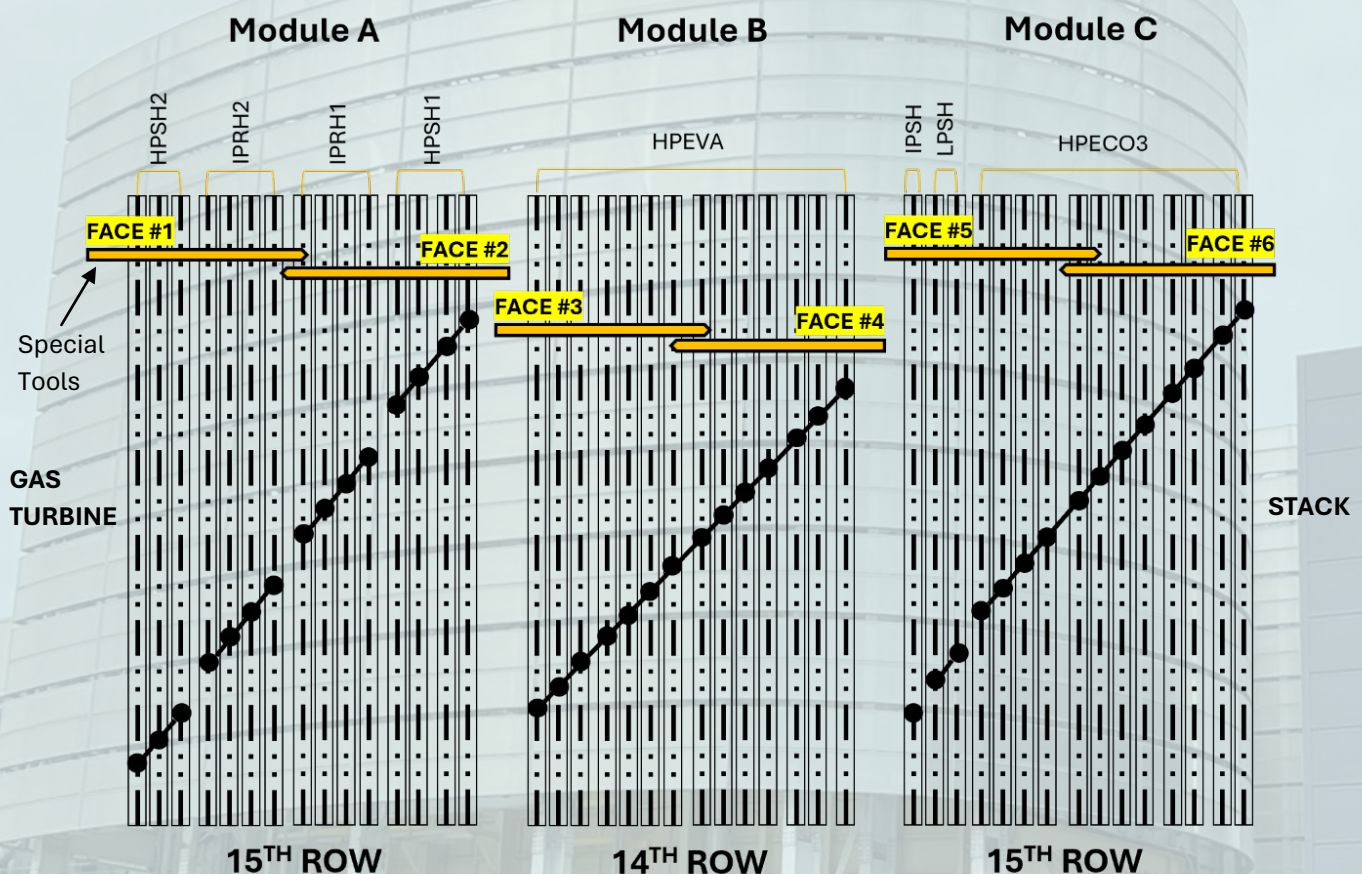
Diagram 1.3 illustrates the side view of the three heat exchanger modules where the HRSG Deep Cleaning TM procedure was applied. The cleaning began with the upstream face of module A (from top to bottom), then proceeded to the other faces until reaching the downstream side of module C.

The main challenge faced by PIC during the cleaning process of both HRSG units was to ensure the meticulous application of the deep cleaning procedure, **applying special tools with a "line-by-line"** approach as demonstrated **by the red dots in each of the 24 subdivided sections of module B**. These sections were heavily encrusted with compacted thermal insulation material in all deep rows of tubes.

To ensure better cleaning results, special tools were manufactured according to the configuration of the HRSG heat exchangers. A total of six faces were accessed by PIC's blast technicians who applied our deep cleaning methodology as illustrated in the diagram 1.3 below.

To adhere to this rigorous cleaning protocol, **approximately 416 applications** of our specialized tools were required at each tie level, moving from left to right and vice versa. **This totaled approximately 2,490 applications** for each face (upstream and downstream side).

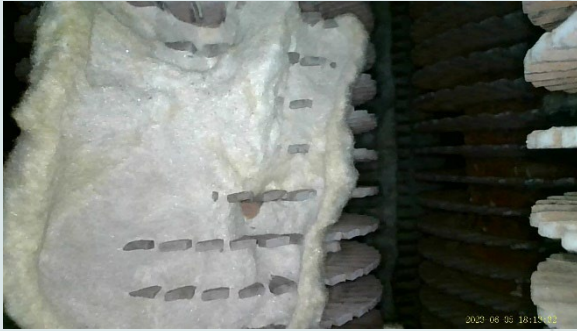
10TH Row of Tube

BEFORE CLEANING

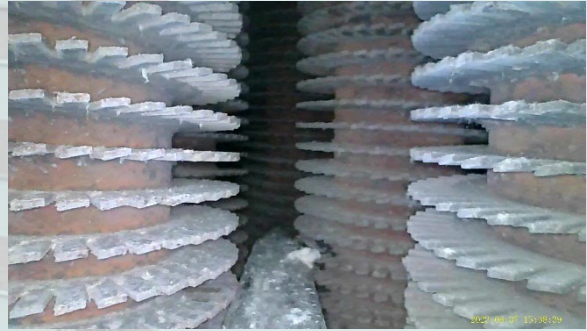
10TH Row of Tube

AFTER CLEANING

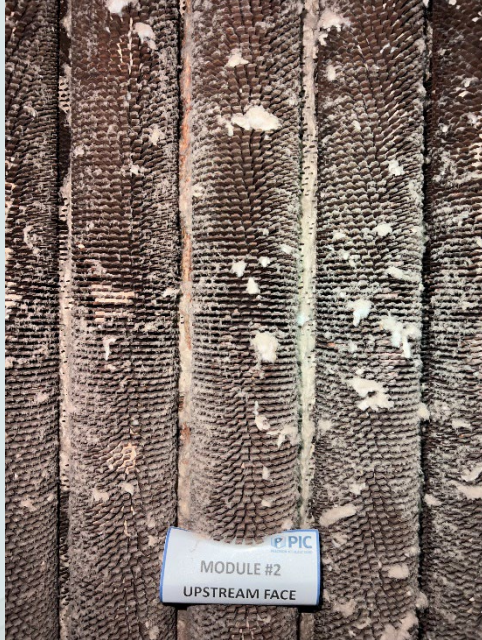
BEFORE CLEANING

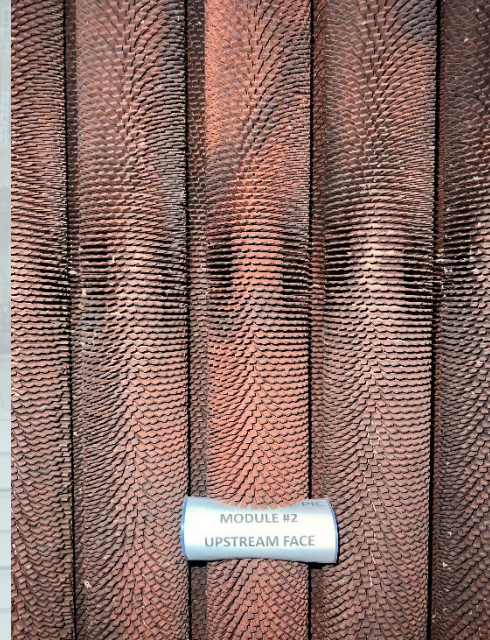
AFTER CLEANING

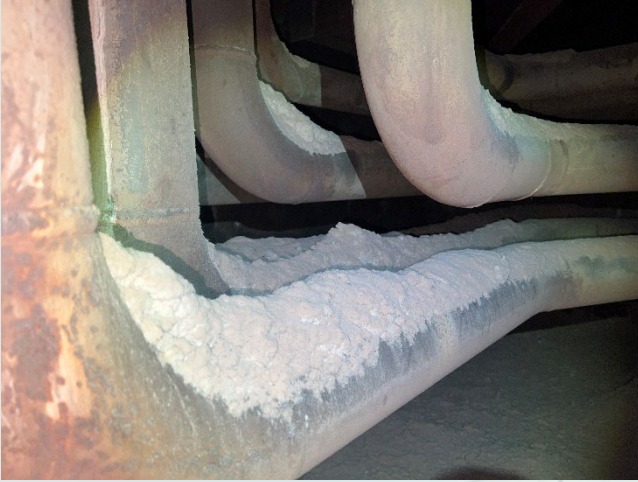
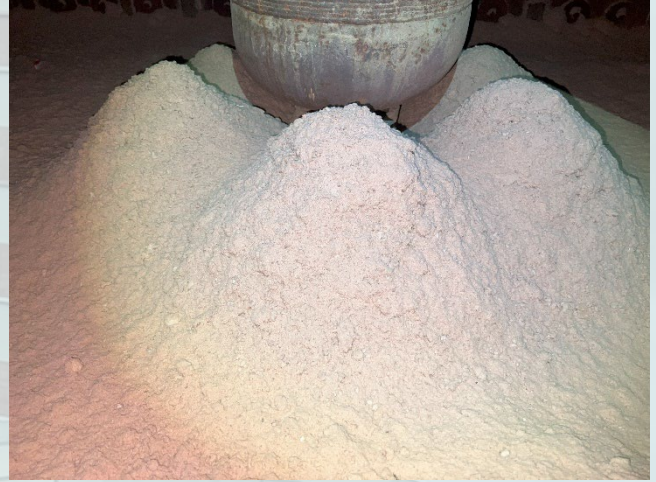
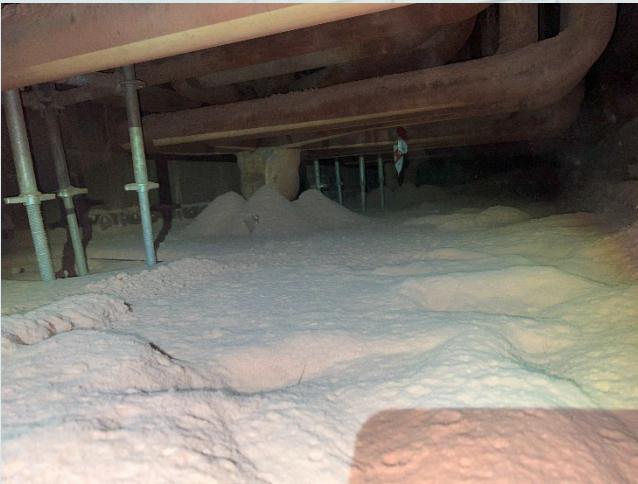
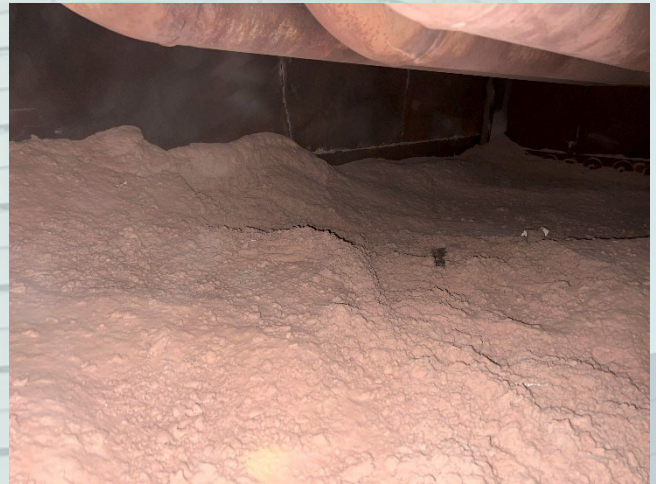
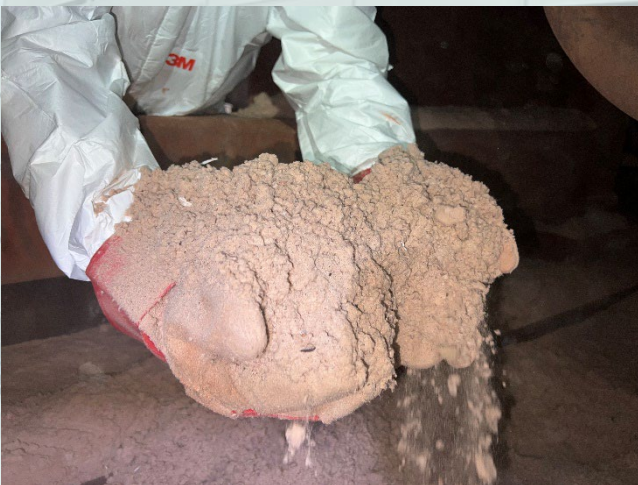
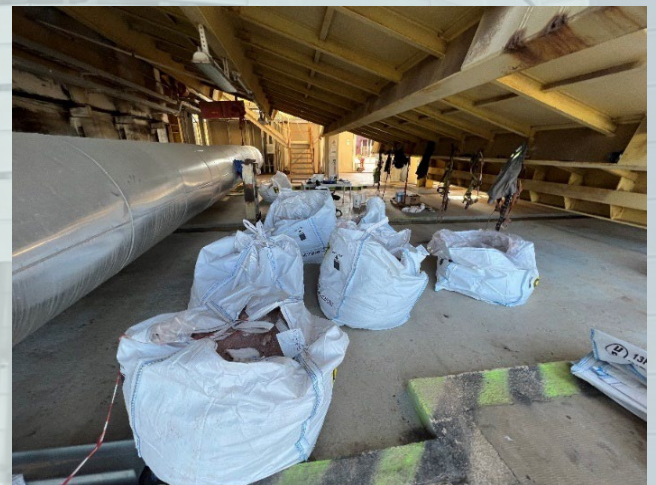
APPROXIMATELY SIX TONS OF DEPOSITS REMOVED FROM BOTH HRSG UNITS
