RECOATING WHILE REFUELING

Rehabilitating In-Service Fuel Tanks

BY DAVID HUNTER,
POND & COMPANY, INC.

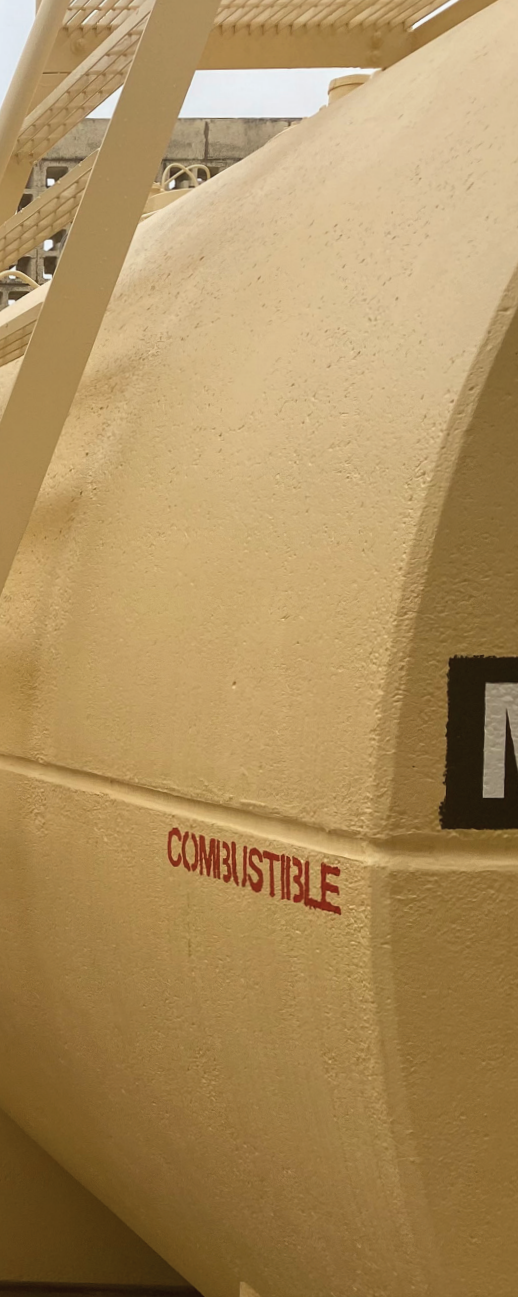
Fig. 1 (top): Seven fuel storage tanks—including these two concrete-encased vessels—required rehabilitation.

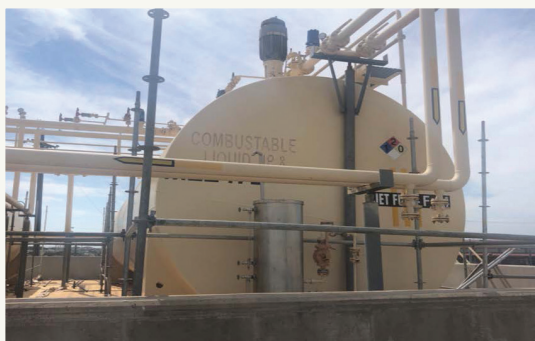
Fig. 2 (bottom): The original tank coatings had faded, exhibited poor adhesion and outlived their intended service life.

In July of 2019, the coatings rehabilitation project began. For the carbon steel tanks, wet abrasive blast-cleaning was carried out, using garnet abrasive, to provide an SSPC-WAB 10/NACE WAB-2, Near White Wet Blast finish. The two concrete-encased tanks were brush-off blast-cleaned to remove the existing coatings and roughen the concrete fireproofing materials.

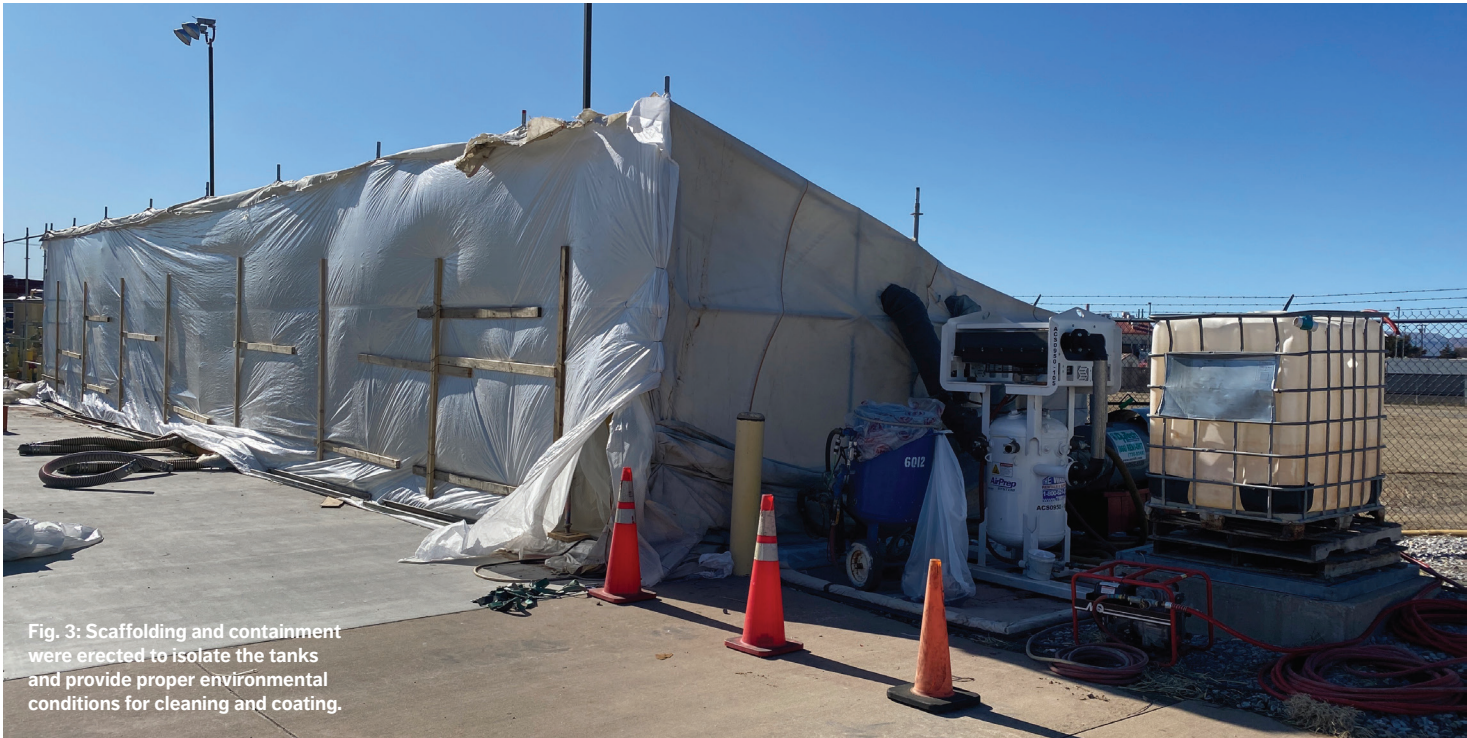
Fig. 3: Scaffolding and containment were erected to isolate the tanks and provide proper environmental conditions for cleaning and coating.

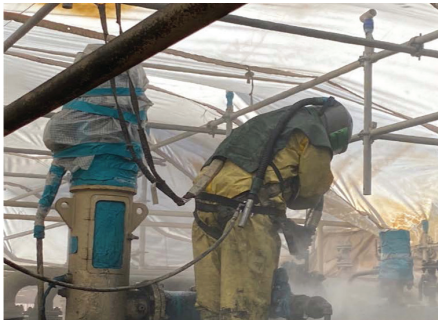
Fig. 4: The contractors used wet abrasive blast-cleaning to prepare the steel tanks.

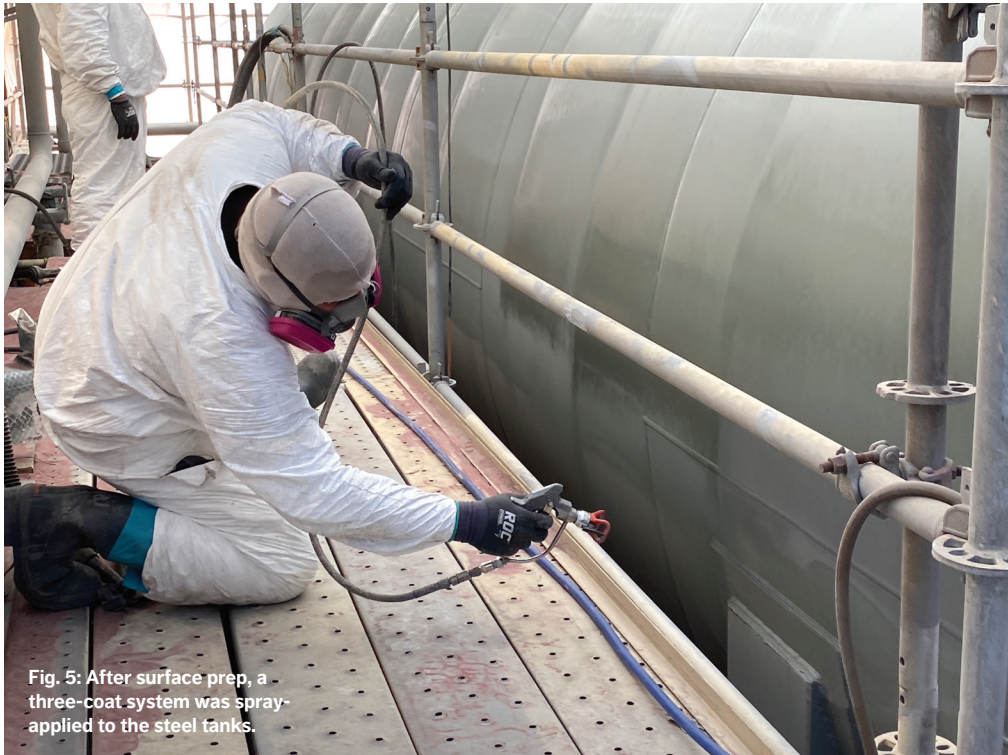
Fig. 5: After surface prep, a three-coat system was spray-applied to the steel tanks.

After surface preparation, the steel tanks received a three-coat, organic zinc-epoxy-urethane coating system in compliance with MIL-SPEC coating specifications. The concrete-encased tanks

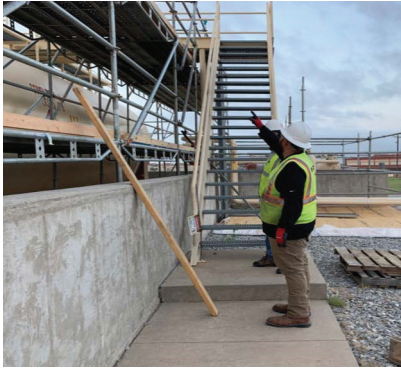
Fig. 6: A coating inspector examined the tanks after work was completed to ensure quality application and curing.

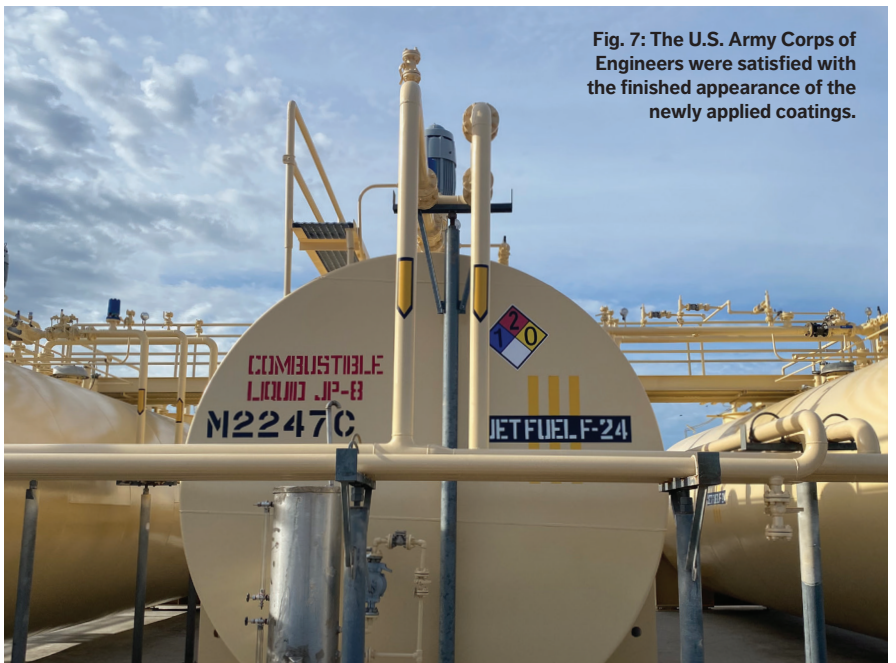
Fig. 7: The U.S. Army Corps of Engineers were satisfied with the finished appearance of the newly applied coatings.
