Muck Burn Flume,
Dumfries & Galloway,
Scotland, UK

Cubby Construction
Ltd on behalf of
Scottish Power

CC8™ was used to
remediate a dilapidated
concrete flume forming
part of a hydro-electric
system.

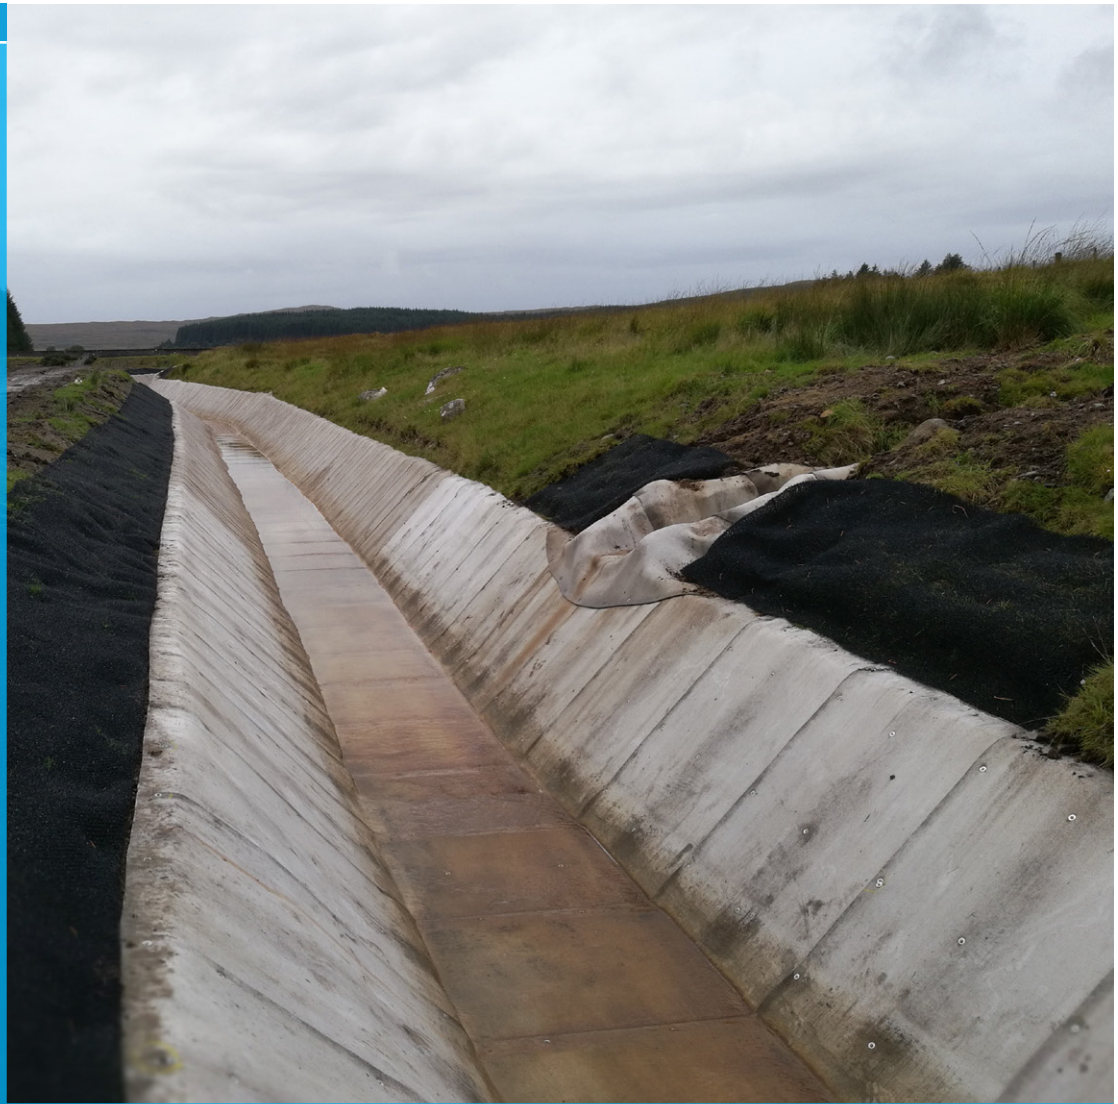
Completed installation at Muck Burn Flume

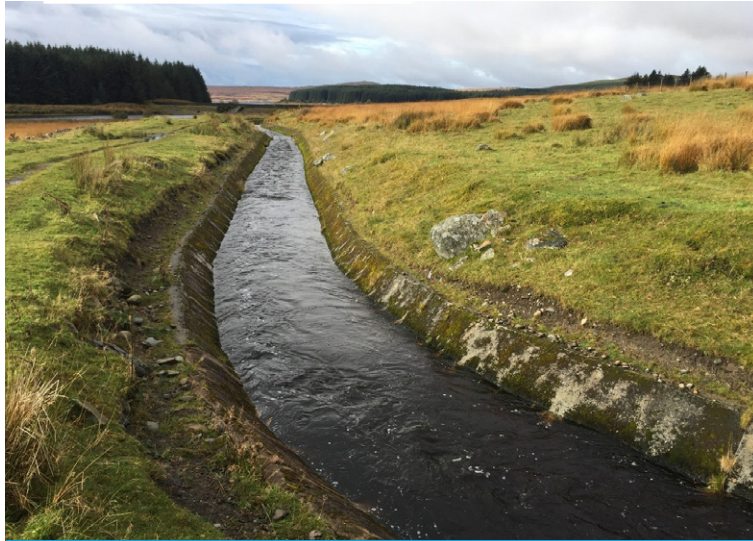
Water flow in original concrete flume

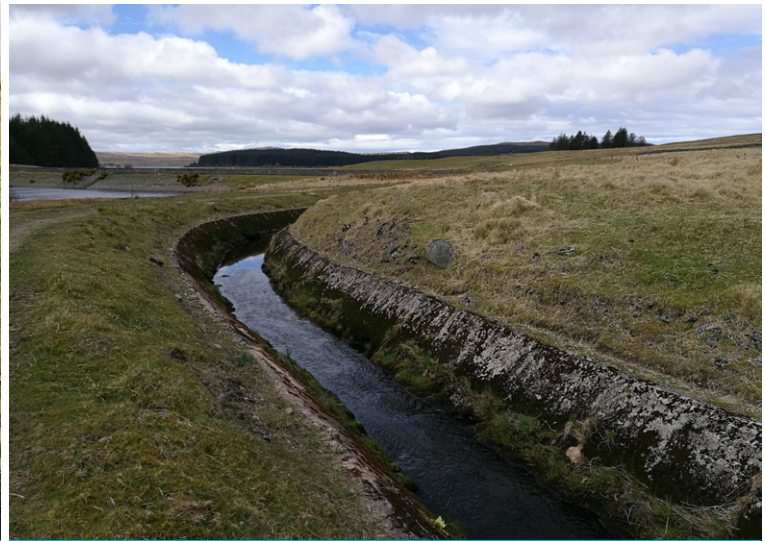
Algae, moss & vegetation growth within the flume channel

A civil general inspection undertaken in June 2014 noted that the condition of the flume was poor in significant areas, and some localised repairs were carried out in 2015. The deterioration to the structure is consistent with erosion and frost damage. Rather than using conventional concreting techniques, CC was proposed to significantly mitigate the need for costly periodic repairs.

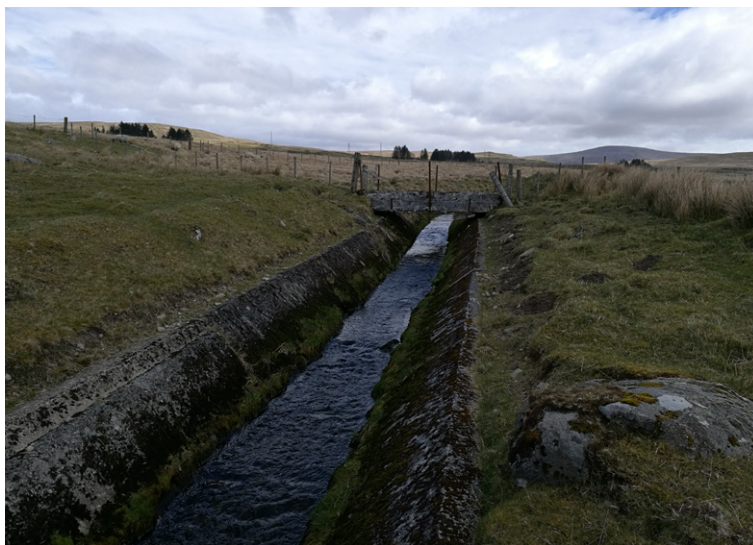
360m dilapidated concrete slabbed flume prior to installation

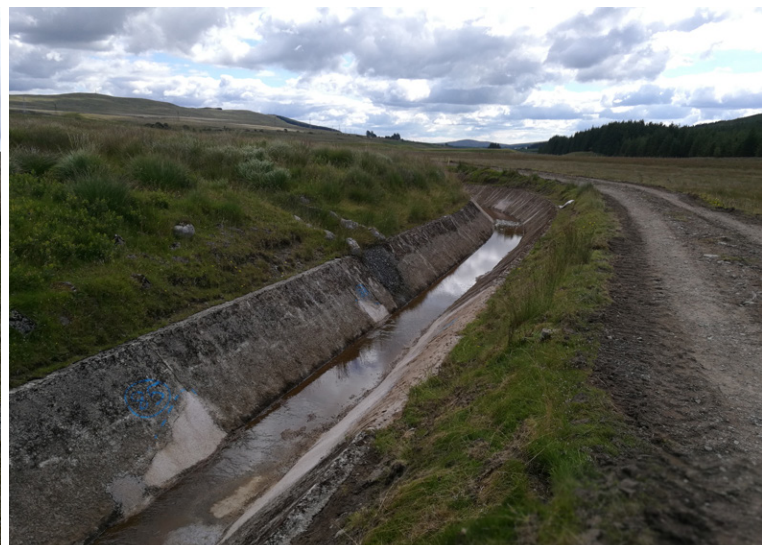
Vegetation & algae removed and water diverted out of the flume

Prior to installation, the flume was pressure washed to remove vegetation and minor repairs were carried out using a semi-dry grout mix to fill any voids in the concrete to ensure intimate contact between the CC and the concrete substrate. The water flow was then diverted into a nearby channel by building an earthen dam and using sandbags. Bulk rolls of CC8™ were then delivered to site in staggered deliveries to reduce onsite storage and accommodate the speed of the installation crew. The bulk rolls were then mounted on a spreader beam, which was hung from a Komatsu PC210LC-7 Hydraulic Excavator.

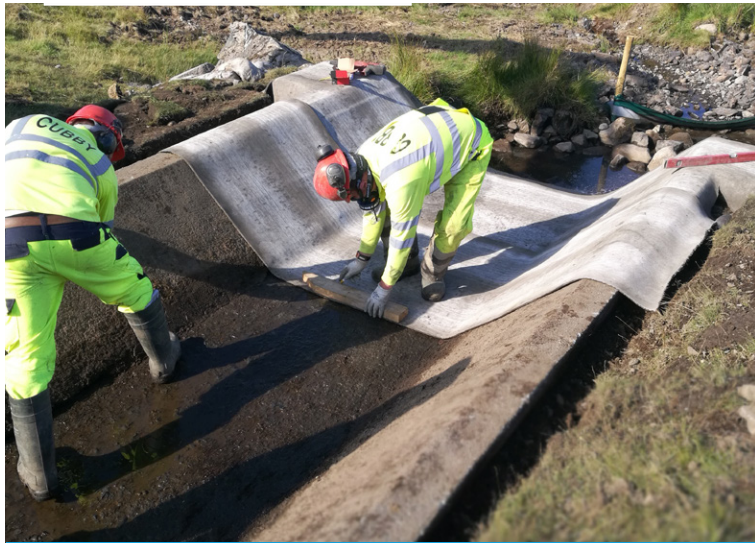
First layers of CC being laid into anchor trench & overlaps marked

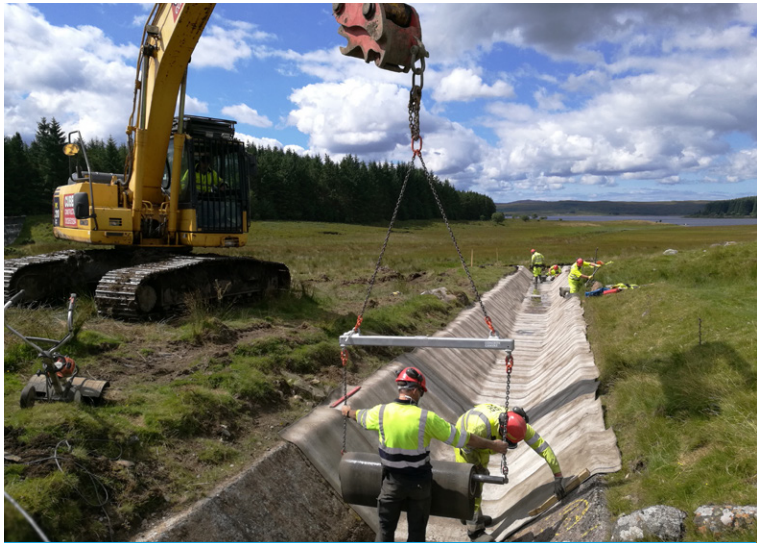
CC dispensed with a spreader beam & cut to length

The CC was then rolled across the width of the flume before being cut to specific profile length with an angle grinder. Each length of CC was laid transversely, with adjacent layers overlapped by 100mm in the direction of water flow, and fixed in place using 34mm Hilti nails with 25mm diameter washers shot fired at centres not exceeding 600mm. Cubby Construction were extremely diligent in preparation and ensured the 100mm overlaps and 600mm Hilti spacing intervals were clearly marked in chalk prior to fastening to ensure the correct interval spacing.

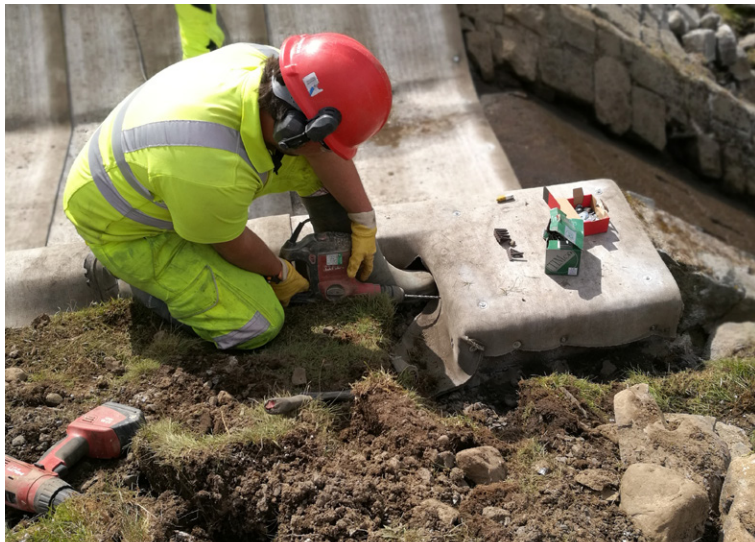
Installing 34mm Hilti nails with 25mm washers

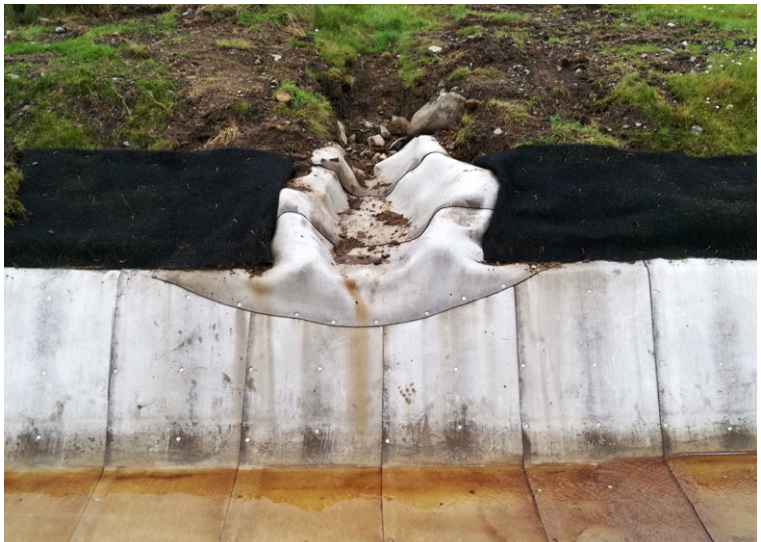
Inlet ditches lined with CC to direct bank runoff into flume

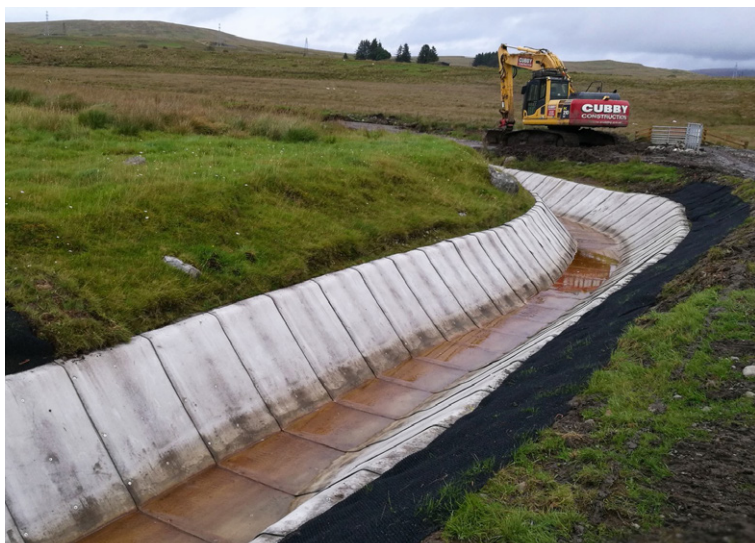
CC able to accomodate sharp bends

2,000m² of CC8™ were installed in less than 3 weeks by 5 people, despite challenging weather conditions. The CC was able to easily accommodate sharp bends, junctions and inlet channels, along with interior and exterior pipe protrusions. CC also has a very low wash out rate and low alkali reserve meaning that it was not required to treat the run off from installation. The client was pleased with the speed and ease of installation, along with the long term erosion protection the CC material provides which will significantly reduce the costs for future maintenance repairs for the flume.

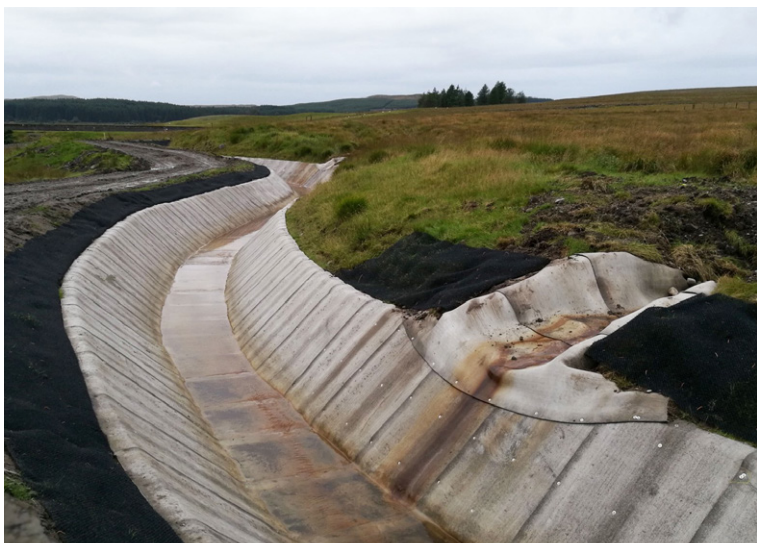
CC lined channel with corner & inlet channel detail

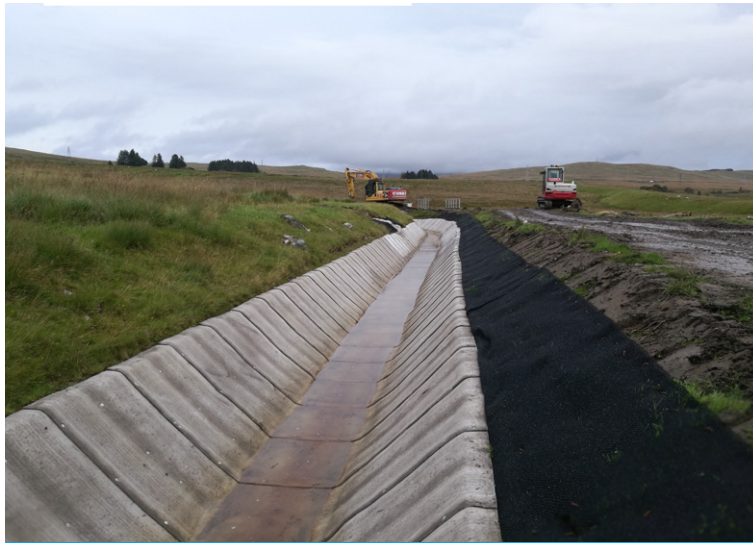
CC layers overlapped in the direction of water flow providing natural weep paths

In order to prevent any build-up of hydrostatic pressure between the original concrete slabs and the CC, the joints were left unsealed and free draining. These free draining joints create natural weep paths to allow water ingress into the flume. The end sections of CC were cut with an angle grinder post-set to provide a neat termination and any inlet areas with direct bank water runoff were either lined with CC or buried into an anchor trench. The CC material was hydrated after each day's work using a hose with spray nozzle attachment and a 6000L water carrier.

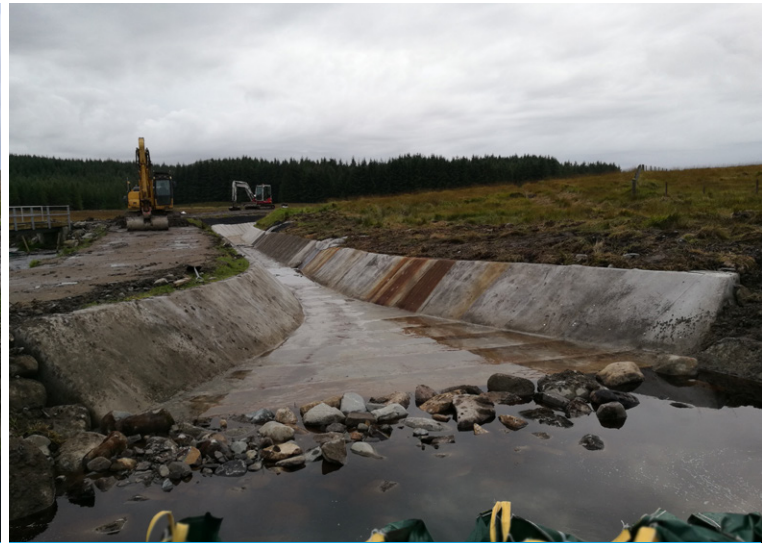
Flume inlet with an anchor trench running across the width of the channel

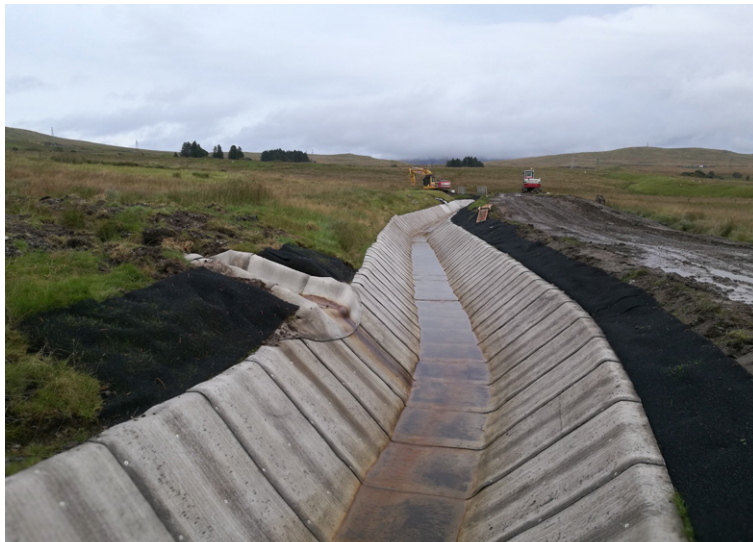
Remediated flume lined with CC8™ transverse layers

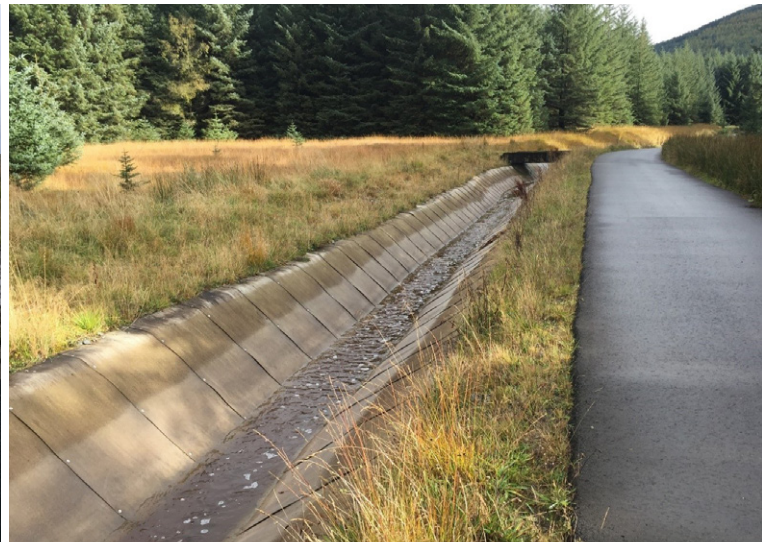
Original Bowburn Flume 4 years after installation requires minimal maintenance

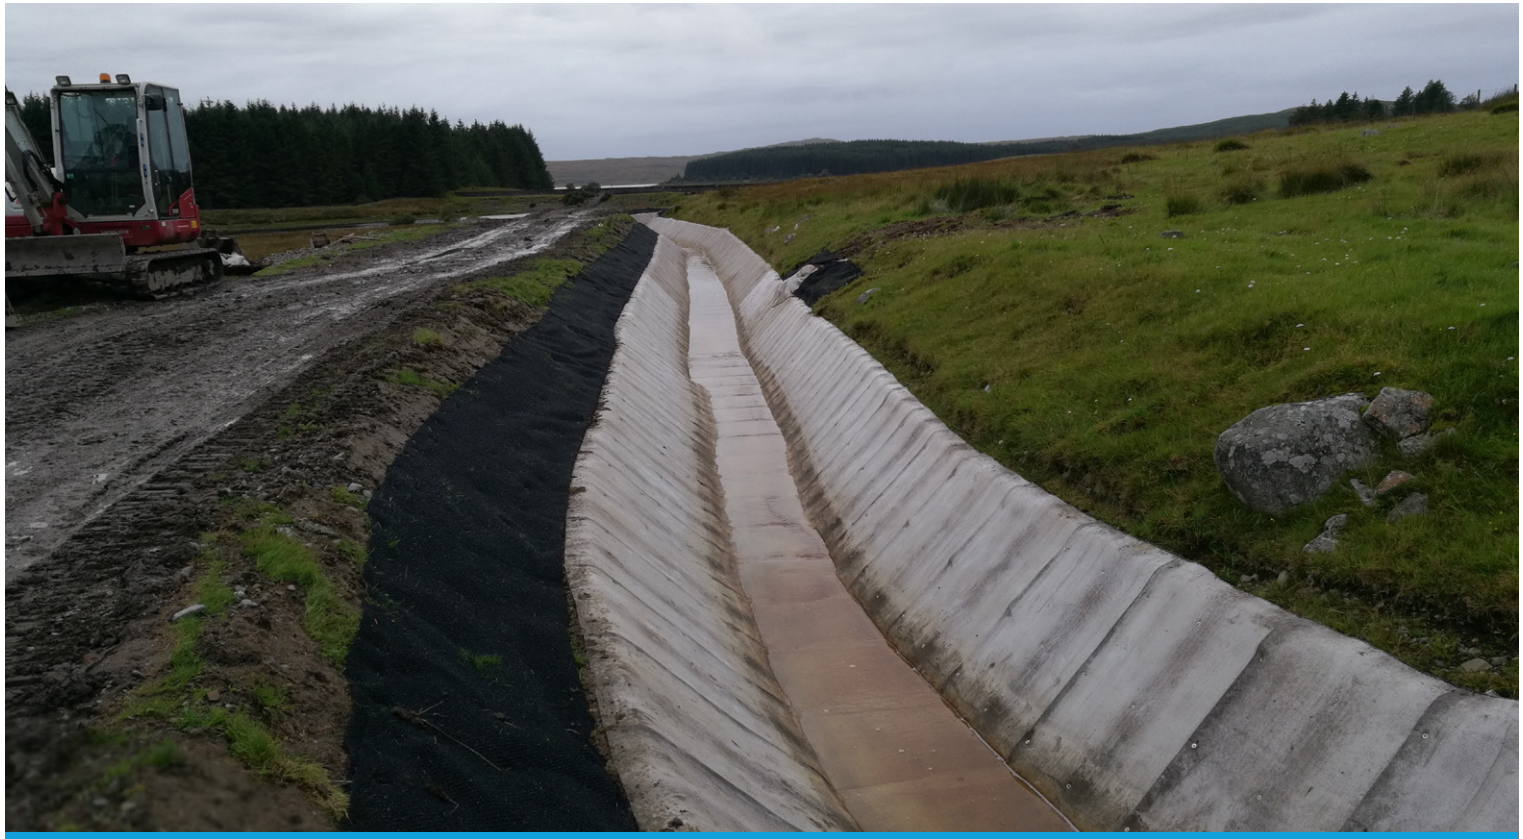
Completed Installation
