# White Paper

## Mitigating Corrosion/Erosion in Waste to Energy and Biomass Boilers

*Comparing the effectiveness of commonly used technologies, including refractory, weld overlay, thermal spray and high velocity thermal spray*

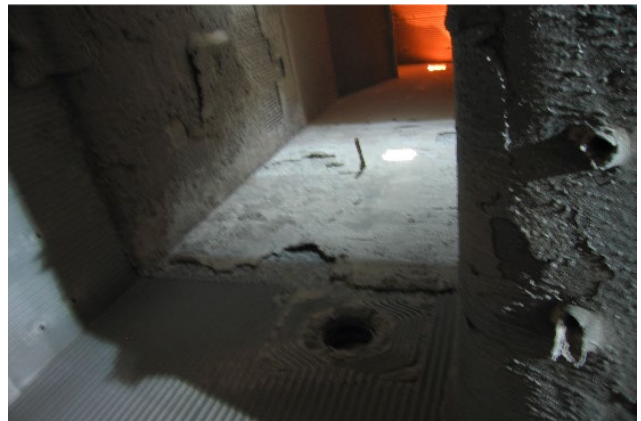
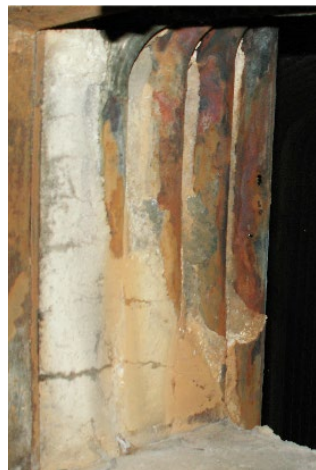
Almost New Refractory

**Refractory effectively protects the waterwalls but, due to its low heat transfer, even the latest generation materials reduce heat transfer significantly.**

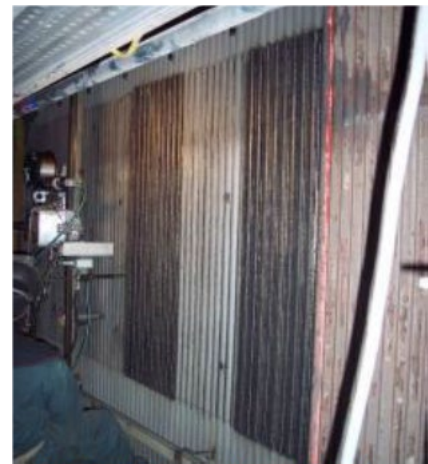
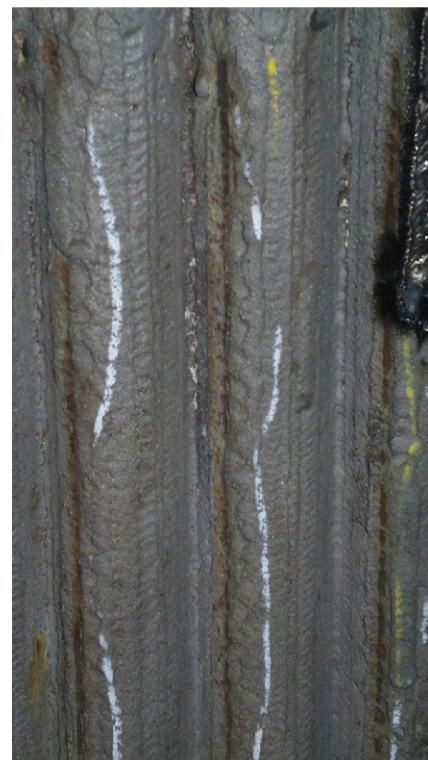
*Field services – on site weld overlay*

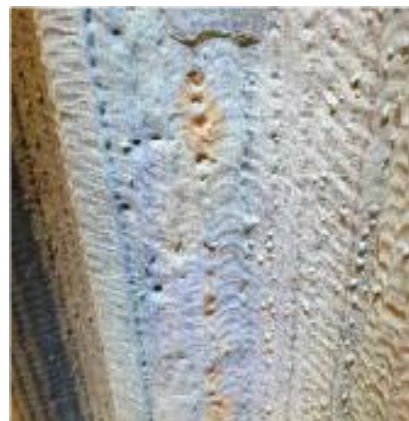
Shop weld metal overlay

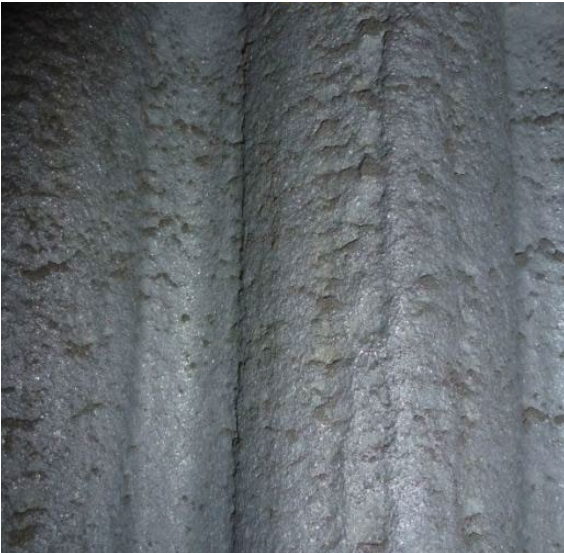
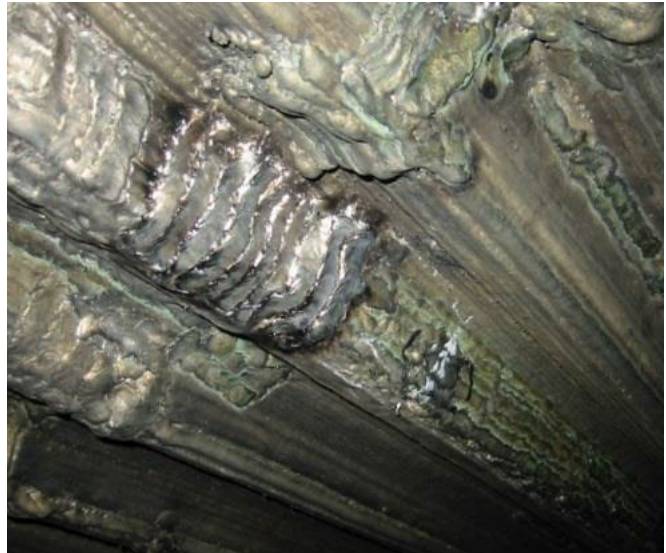
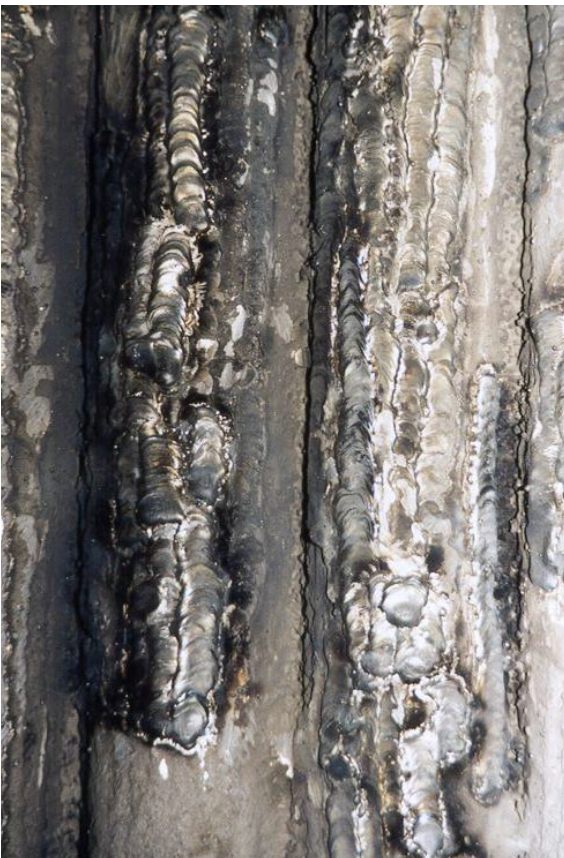
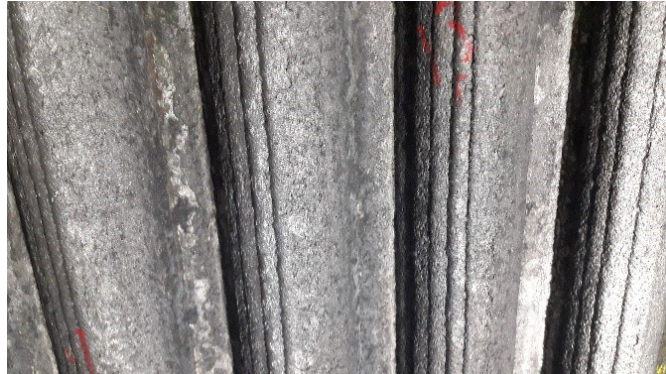
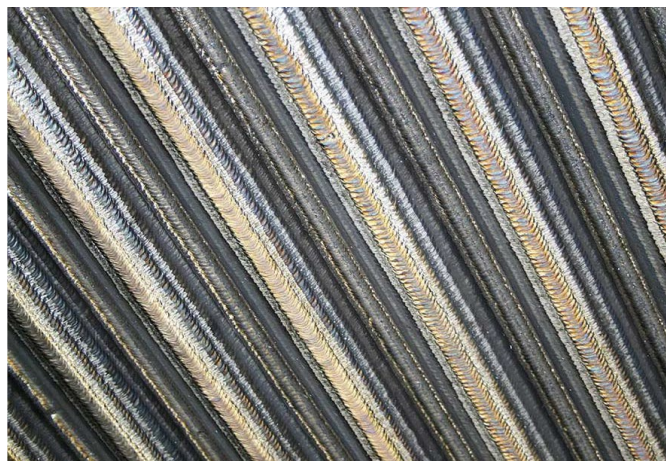
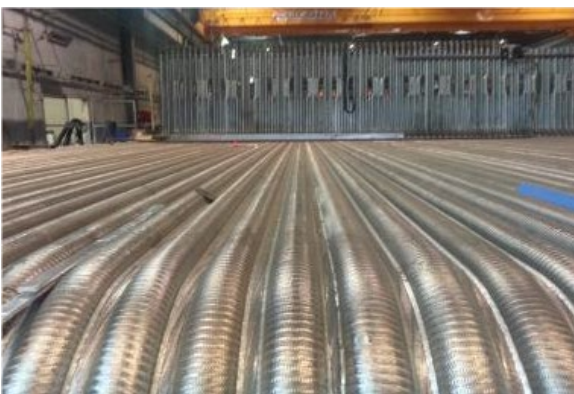
After years in operation alloy 625 weld overlay will also age. Typically, the surface becomes “spongy”. Chromium forms chromium oxide layers to protect from corrosion, but this layer gets worn and reformed until the layer of alloy is “consumed”. The phenomenon is not uniform, consequently some areas will age faster than others.

Weld overlay can be repaired, provided that surface preparation can be carried out to remove the “aged” material. This operation, usually performed by grinding, is time consuming. It can be performed locally to “maintain” the barrier, but once the aged surface is too large, the replacement with new shop-applied weld overlay panels or other protection means needs to take place.

**Alloy 625 performs exceptionally well at temperatures up to 400°C/752°F. Above this temperature, the lifetime is reduced by half with every 10°C/50°F increase**

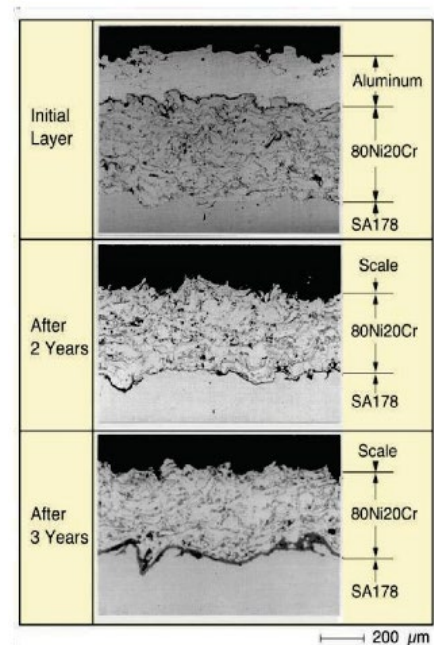
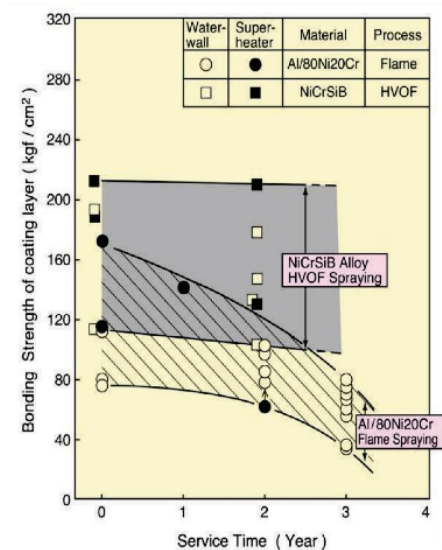
Thermal spray technology has been used for the application of erosion resistant alloys in the power industry since the 1980s. However, it was quickly understood that the thermal spray process itself negatively affects the properties of the alloy being sprayed and can be difficult to use for corrosion protection, with exception of TSA (Thermal Spray Aluminum), since it protects by the means of a cathodic sacrificial system. The resulting as-applied cladding, when using off-the-shelf metal alloy wires and conventional thermal spray equipment, was permeable. This endemic permeability as a result of the structure and as sprayed chemistry, weakened by high internal stress and low bond strengths with the base metal, created a unavoidable pathway for corrosion agents.

Once the corrosion agents reach the substrate, corrosion, sometimes even accelerated, can develop under the coating causing delamination from the substrate.

Some improvements have been unsuccessfully attempted with sealants or bonding layers, only lasting ~2-3 years in service.

HVOF (High Velocity Oxy Fuel) can be performed with better results, but the application is limited to shop only, due to safety and process control factors for manual application. As a result, annual maintenance is required to ensure lasting performance.

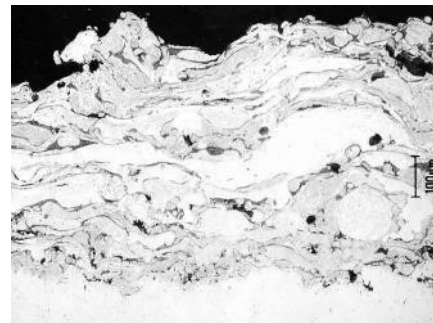
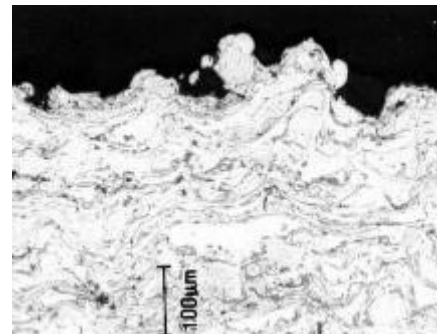
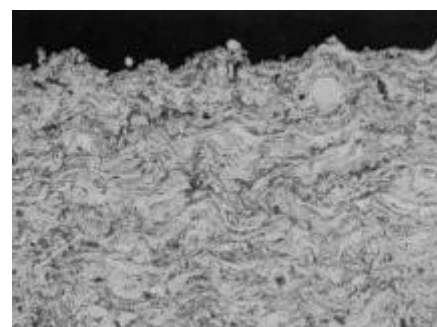
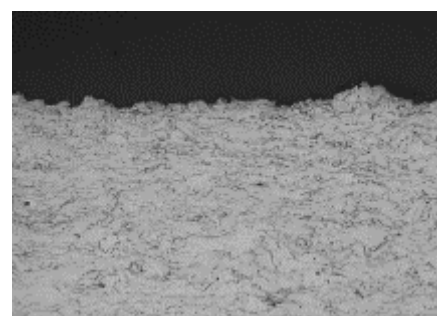
Traditional thermal spray processes create permeable layers, which manage to interconnect and create a path for the corrosive agents. The first priority for the development of this new technology was to apply a minimal permeability layer.

Increasing the propelling gas speed facilitated the metal droplets atomization in smaller particles with a more homogeneous size. In addition, these particles reach the substrate with higher velocities. However, melting metal alloys “in air” leads to the oxidation and sensitization of the particle surface, while replacing the air by an inert gas is not an option from the safety and cost perspective.

A clever solution has facilitated the reduction of oxide content below 1%.

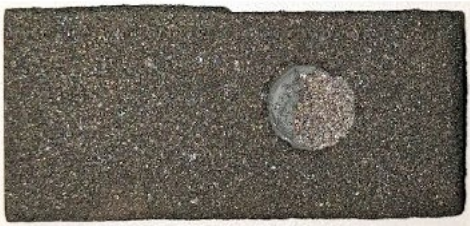
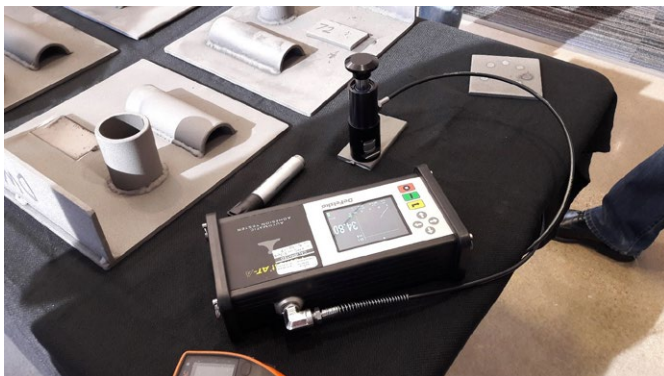
The Thermal Spray applied cladding is anchored by mechanical connections, mainly related to surface preparation and particle chemical properties. The bond strength is even more important with high operating temperatures. Applied CRA materials have similar coefficient of thermal expansion to the base metal, in order to reduce stress at the interface. The thickness of the CRA layer is also critical.

When corrosion develops at the interface, the bonding resistance disappears, since the iron oxides have no mechanical strength. Clean-blasting, in addition to removing the dust layer, will also generate mechanical forces to remove the non-bonded layer.

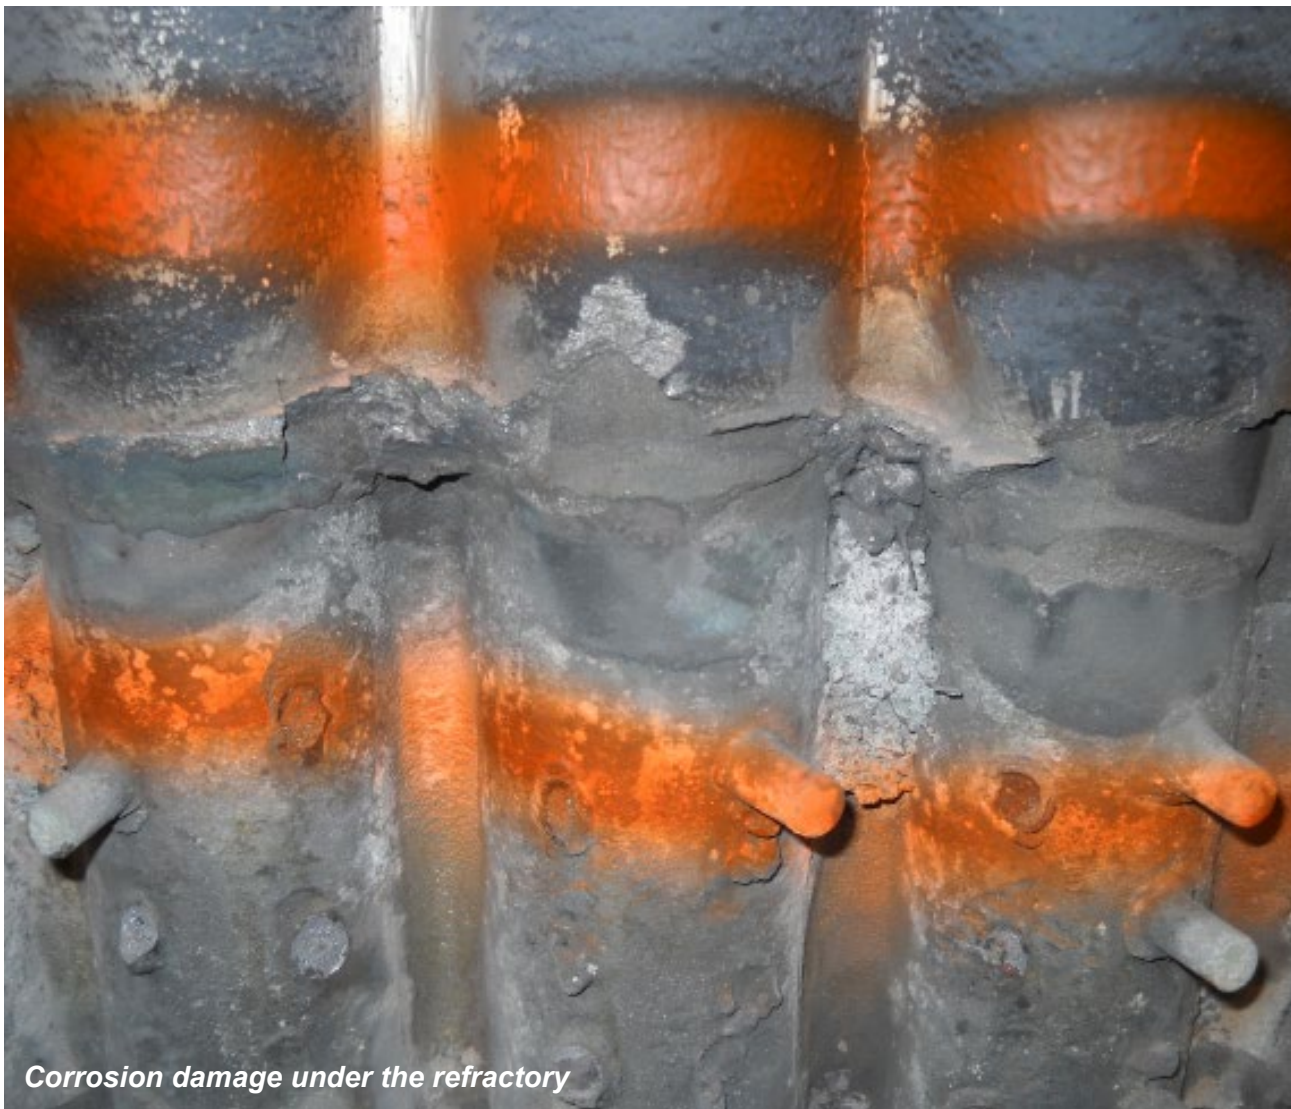
*Corrosion damage under the refractory*

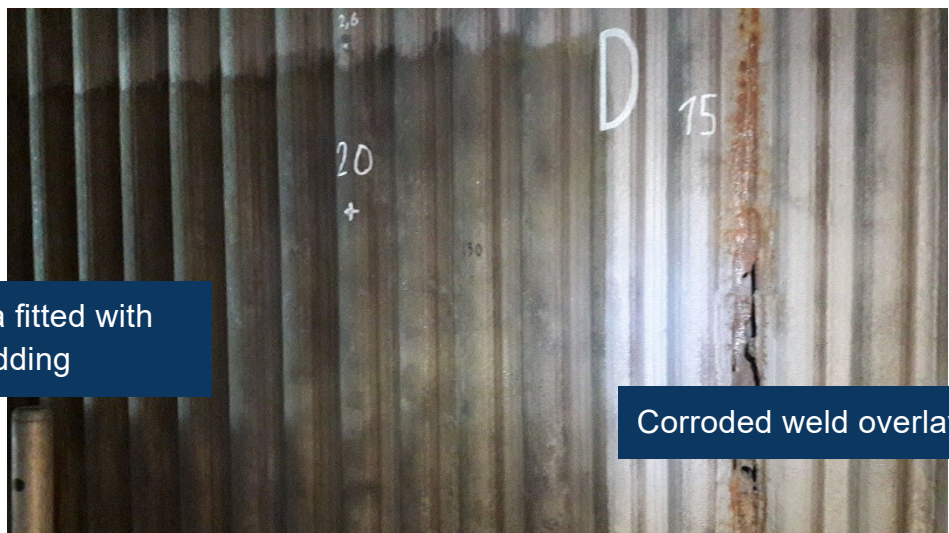
No corrosion on area fitted with IGS 5000 Series cladding

Corroded weld overlay

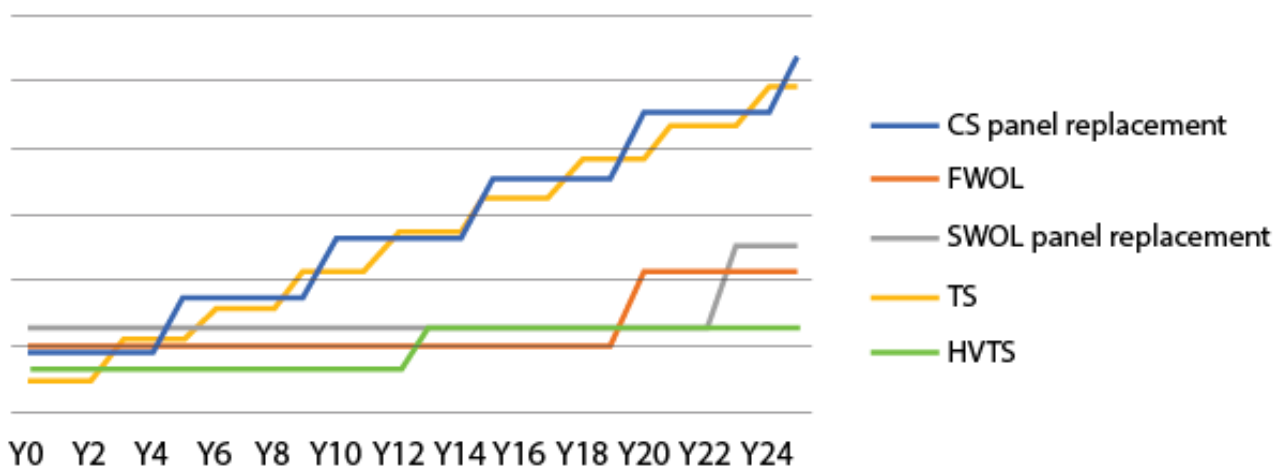
### 150m<sup>2</sup> projected waterwall

The following table gives indication of the cost versus return on investment of various solutions for a projected surface 150m<sup>2</sup> area. The cost can vary slightly based on the location, while the lifecycle may vary significantly based on location, fuel, boiler design and other influences. Life cycles for the different options relative to each other remain somewhat consistent though.

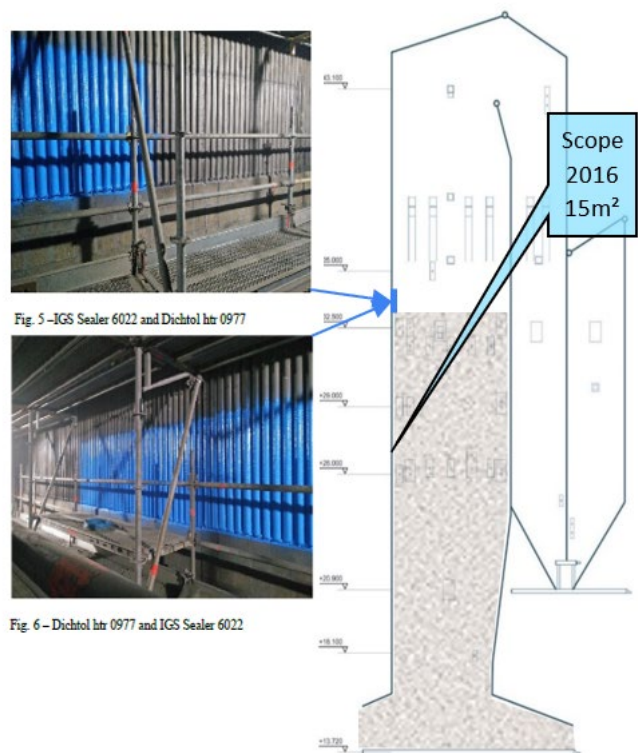
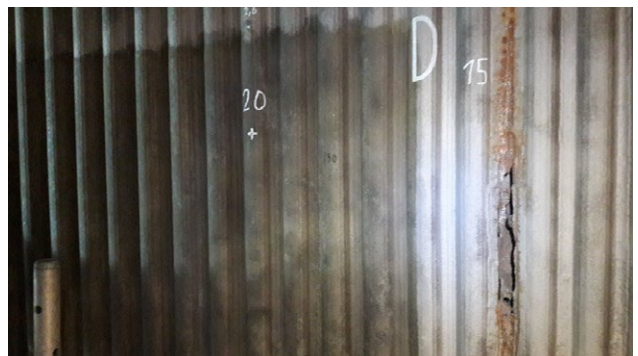
The inspection in 2019 has revealed:

- Unprotected alloy 625 weld overlay continued to degrade, with through-wall defects on the membrane
- Alloy 625 areas protected with IGS8000 series, a material previously developed for the coal power sector, were exposed
- Alloy 625 areas protected with IGS5000 series, a material developed specifically for the WtE and Biomass industry in 2016, showed no signs of wear or degradation. IGS5000 series was unaffected with no spalling or degradation, even on the membranes, after 32 months in service.

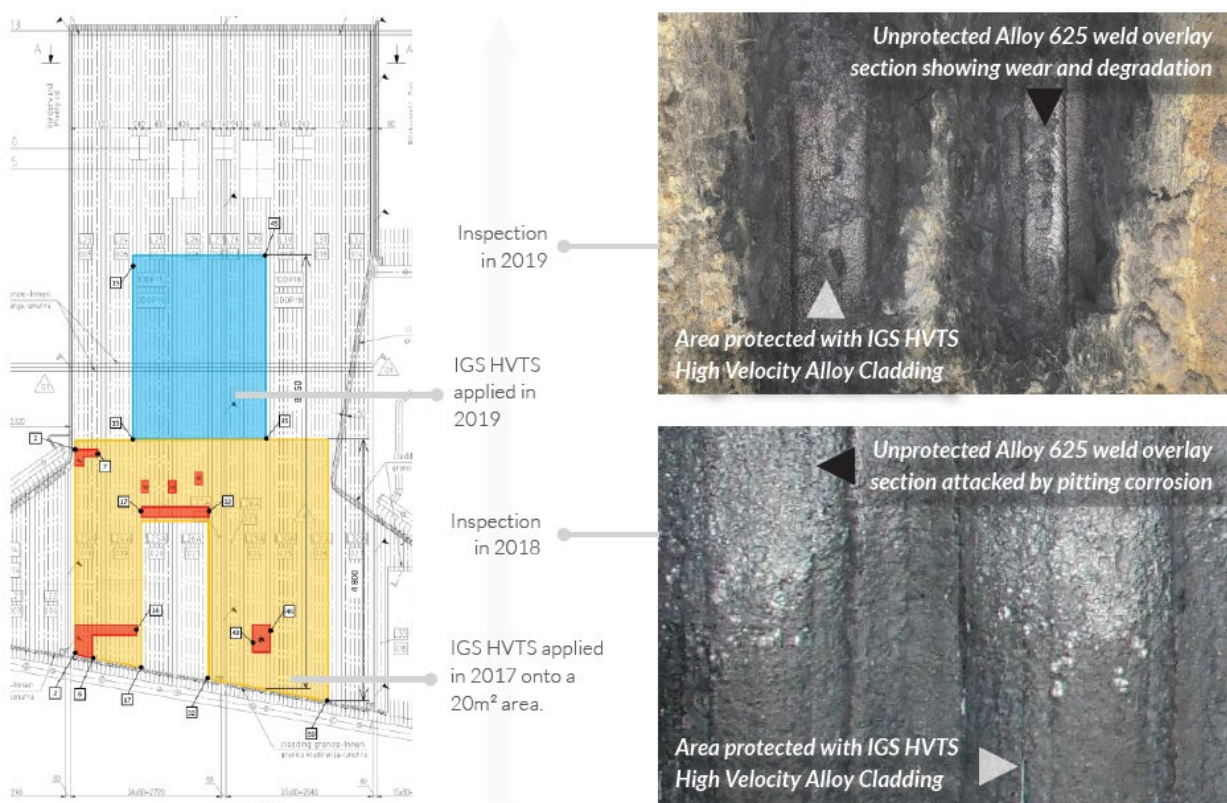
Rapid alloy 625 degradation was being observed on the waterwall panels after one year in operation. The plant needed to maintain a 98% availability and could only consider solutions that could be applied within tight turnaround schedules.

As a result, Rennergia has elected to test four thermal spray vendors. Each was given a small area within the boiler, performance was evaluated after one year in operation, during the next turnaround. Two of the vendors who used a low velocity thermal spray process have failed as their cladding delaminated and exposed alloy 625 to further degradation. IGS 5000 series and another cladding, both using the High Velocity Thermal Spray (HVTS) process have performed well. Due to the other vendor's capacity limitations, IGS was awarded the contract in boiler protection.

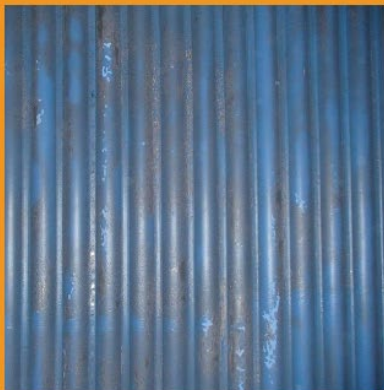
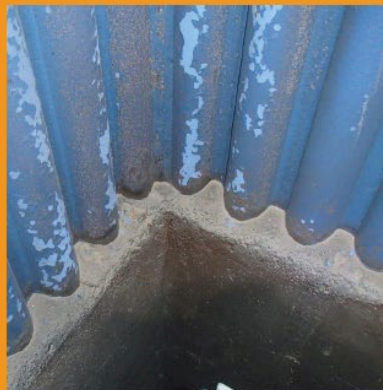
2018 INSPECTION

In August 2018, IGS conducted its first annual inspection of the cladding with no deviation on the HVTS cladding thickness. Inspection the following year was conducted, and the report stated: “No black areas were detected (bleed through), the cladding turned out to be completely intact and without material loss. Measurements taken showed results similar to those from the year of application.”
