Decommissioning and Restoration – Fostering Excellence through Regulations, Innovation, and Sustainable Practices

30–31 JULY 2024 | BANDAR SERI BEGAWAN, BRUNEI

Identify, Remediate and Verify Cross Sectional Cement Barriers for Permanent Well P&A

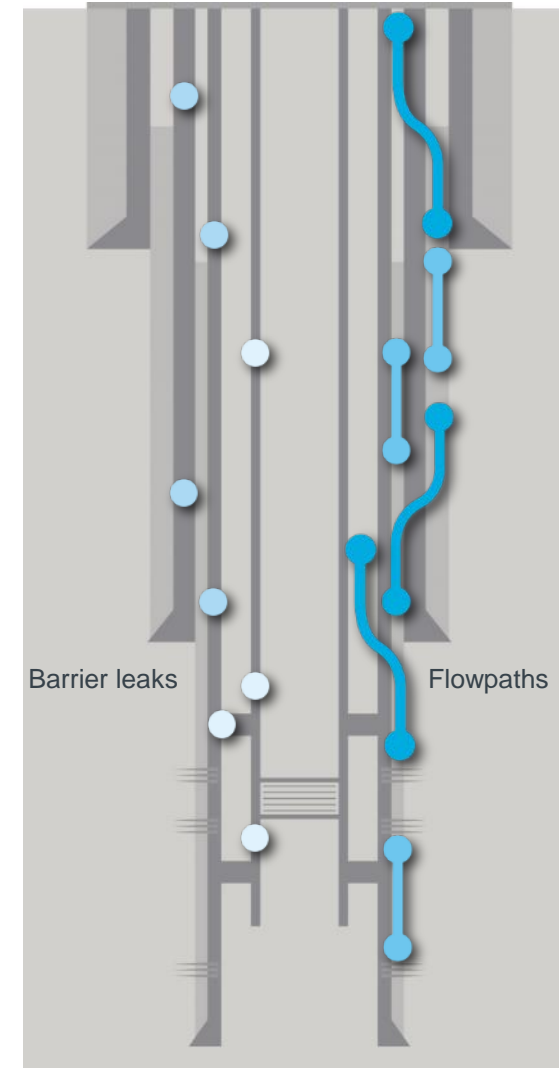
A well is a complex system – multiple potential failure modes

Barrier leaks

- Fluid movement from one side of a barrier to the other
- Tubing
- Production casing
- Outer casing strings

Flowpaths

- Fluid movement along the wellbore
- May be behind multiple casing strings
- A full flowpath may include a barrier leak

The acoustic energy at the tool will depend on many factors:

- Fluid type
- Differential pressure
- Leak rate
- Frequency of sound produced
- Proximity of the source

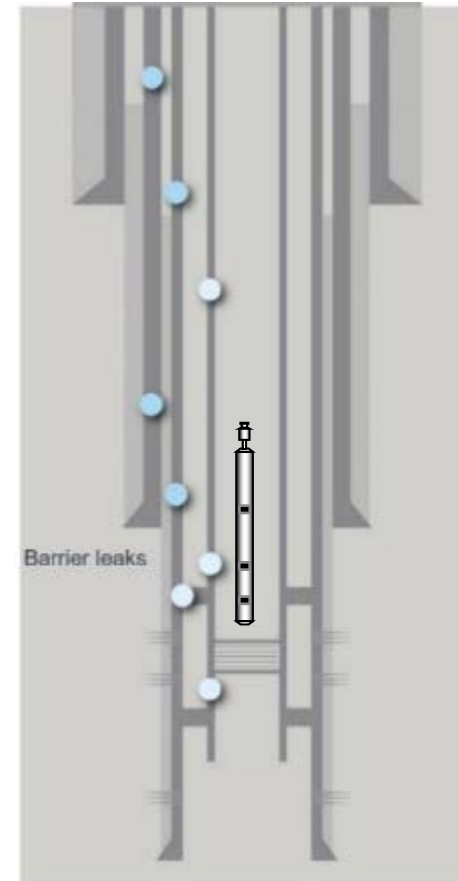
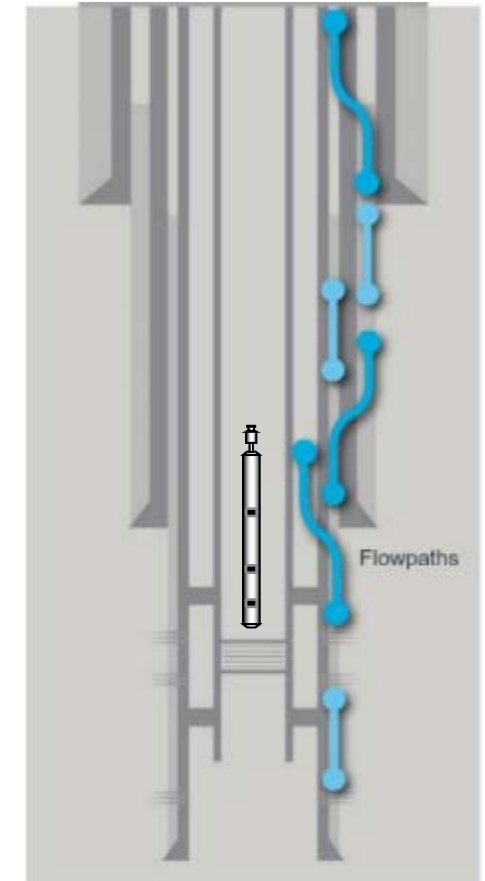
Active acoustic-cement condition

- First barrier
- Further barriers?

Passive acoustic-cement performance

- First barrier
- Further barriers ✓
- Complex leak paths

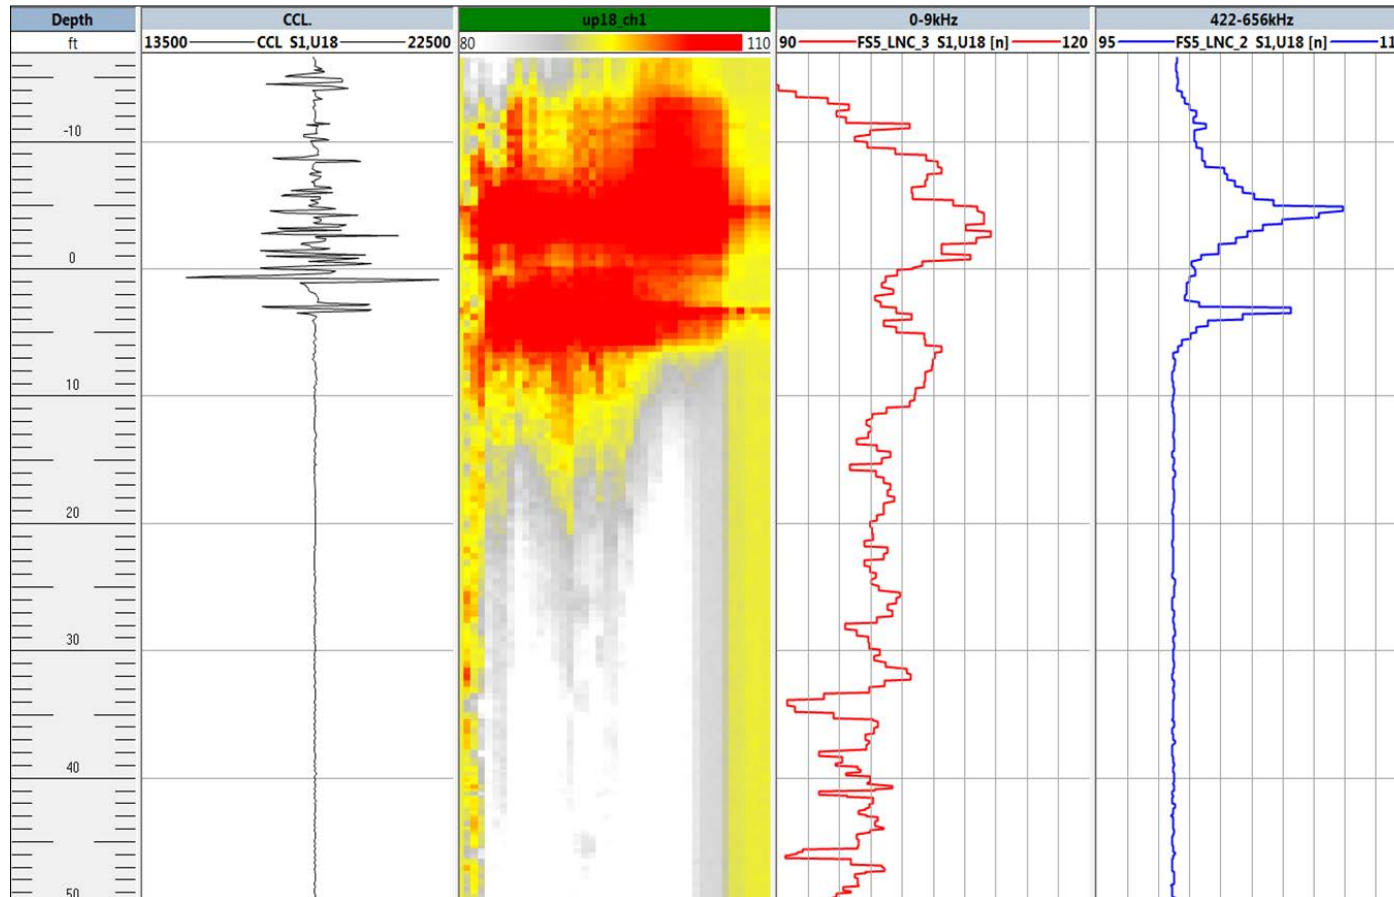
Comprehensive downhole acoustics diagnostics

- Acoustics event more evident at 422-656kHz for this leak
- Absence of broad frequency bandwidth is detrimental

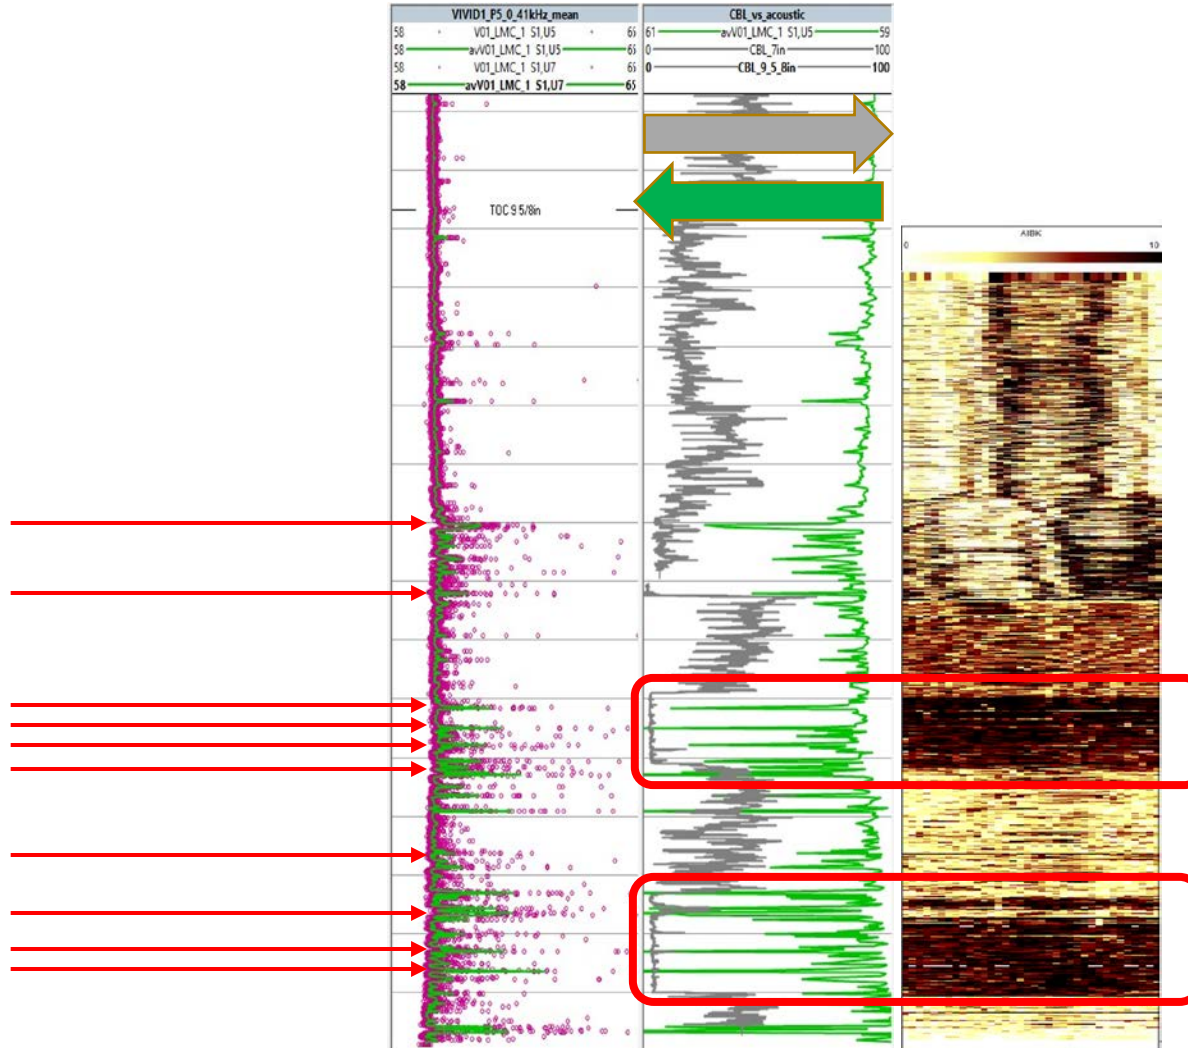
Cement performance & condition

- Zone of interest
- Temperature
- Acoustic
- Bond log with passive acoustic
 - CBL Amplitude
 - Time-averaged Noise
- Impedence map
- “Good” Cement
 - Low CBL amplitude
 - 360° coverage – no channels
- Clear leak path
- 250m “good” cement **LEAKING**

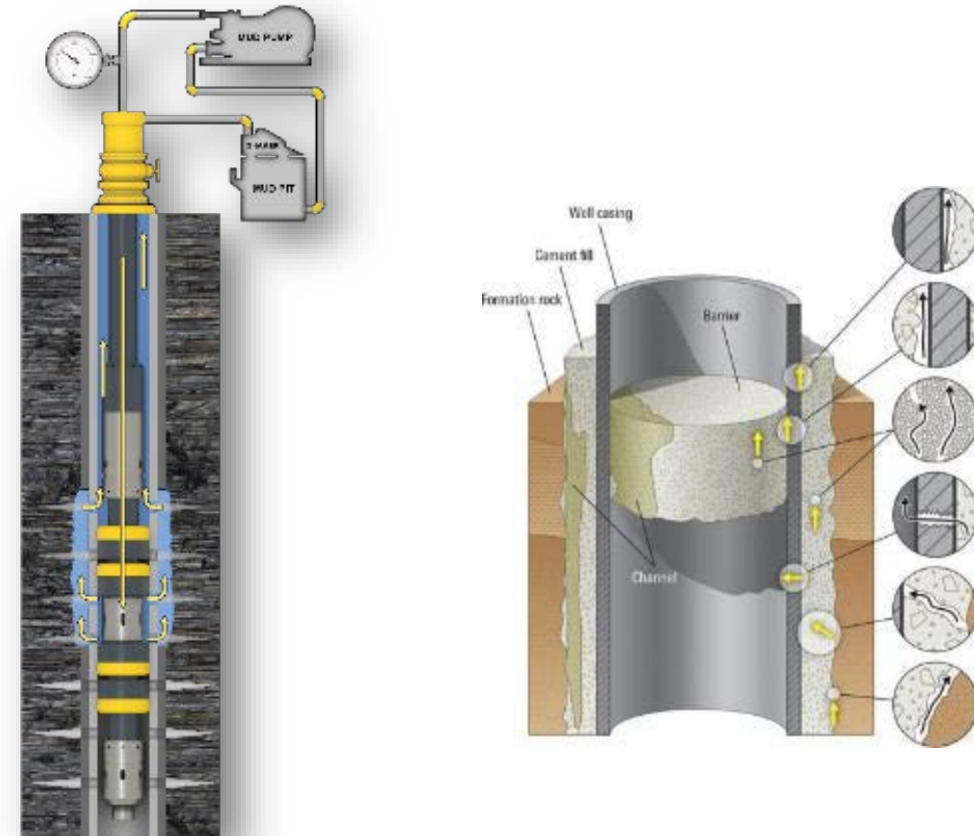
Features and Benefits

- Time-saving alternative to Section Milling
- Closed loop system for optimum use of hydraulic energy
- Traditionally used for loose annulus content
- Continuous service quality improvement

Typical length of interval

- Combining Primary and Secondary Barrier
 - 80 m to cover min 2 x 30 m
- Single Barrier
 - 50 m to cover min 1 x 30 m

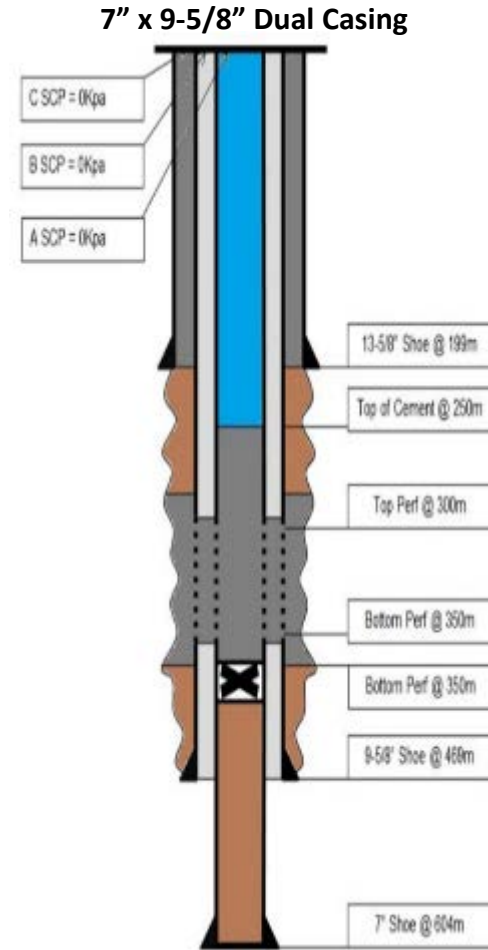
Pressure had been observed on the B annulus between 7” 29# and 9 5/8” 40# casing of up to 1100 kPa. Gas was clearly migrating through a poor foam cement job.

A thorough wash through 7”x 9 5/8” into 12.5” bore hole with 10,4ppg weighted mud followed by a systematic spacer/cementing pump and pull process weighted 12.5ppg Class E + and 15.8ppg Class G respectively. The close loop system with opposing swab cups allowed us confidently to displace the cement exactly into the target zone through the perforations.

A solid rock to rock barrier replacing the original poor foam cement. Gas migration to surface has now ceased, allowing surface casing pressure to read 0 kPa after final bleed off inside of the B annulus. The well now no longer requiring constant manual bleed down by well integrity operators to keep below the MAASP rating of 1500 kPa. Six months on from the operation being conducted and pressure at surface remains at 0 kPa

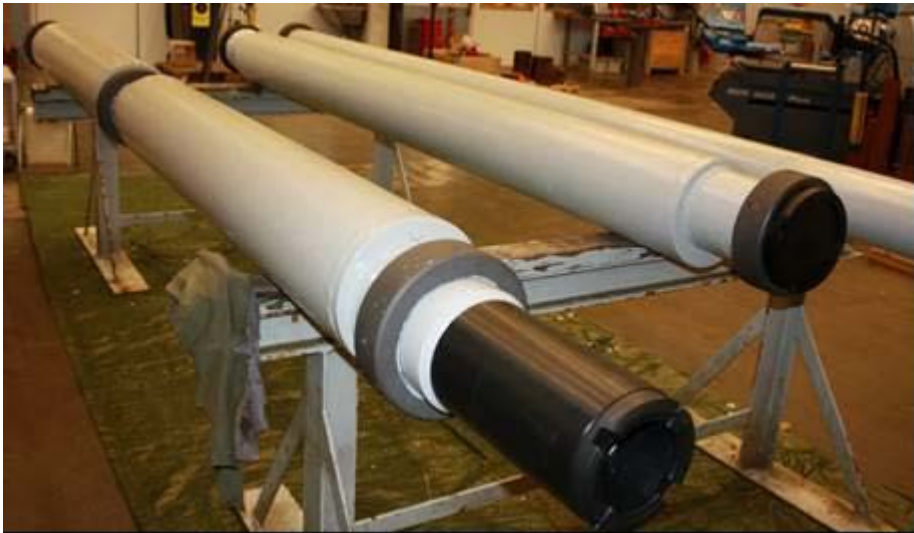
Verification of barrier – Cement Performance Evaluation

- Condition vs performance
- Test cells designed
- Good cement bond log

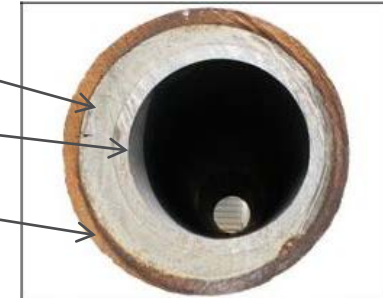
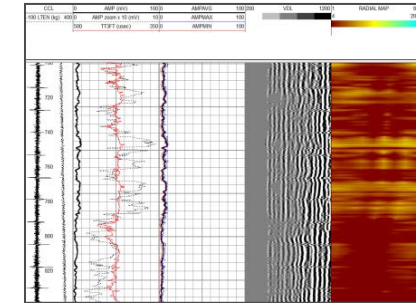
Expanding Class G cement

7" tubing

9-5/8" casing

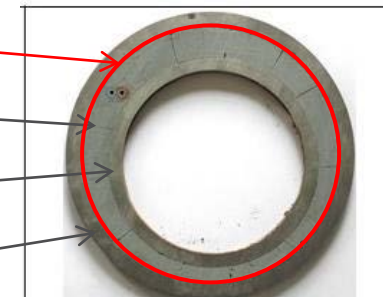
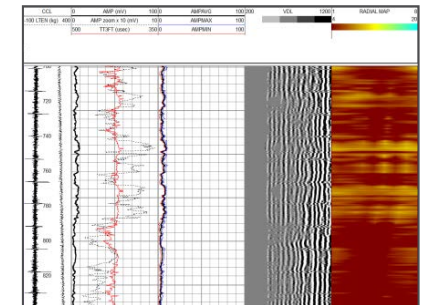
Exterior micro-annulus

Standard Class G cement

7" tubing

9-5/8" casing

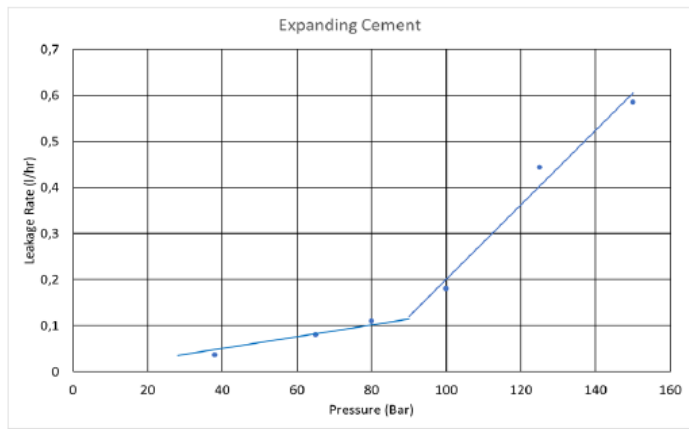
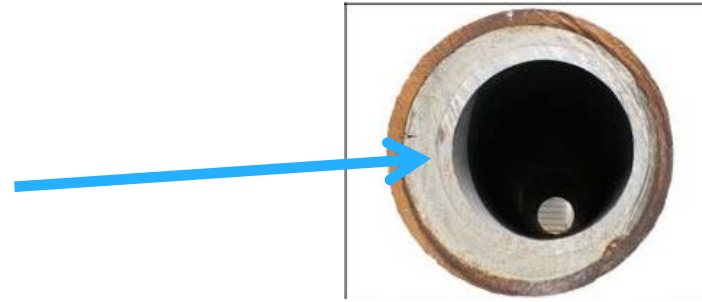
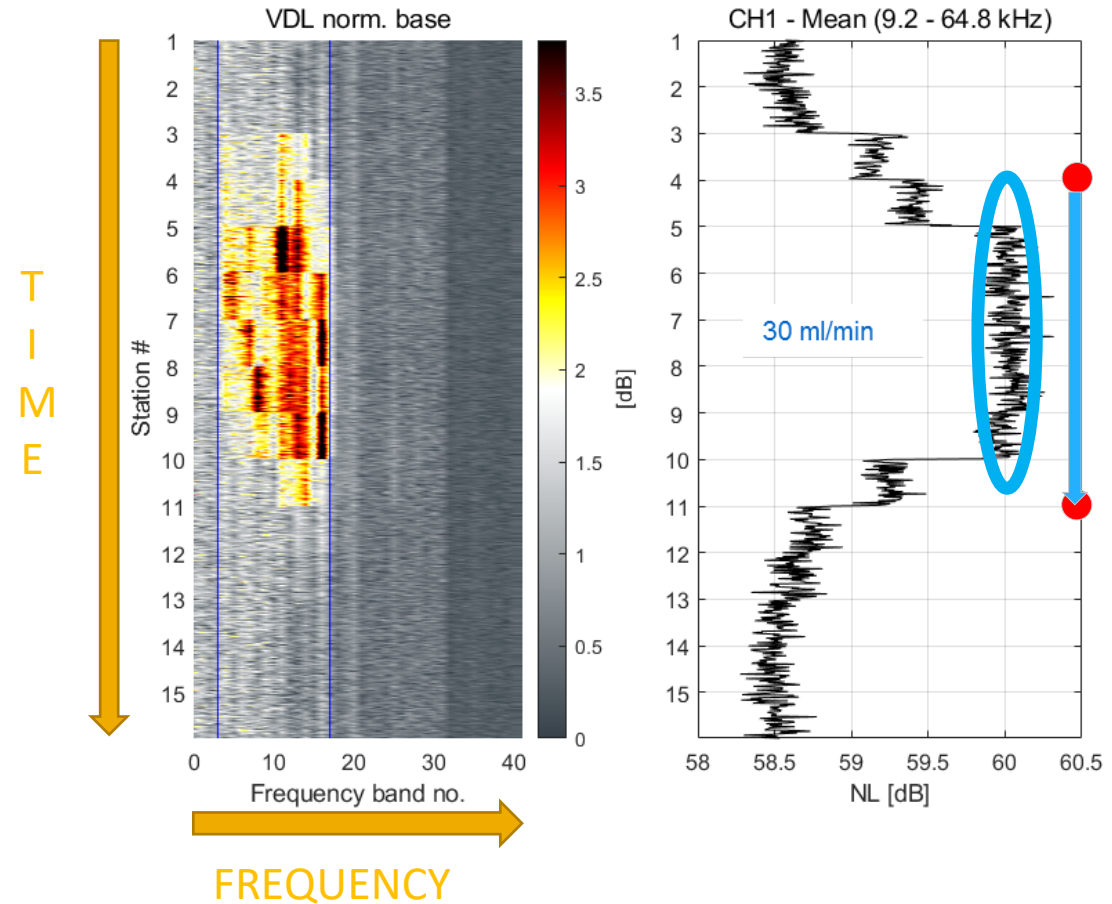
Good cement?

- Water pumped into cemented annulus
- Cement debonding at high pressure
- Data recorded for 1 minute every 25cm
- Elevated noise through test section
- Metered at 30ml/min (0.008gpm)

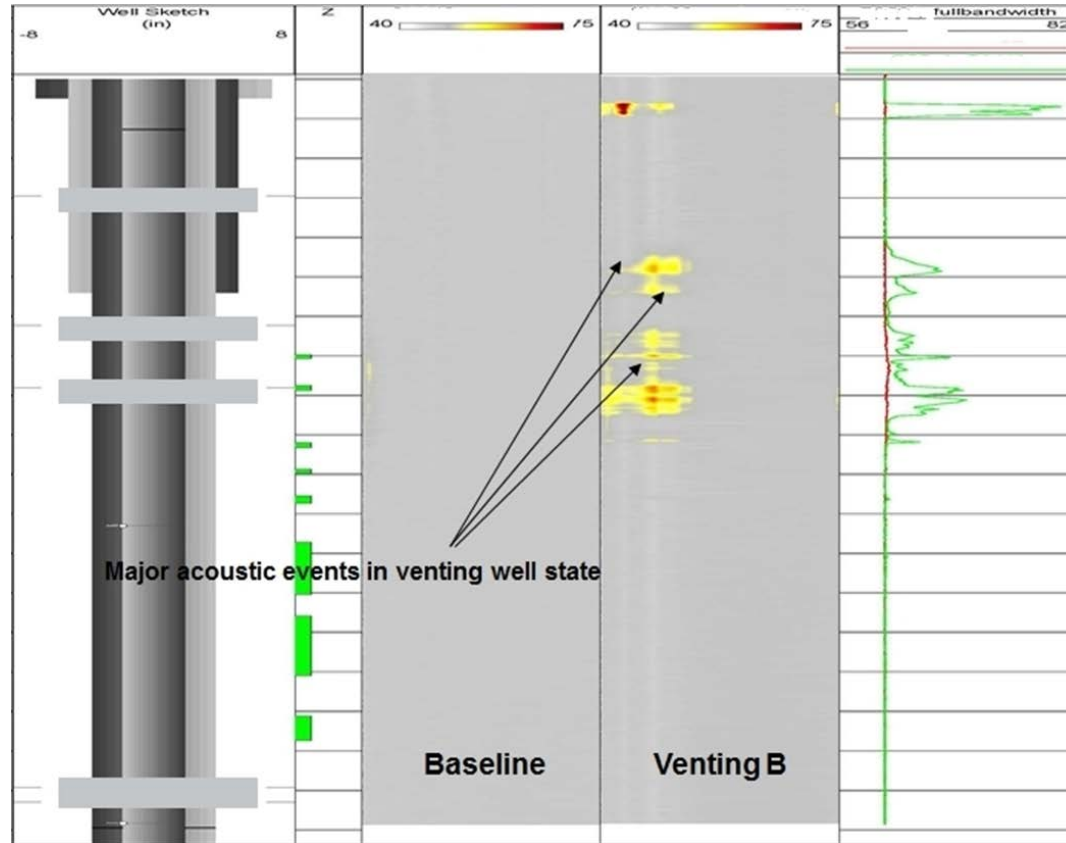
Cement Performance Evaluation

- Build-up around 70psi per day
- Venting B annulus activates flow
- Mapping of the migration to surface possible
