Decommissioning and Restoration – Fostering Excellence through Regulations, Innovation, and Sustainable Practices

30–31 JULY 2024 | BANDAR SERI BEGAWAN, BRUNEI

The Development of a Rigless EPSm Framework to Decommission Mature Phase III Well Stock in Australia

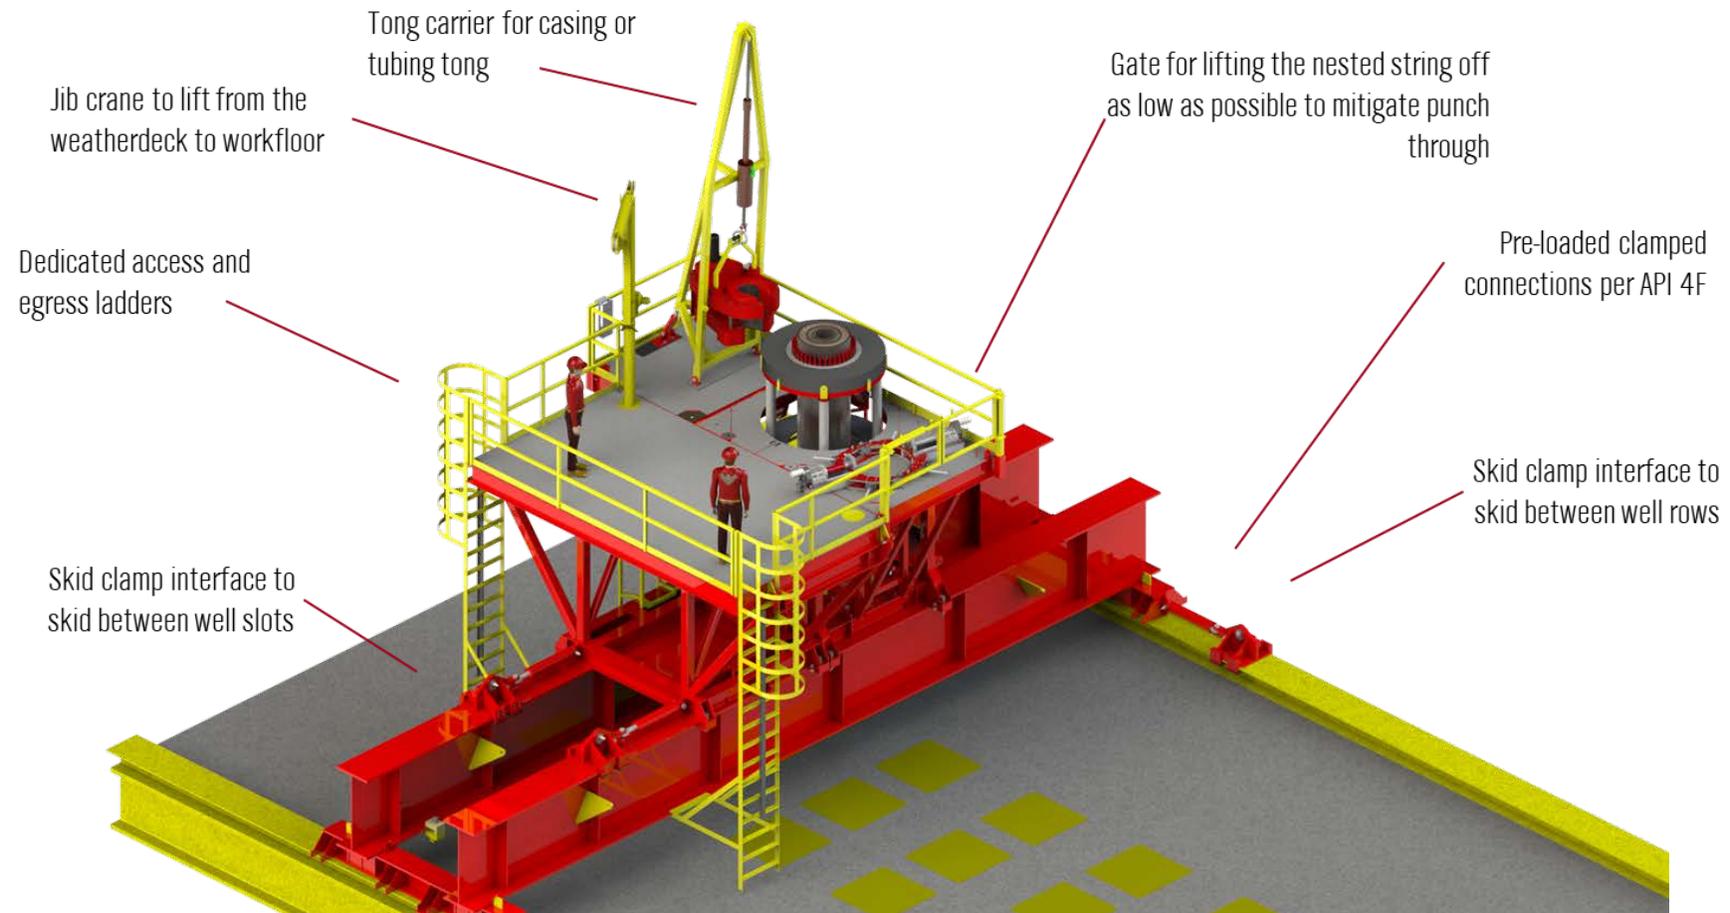
Sustainability – The Unit – Doing what an MODU Can Do!

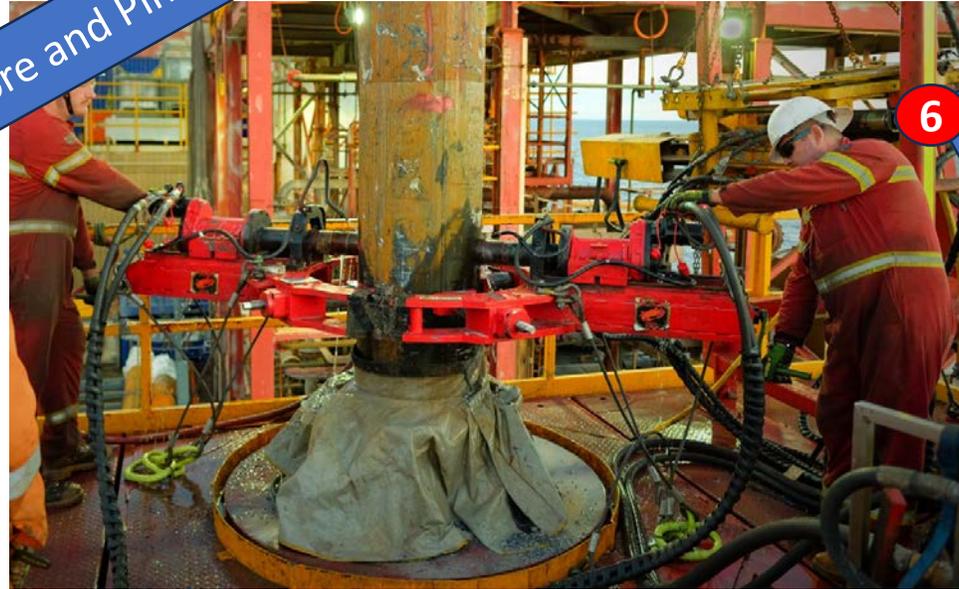
4

Bore and Pin

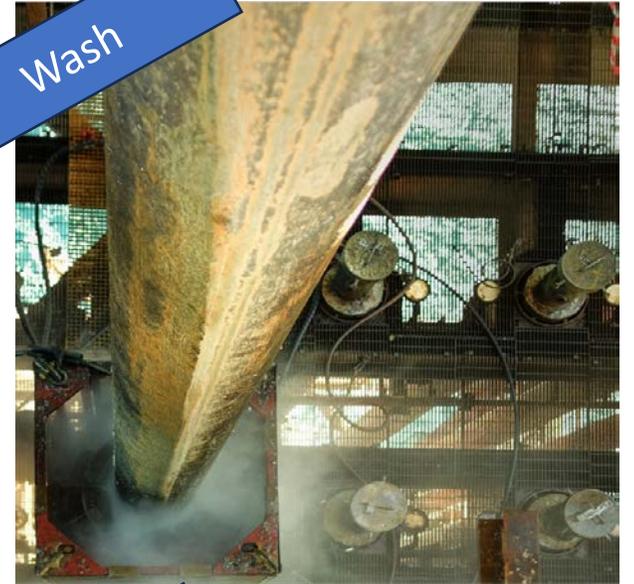
6

Wash

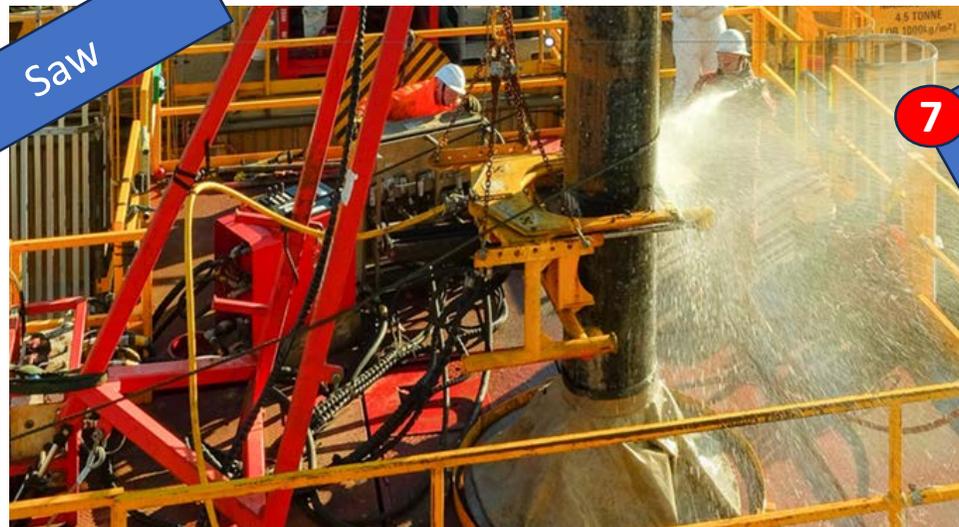
5

Saw

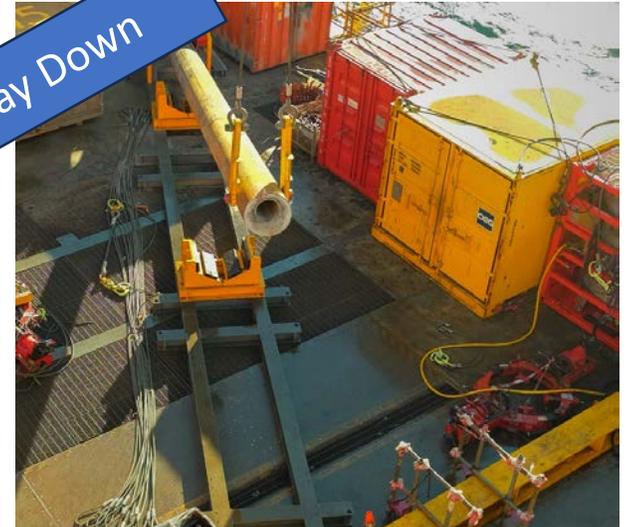
7

Lay Down

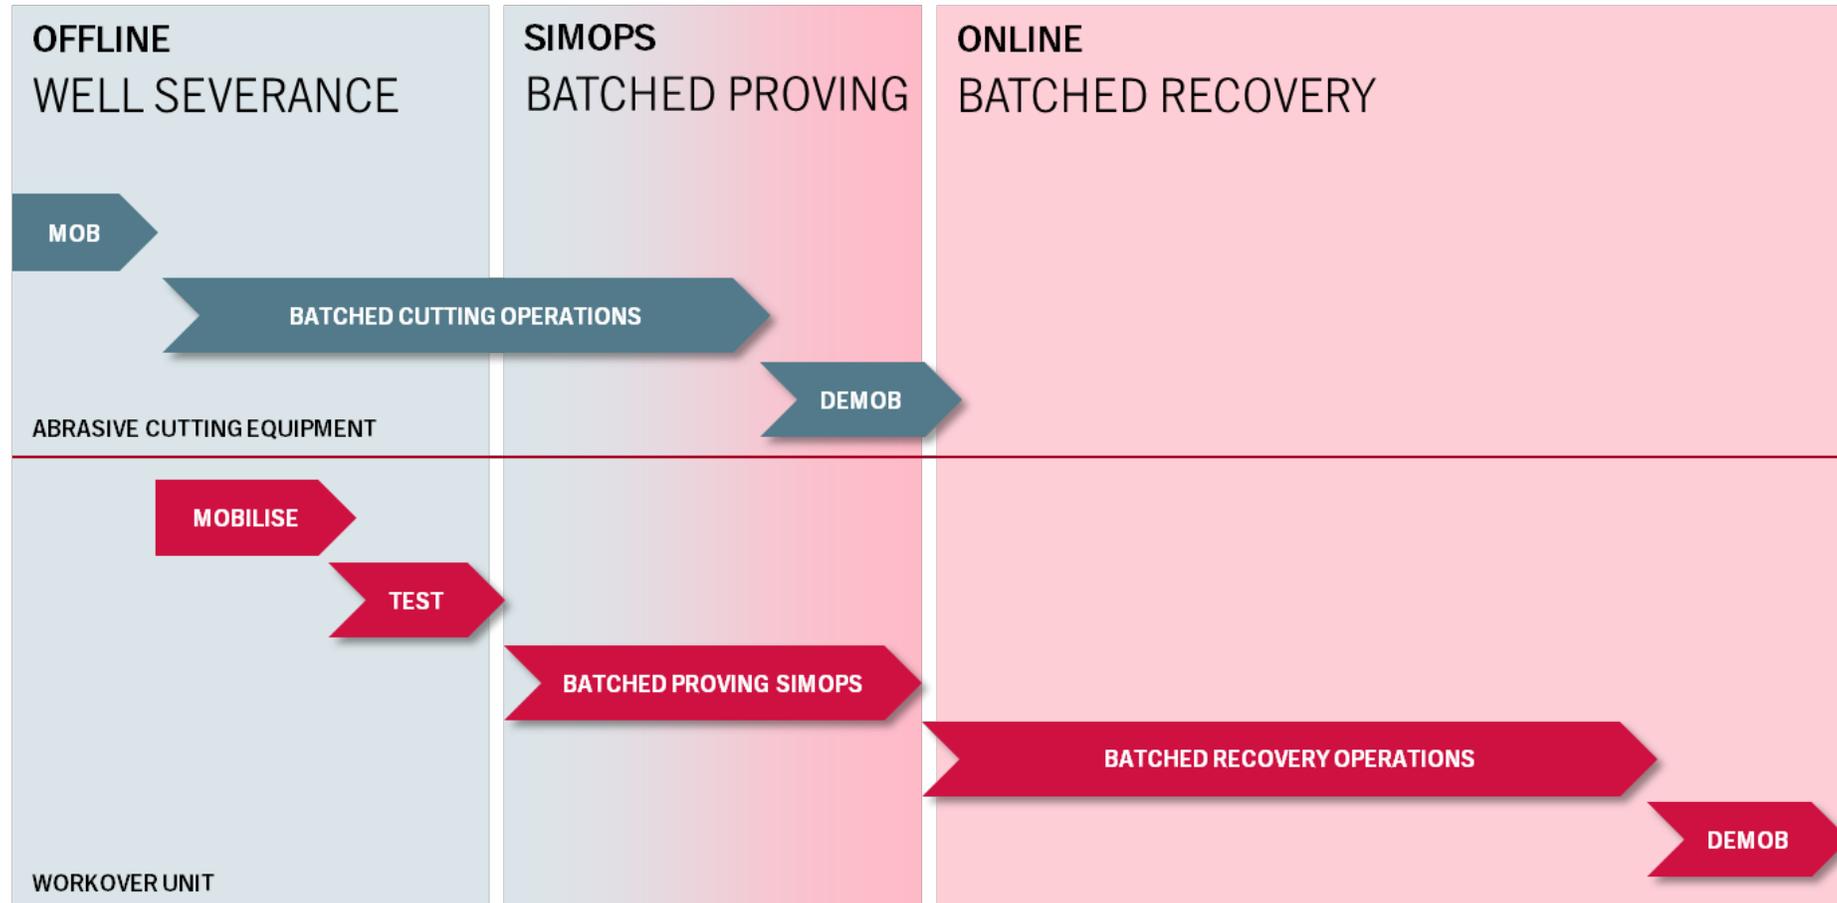
SIMOPS and Optimisation – Execution Framework

- 21 Wells
- 3,394 Operating Hours
- 0 QHSE Incidents
- 99.1% Productive Time
- Multi-Skilled Decom Crew
- 7 Service Lines
- 1st In country project developed with regulatory approvals

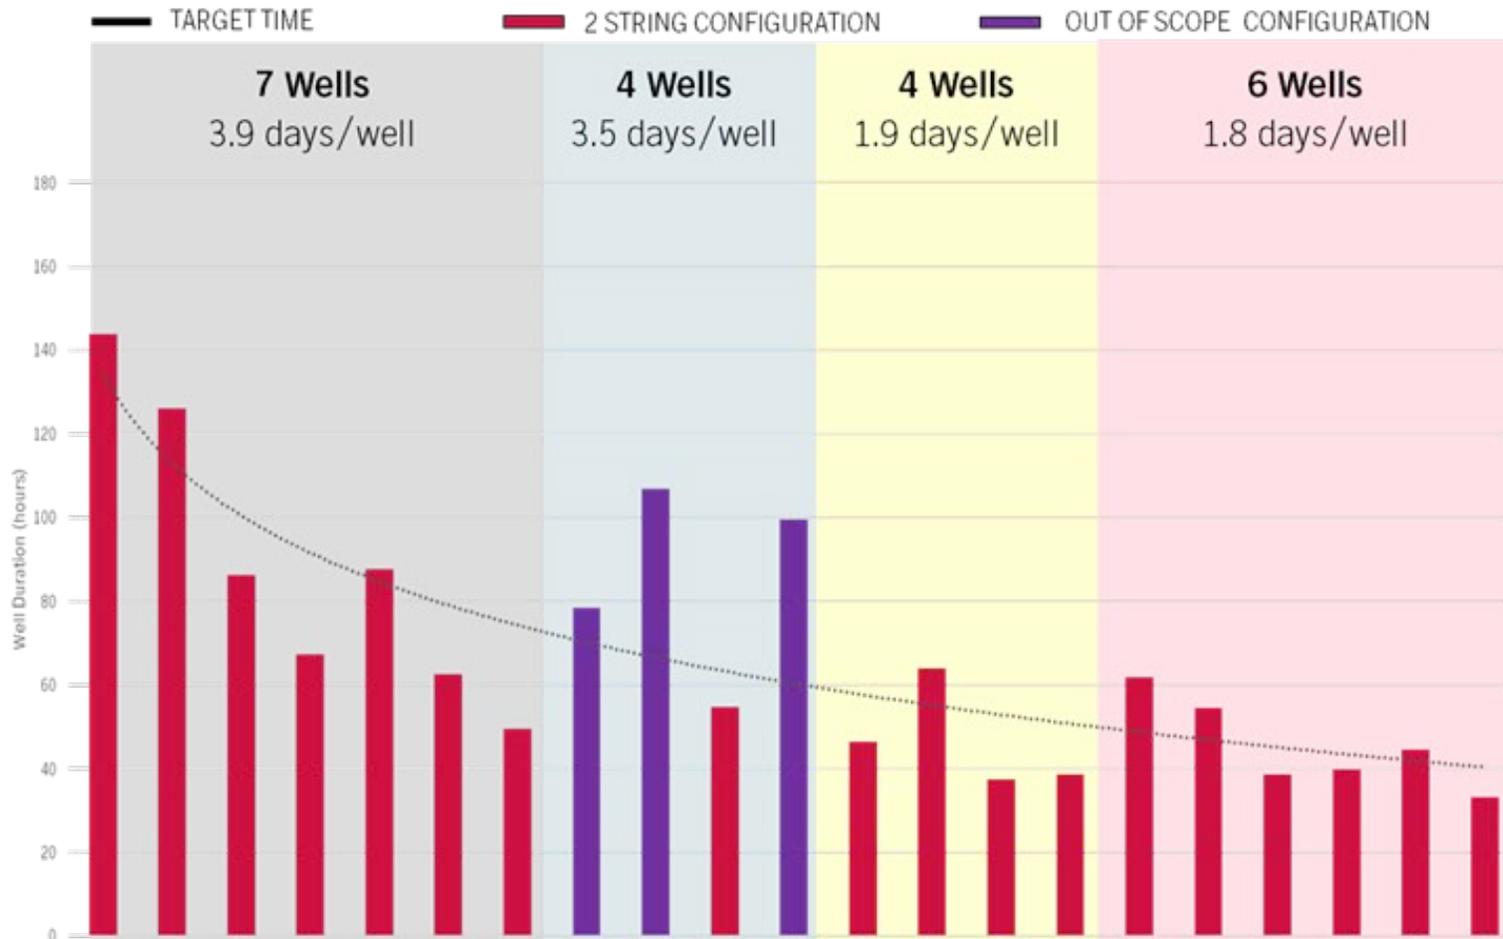
Learning Curve Breakoff

- Breakoff significantly higher – COVID
 - Use of local crews only
- 3 Wells – **Purple** – Wells Out of Scope
 - Found irregular wellheads
 - Additional casing – Client unaware!
- Strong Learning Curve Performance:
 - Core Crew / Multi skilled
 - 21 wells – 3400 operating hours
 - 99% Productive Time

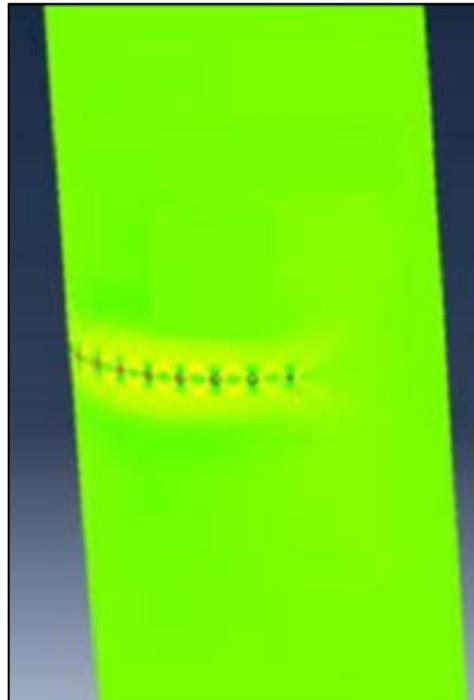
FAILURE

Material loss in prevailing wave direction

RESULT

Pinhole corrosion through surface wall

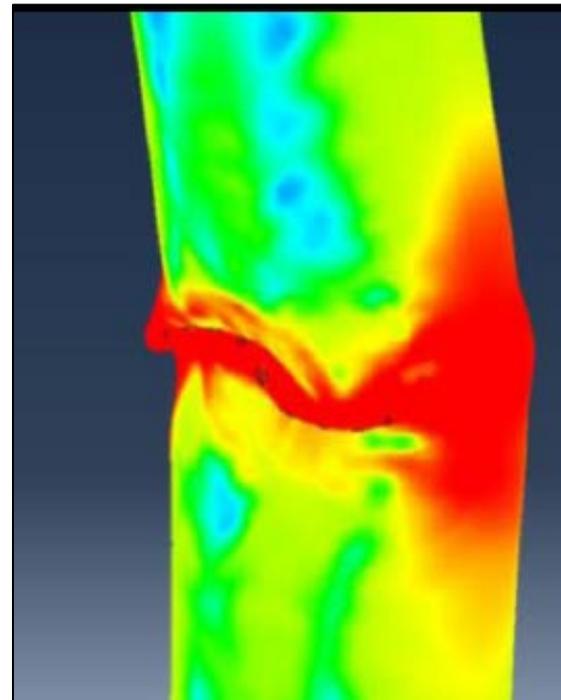
FAILURE

Buckling (collapse) of conductor

RESULT

Compressive collapse and material failure

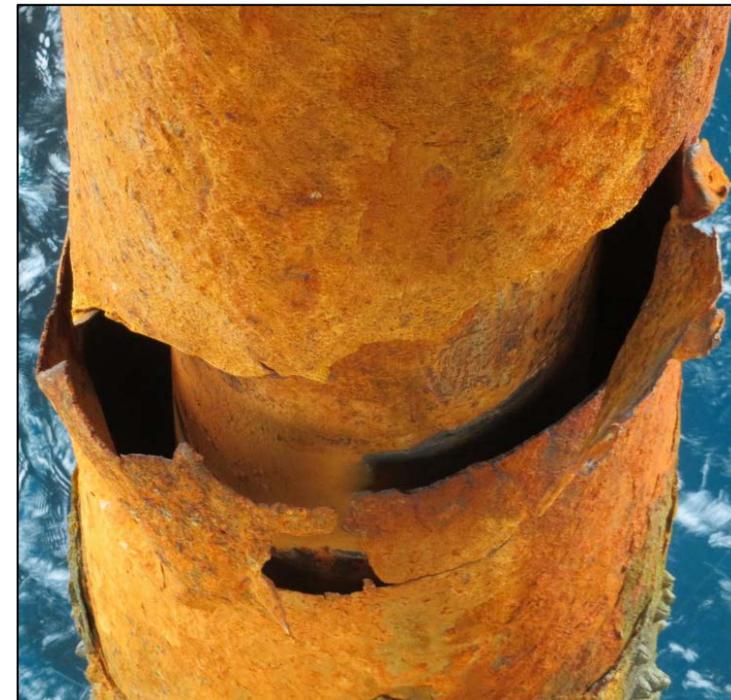
FAILURE

Circumferential failure of the conductor and extensive localized material loss

RESULT

Upper section of conductor is unconstrained. Lower section is subject to accelerated material loss at the splash zone
