Subsea to Floating: A Unified Field Development Approach

When Repair Is Not Feasible: Engineering Trade-Offs in Locking Open a Subsea Production Master Valve

Jaeyeol Jung, Pyae Phyo Win Maw

POSCO INTERNATIONAL Corporation

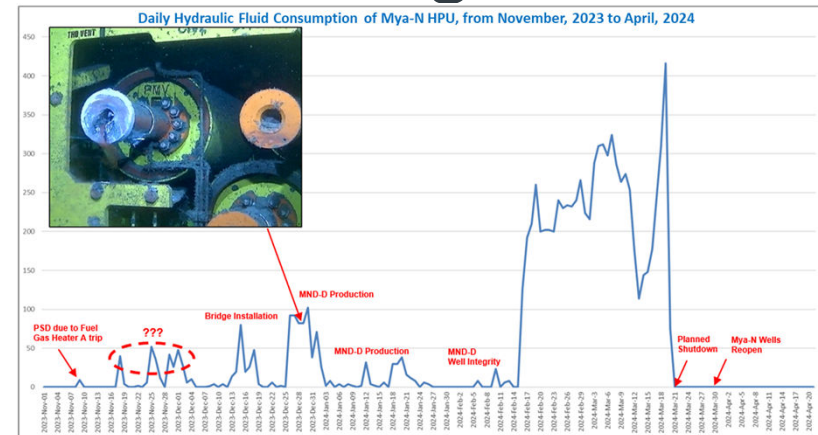
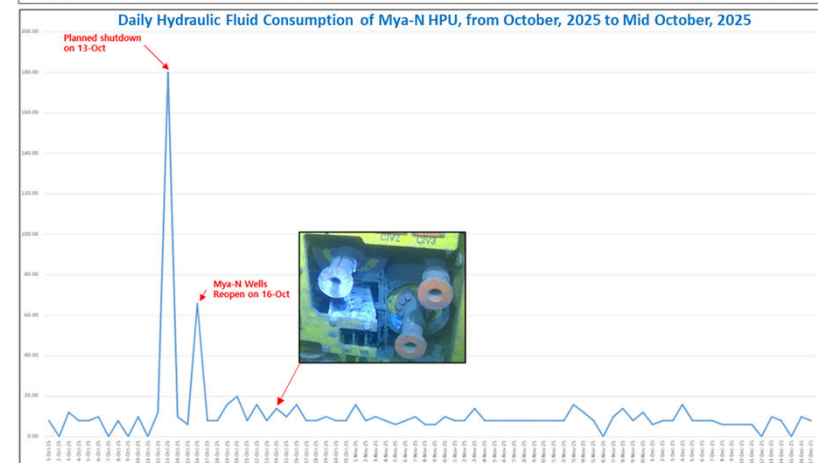
- 1st hydraulic leak suspected Nov 2023
- Confirmed leak from PMV of Mya-N A well
- Leak escalated after Mya-N D Well Integrity Test
- Fluid loss up to 400 L/day at peak
- No leakage detected following April 2024
- Recurrence of hydraulic leak suspected after wells restart in October, 2025
- Minor leakage confirmed from same location
- Further deterioration risks PMV functionality and production disruption

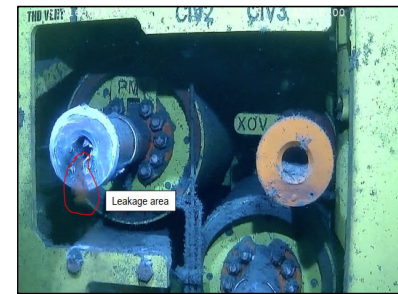
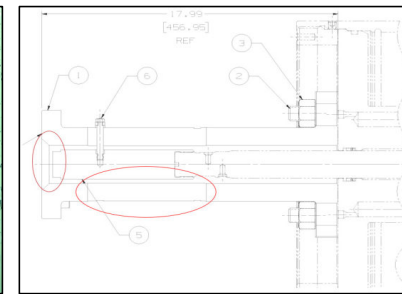
Leakage Area from MND-A PMV

- Actual root cause cannot be confirmed without removing actuator assembly from XT
- Possible root cause analysis studied with OEM

No.	Possible Root Cause	Possible Reasons	Possibility
1	Actuator Upper Stem Damage	Defective Material, Faulty Design, Upper Stem damaged, Wrong assembly and test, faulty part	Low
2	Piston Housing Damage	Wrong Assembly and Test, Faulty Design, and Piston Housing Damage	Low
3	Pip Seal Defect	Defective Material	Low
4	Pip Seal Damage	Faulty Part, Wrong Assembly and Test, Faulty Design, Degraded seals	Low
5	Marine growth on Upper Stem	Damage to Coating isolating Stem from CP	Medium
6	Calicious deposits on Upper Stem	Extended water circulation in Upper Stem area, Damaged Coating on the Stem	Medium
7	Spring damage	Spring corrosion and damage	Low
8	Piston Housing damage	Faulty Design, Wrong Assembly and Test	Low

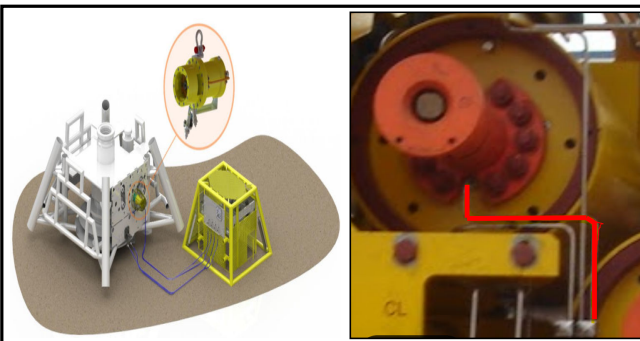
PCOL to Reinstatate Actuator Function

- Platform Controlled Override Linear (PCOL) system enables remote actuator override
- API Type A/B/C Interface Compatible
- Requires SCM hydraulic connection
- No available hydraulic connection from SCMMB to supply control fluid to PCOL tool**
- Only accessible part of tubing circuit from SCMMB to actuator is the highlighted line**
- Hot tap into that line would be a possible method of diverting fluid to PCOL**

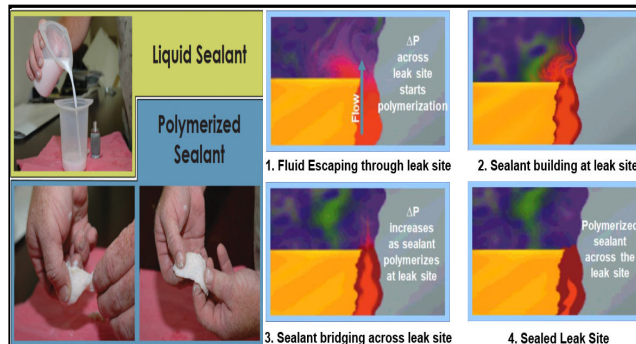
Injecting Pressure Activated Sealant to Leak Location

- Field proved technology since 1995
- Solidified into polymer at the leak site in the presence of differential pressure
- Excess sealant remains liquid
- Requires pumping down hydraulic control line via SCM hydraulic circuit
- Requires Dummy SCM which is configured to route flow from ROV to leaking actuator only**
- No dummy SCM available**

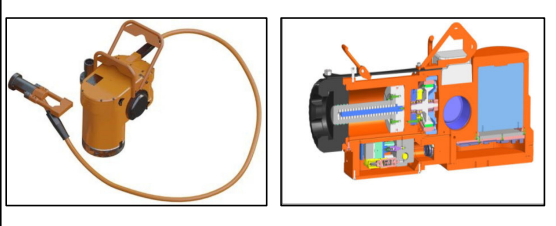
<p>Utilizing E-Actuator for PMV</p> <ul style="list-style-type: none"> Employs an electric actuator to operate the PMV, replacing hydraulic actuation with pure electrical motor control via SCM electrical control 	<ol style="list-style-type: none"> SCM hardware modification to use EC3 and internal wiring changes to control E-actuator. SCM software modification to operate E-actuator instead of DCV. 	<ul style="list-style-type: none"> Reduces upfront cost compared to MQC modification. Provides CRO precise control over PMV. PMV will close during the L3 shutdown.

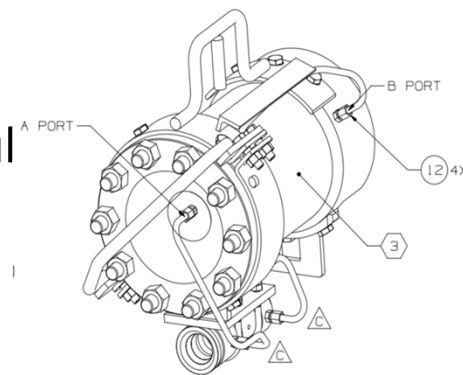
Linear Override Tool (LOT)

- Previous options technically constrained or uneconomic
- Mechanical override to actuator and hydraulic supply isolation to actuator eliminates hydraulic leakage
- Significantly lower cost than alternatives
- Simple ROV-based installation method
- Prior proven tool with long-term field use
