# The Undeniable Value of Inspection

POND & COMPANY

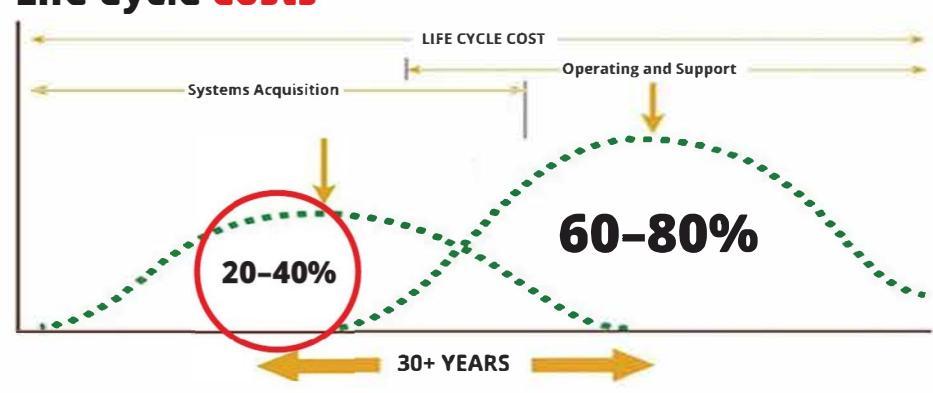
effective long-term than reactive corrections. If we apply this logic to construction practices, the need for preliminary coating inspection becomes clear. Locating coating defects during application prevents the financial impact incurred when the coatings fail prematurely (Fig. 1).

Fig. 1: Acquisition and operational costs of projects COURTESY OF U.S. DEFENSE ACQUISITION UNIVERSITY

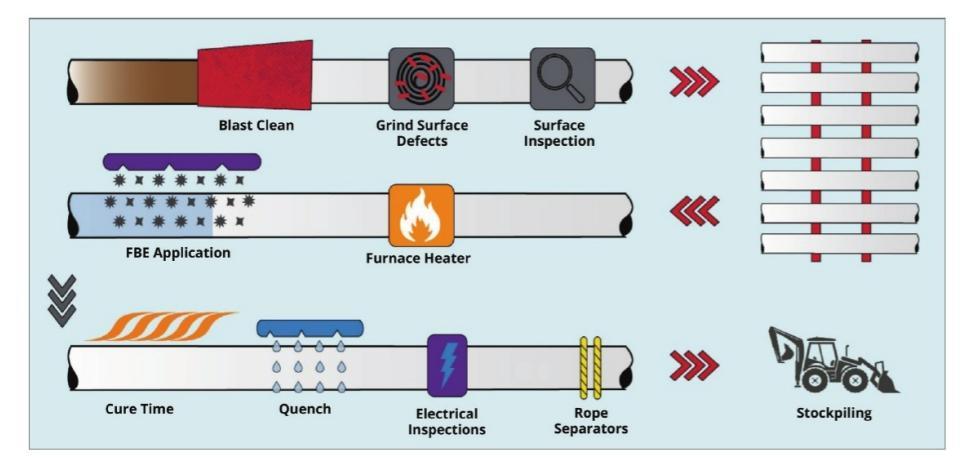
Fig. 3: Fusion bonded epoxy coating application process

In this situation, the pipeline was coated with fusion-bonded epoxy. FBE is a shop coating application in which dry, charged particles of epoxy powder are blown towards a preheated surface and melted and fused to the pipe. The performance of a coating system requires specified materials, applied over a properly prepared surface, under the required conditions in order to maximize service life. The process is detailed in Fig. 3.
