MEASURING BEARING *FRICTION* IN REAL-TIME

WHAT 8.5 BILLION FRICTION DATA
POINTS HAS TAUGHT US.

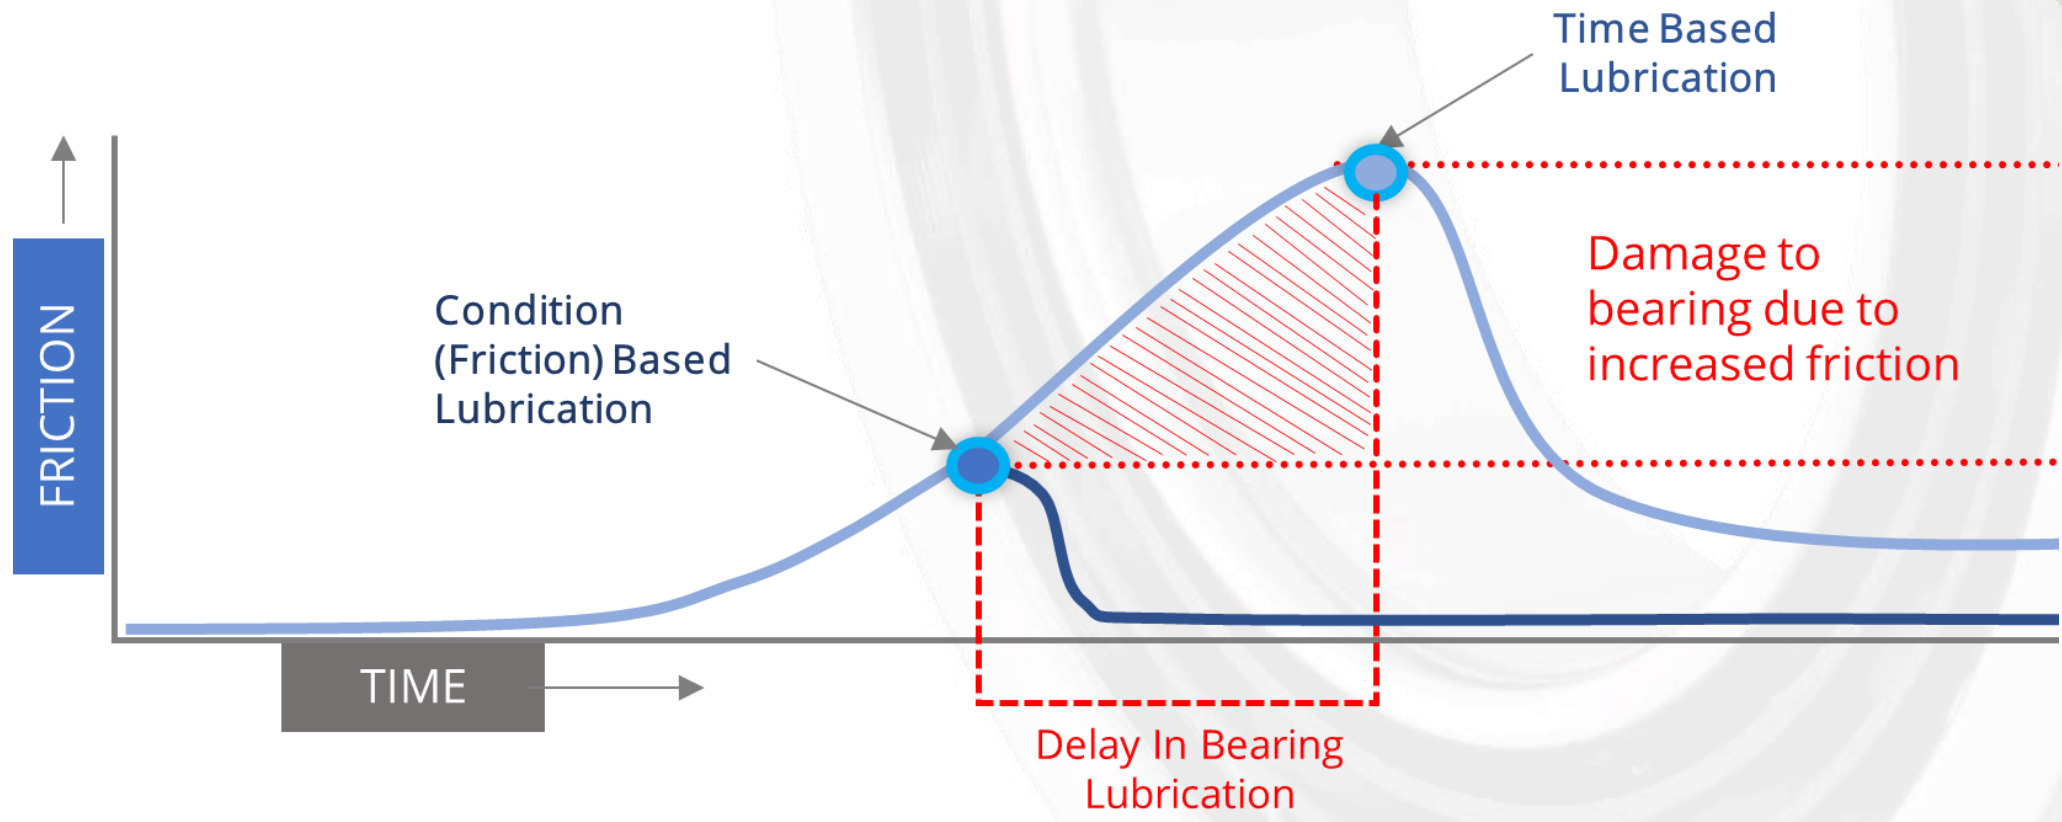
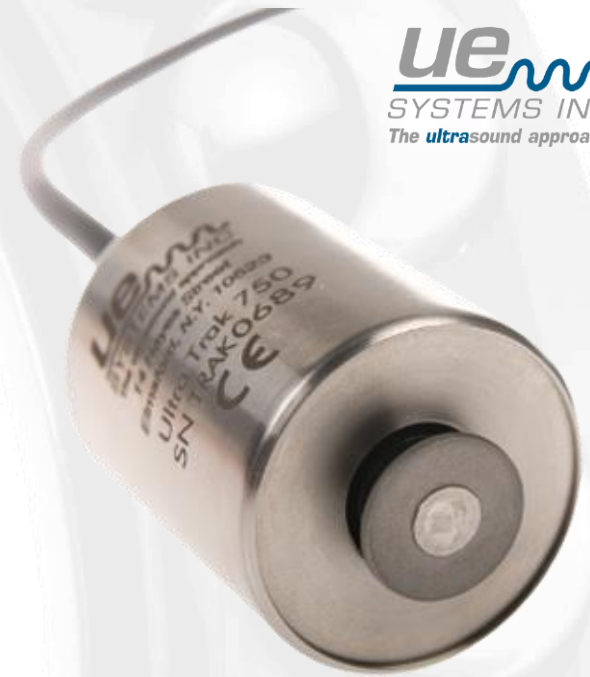
USING ULTRASOUND TECHNOLOGY TO CONTINUOUSLY MONITOR THE BEARING FRICTION

- KNOW WHEN GREASED IS REQUIRED
- KNOW PRECISELY HOW MUCH IS REQUIRED

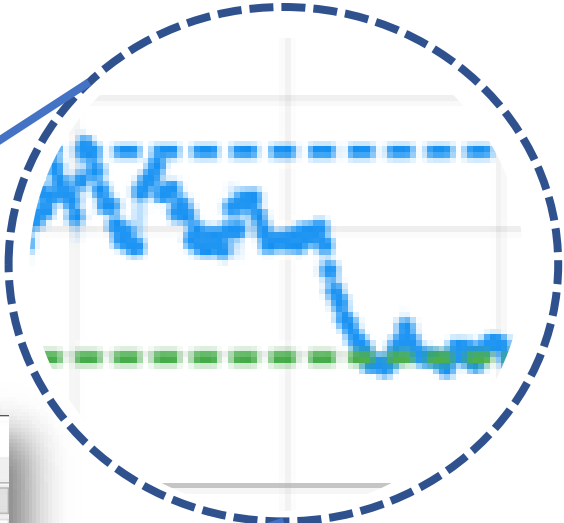
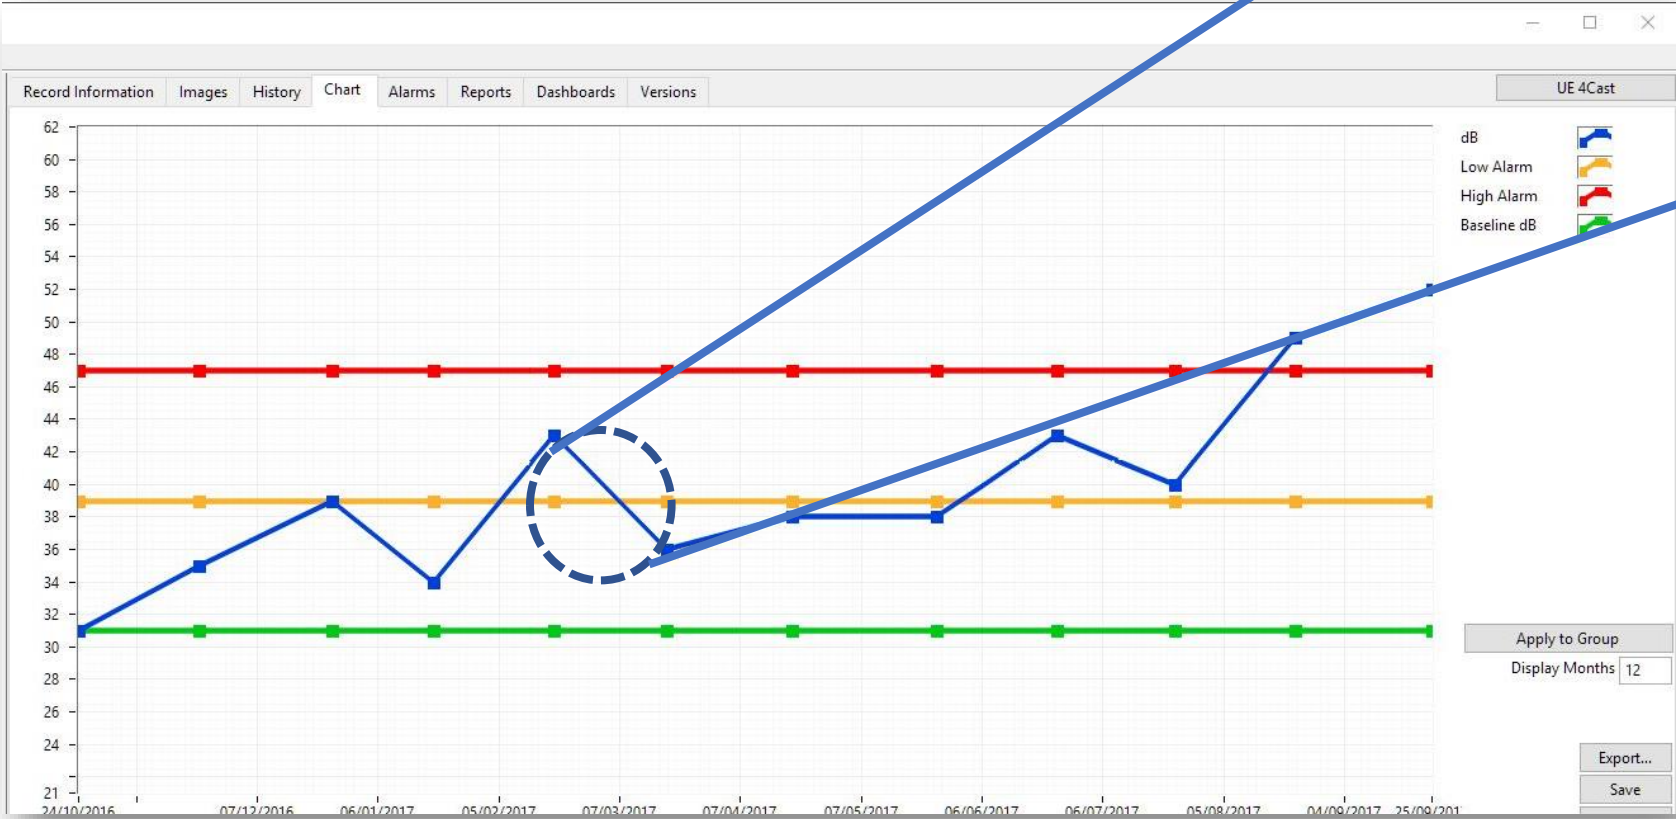
FRICTION TREND ON A MONTHLY ROUTE

MONITOR AND TREND DECIBEL LEVELS CAUSED BY FRICTION - ISO29821-1

+8dB

**ABOVE BASELINE
INDICATES A LACK OF
LUBRICATION.**

+16dB

**ABOVE BASELINE
INDICATES DAMAGE TO
THE BEARING – A FAILURE
MODE BEYOND
LUBRICATION ALONE.**

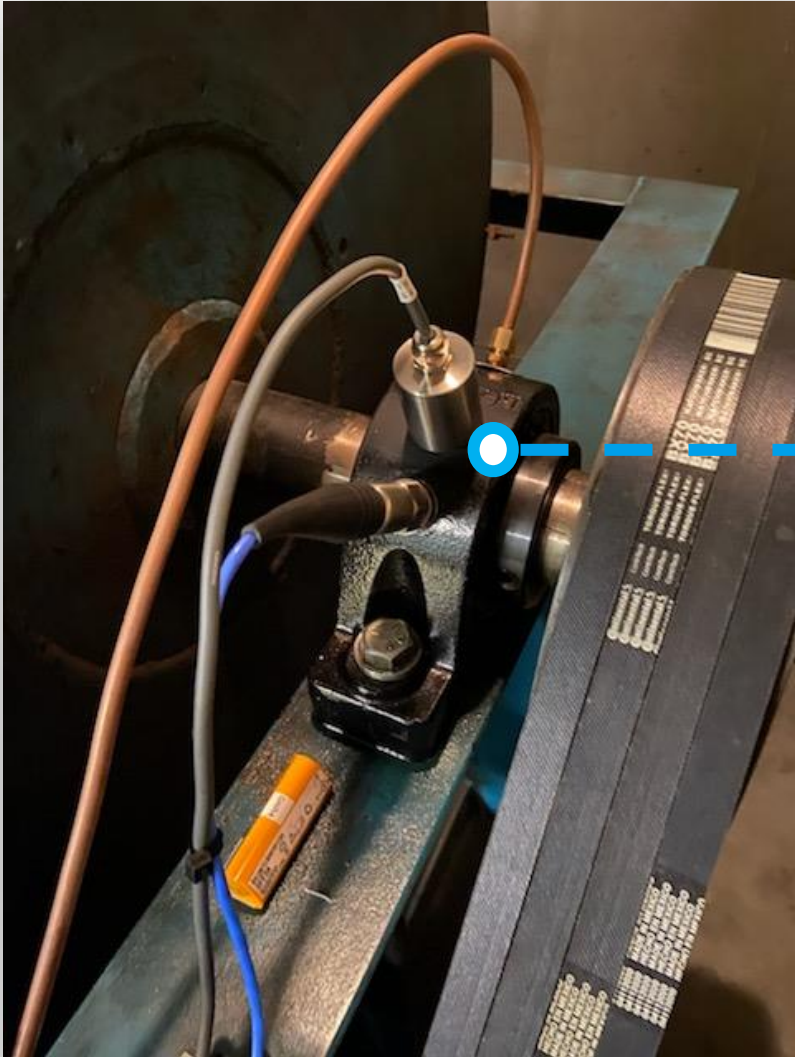
USE CASE | FAN BEARING IN AN AIR HANDLER UNIT

- DRIVE END OF BELT DRIVEN FAN
- VARIABLE FREQUENCY DRIVE
- ADDITIONAL VIBRATION SENSORS
- REMOTE GREASE LINE

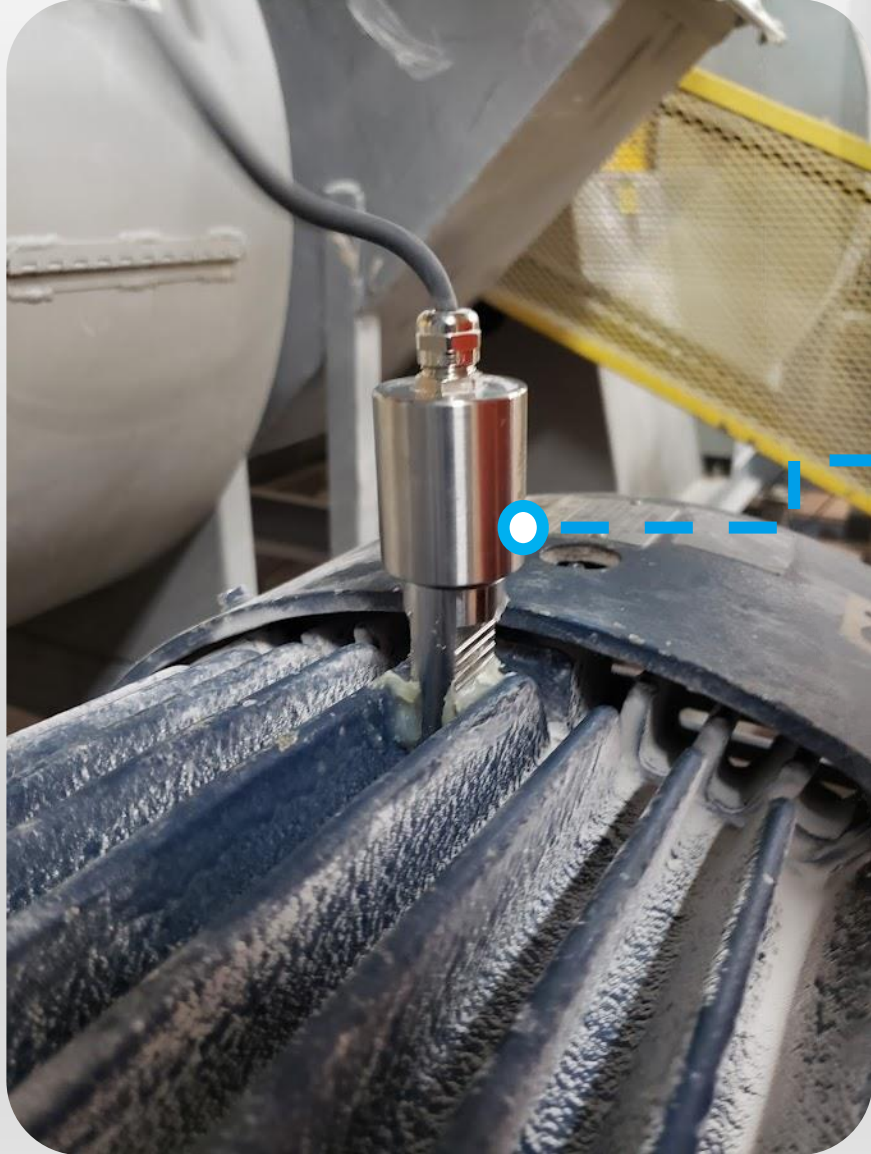
USE CASE BEARING IN ELECTRIC MOTOR

- NON-DRIVE END OF MOTOR
- USED FIN MOUNT

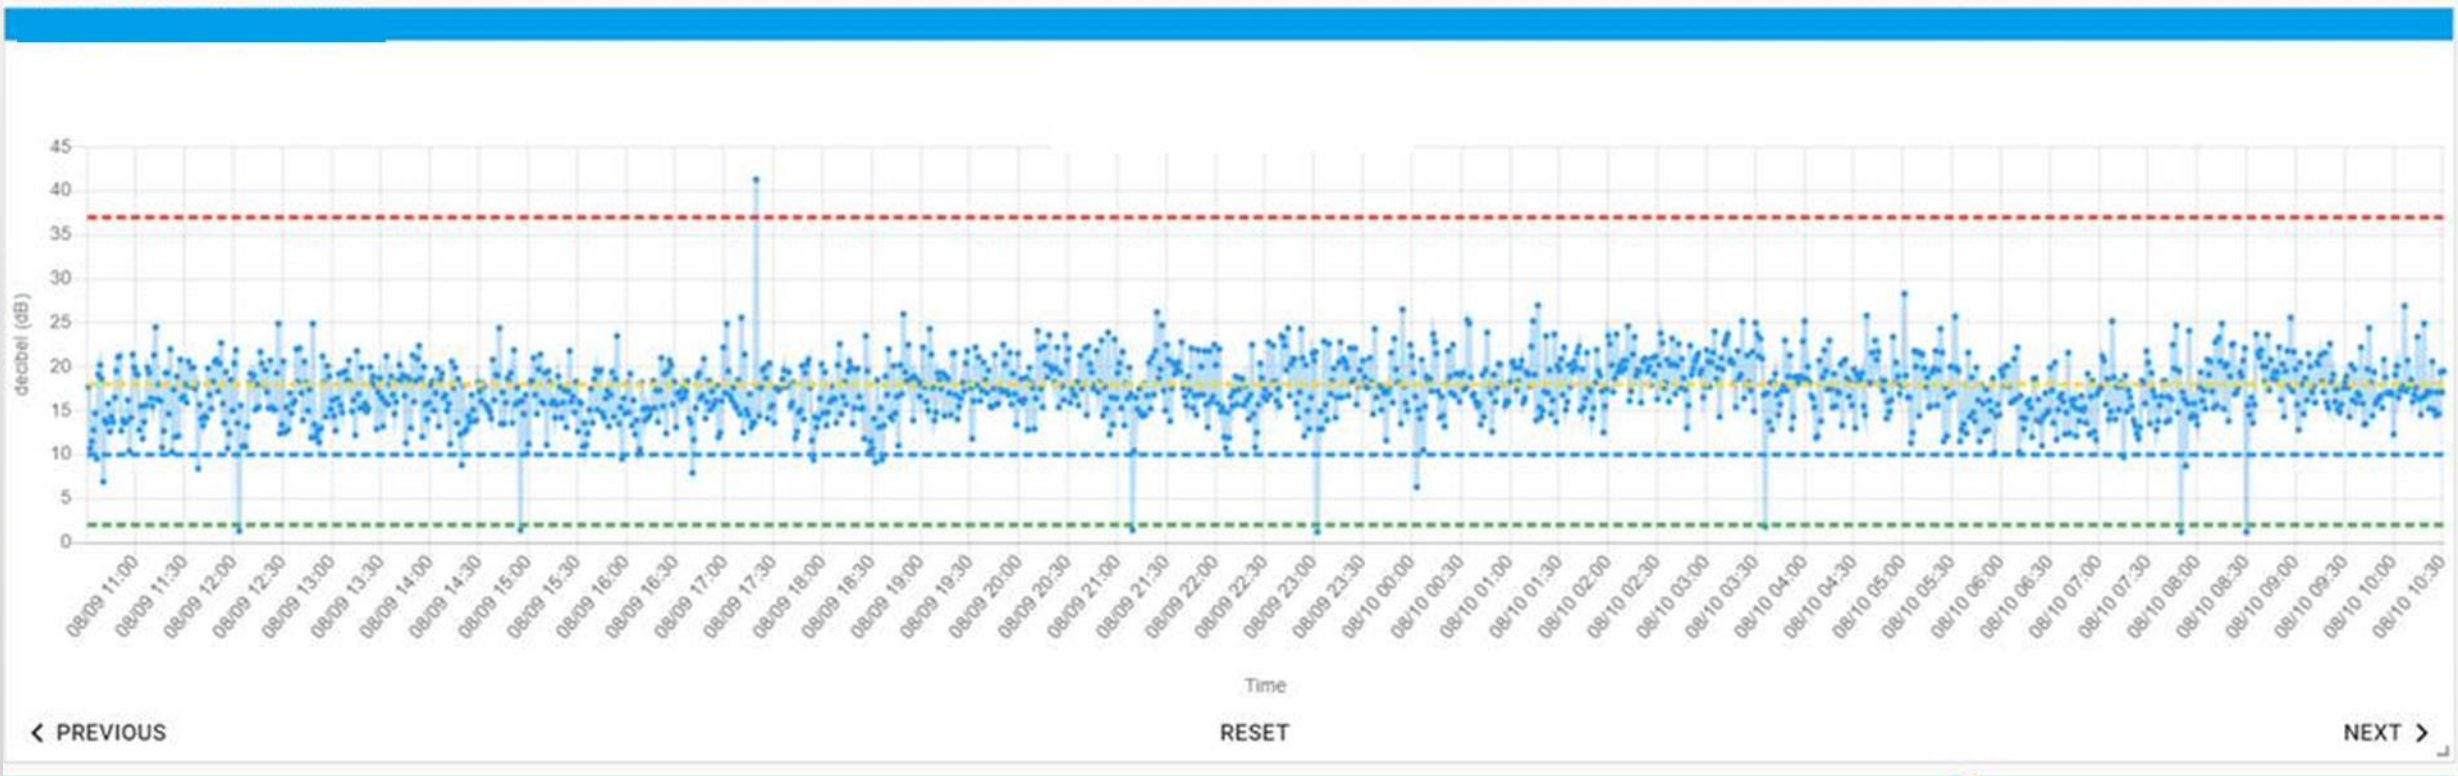
USE CASE FAN BEARING IN ELECTRIC MOTOR

NOTICEABLE IMPACTING IN THE BEARING

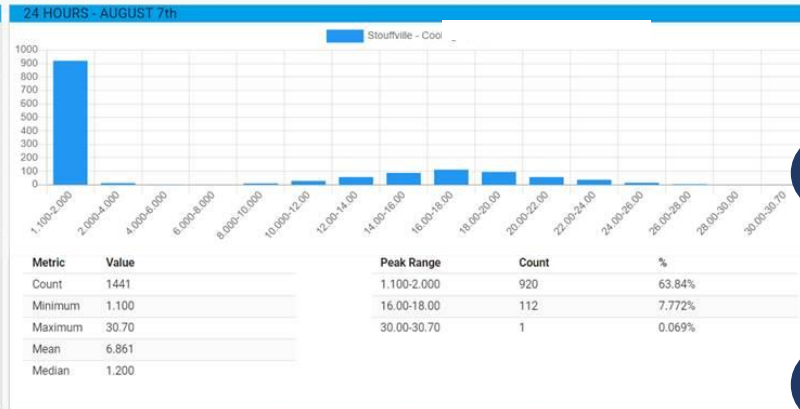
FRICITION DISTRIBUTION IN A BAD BEARING IN AN ECLECTIC MOTOR

- NOTICEABLE INCREASE IN FRICTION OVER 4 DAYS
- NOTICEABLE INCREASE IN THE PEAK-TO-PEAK VALUES.
- NO SINGLE POINT OF FRICTION LEVEL. BEARING IS BOUNCING AROUND

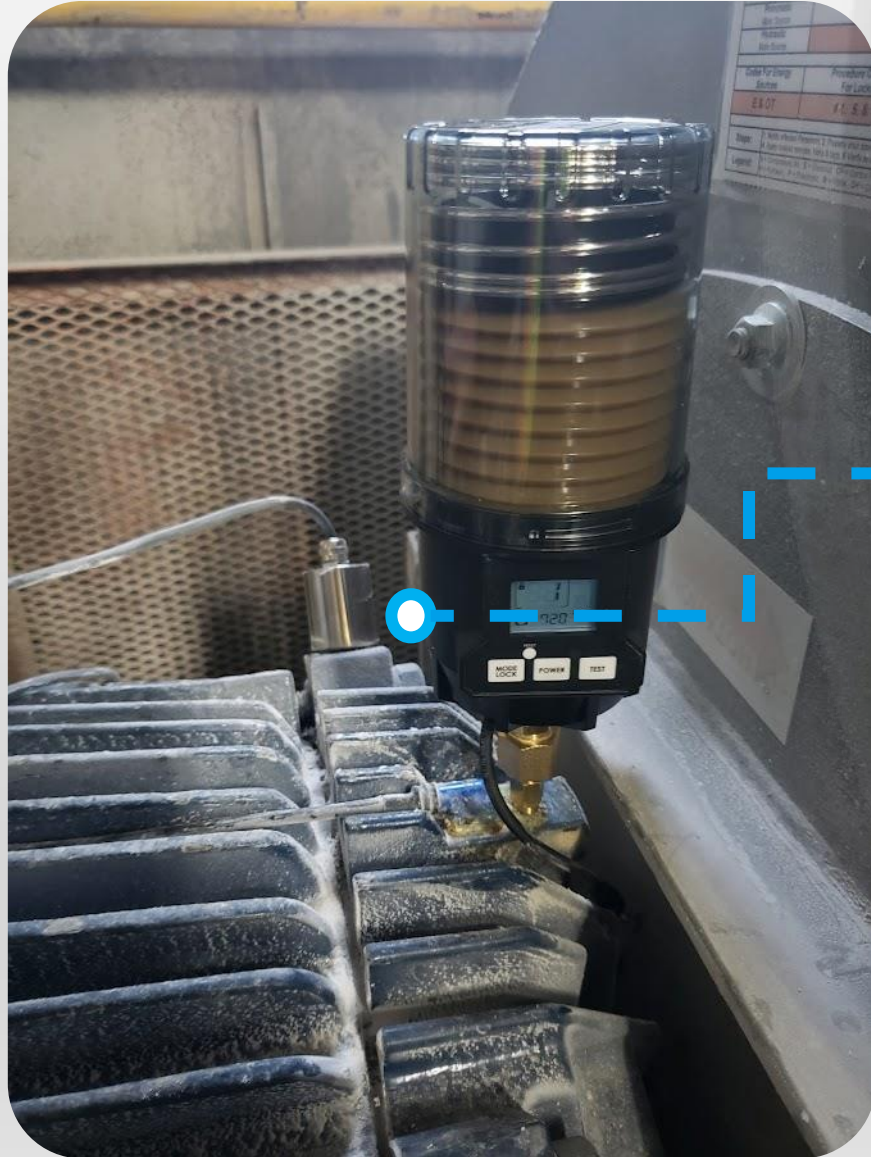
USE CASE | UNDER LUBRICATED BEARING

- DRIVE END OF MOTOR
- ONTRAK SMARTLUBE SYSTEM

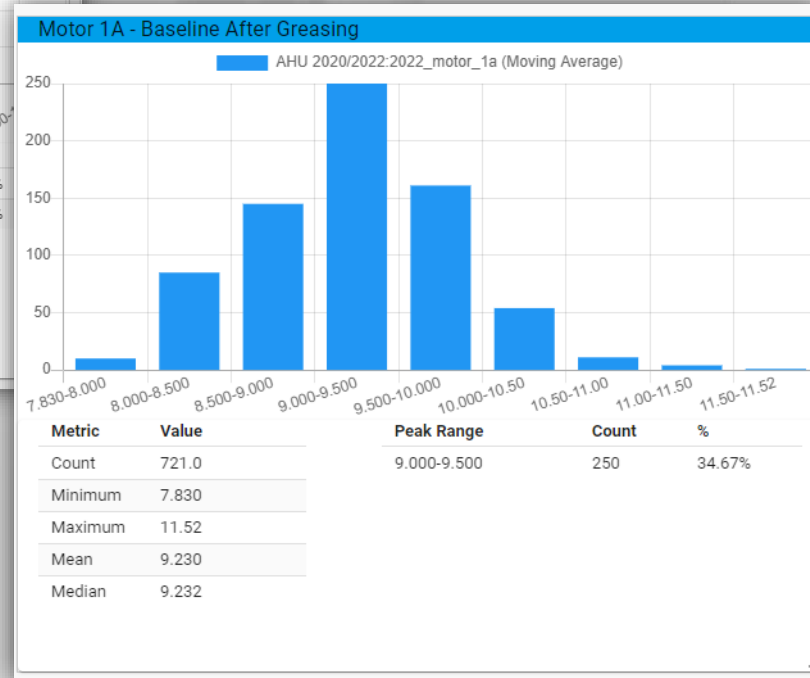
FRICITION DISTRIBUTION IN A UNDER LUBRICATED BEARING

BEFORE LUBRICATION

AFTER LUBRICATION

- NOTICEABLE DECREASE IN FRICTION AFTER LUBRICATION
- NOTICEABLE DECREASE IN THE PEAK-TO-PEAK VALUES.
- NOTICEABLE CENTER POINT ON THE HISTOGRAM

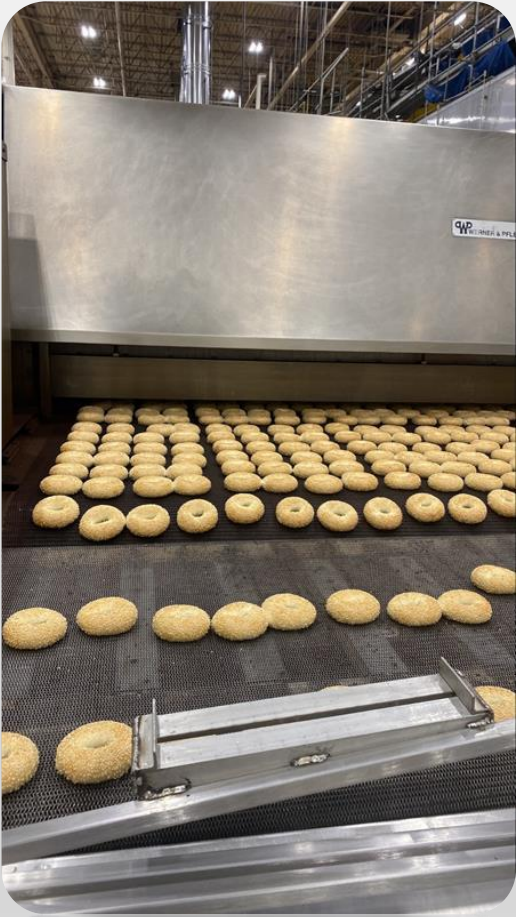
USE CASE 1.8 RPM BEARING

0.33 CC OF GREASE ADDED
