# Integrated Asset Integrity Management for HSSE, Sustainability, and Operational Excellence

## **Internal Corrosion Monitoring - Enhanced Safety Through Innovation**

KHAIRI KADIR

AXESS-CORROSION

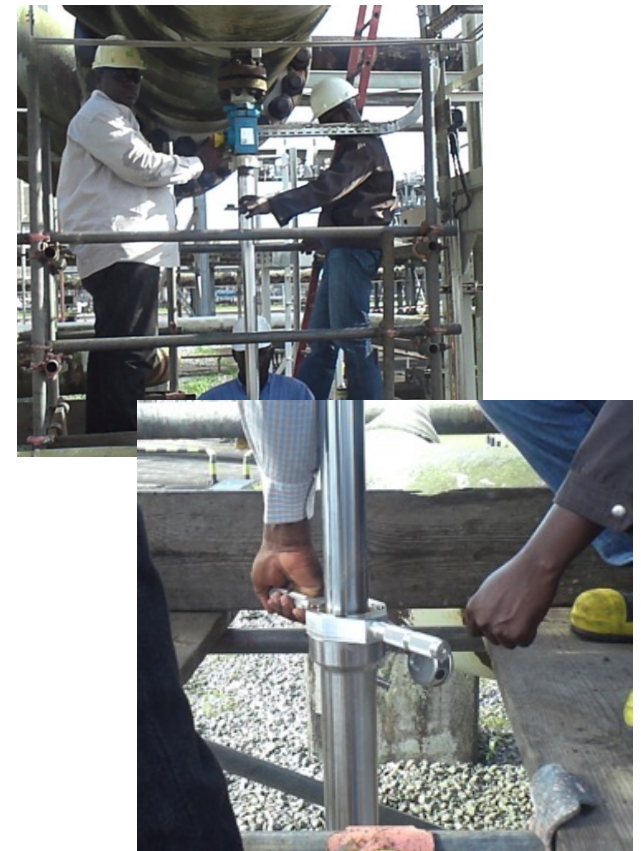
- ◎ Fatality in May 2012 lead to many operators suspending online retrieval of intrusive devices
- ◎ The fatality occurred during the retrieval of an ER probe installed at the 6 o'clock position on a slug catcher line
- ◎ The access fitting had not been serviced in over four years
- ◎ Scaffolding was built to accommodate a technician, located directly below the retriever to help support the weight

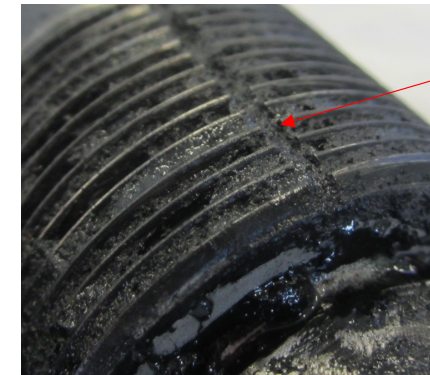
Blocked equalization channel on a hollow carrier plug

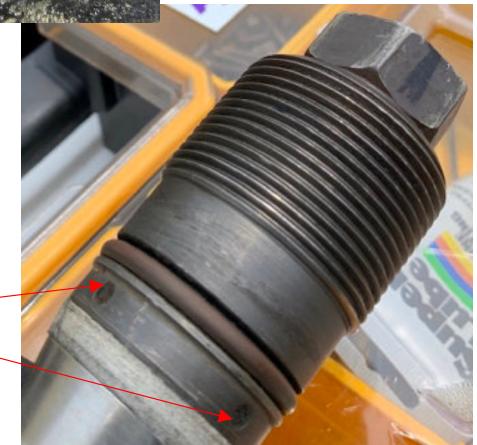
Blocked equalization ports on a solid carrier plug

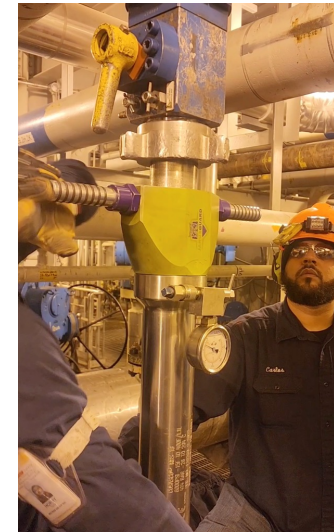
## Success History – Incident Prevention

- ⦿ At the end of 2024, two separate incidents were reported where the guard had undoubtedly protected the lives of two technicians.
- ⦿ The first incident occurred when the technicians were changing out corrosion coupons at the 6 o'clock position. It was assumed that the access fitting contained a 'standard' mechanical 1-3/4 UN thread carrier plug which would require 14 turns to disengage from the access fitting, but it was in fact an ACME thread

- ⦿ This type requires only 9 turns to disengage, so when the technicians had not achieved pressure equalization in the retrieval tool at the 7th turn, they decided to continue to 10 turns and make an assessment to back pressure, or not. At the ninth turn, the carrier plug disengaged and the retriever suddenly pressurized and stroked at 2200psi. The guard stopped the movement of the outer barrel, and the job site was made safe with a near miss recorded.

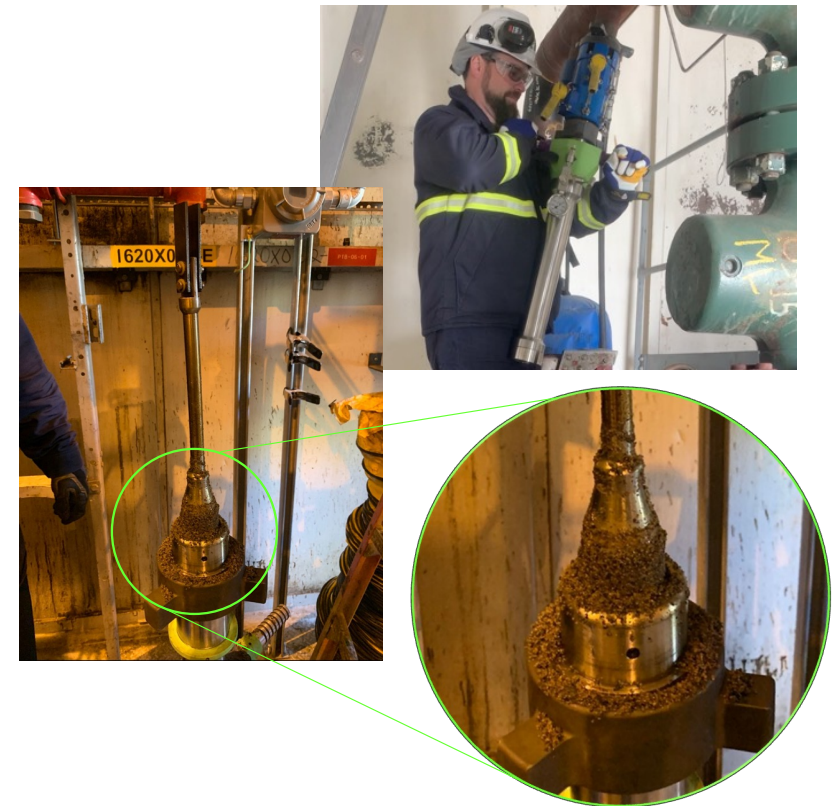
- ③ Use on 100% of all flowline locations enabling online monitoring
- ③ Previously unable to utilize telescoping tools due to debris blocking equalization ports
- ③ Recognized internally as embracing innovation and reducing risk
- ③ Guard engaged at 2200psi in November 2024 recorded near miss
- ③ Client feedback was exceptional, and the guard is now a new standard

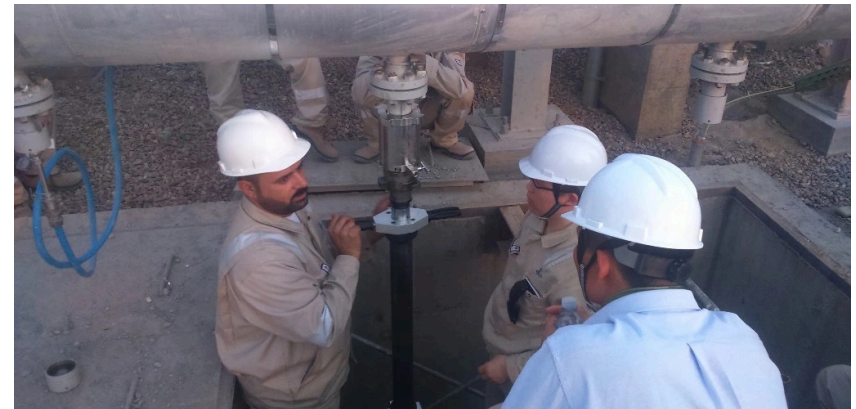
## Clearance for retrieval

- ◎ The required clearance is often not identified prior to design and fabrication
- ◎ This can lead to fittings welded to the pipe that may never be serviced
- ◎ In onshore applications access pits may need to be designed and they can accumulate toxic gases and are not always practical or possible

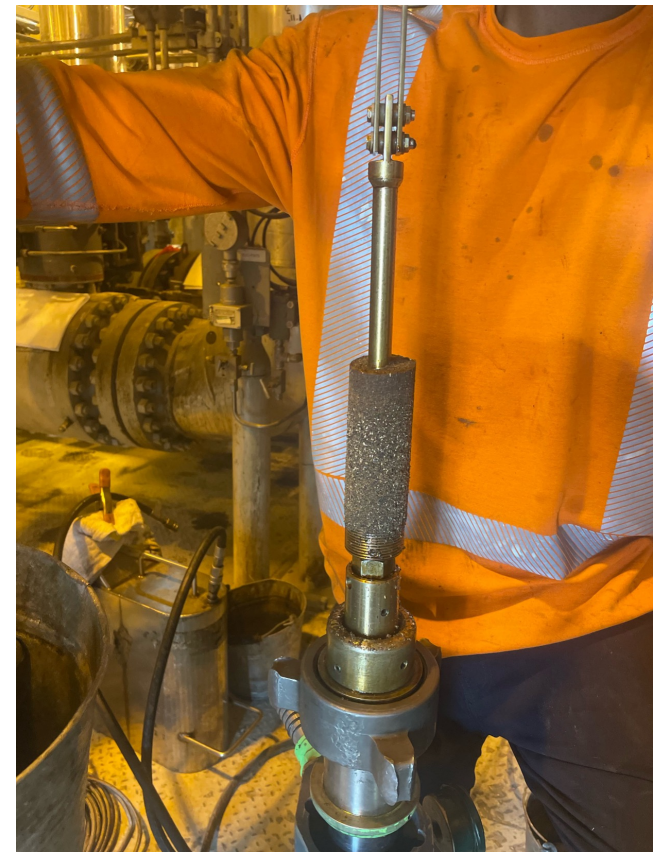
## Performance of 6 o'clock Access Fittings

- ⊙ Accumulation of debris in the 6 o'clock access fitting “trap”
- ⊙ Risk of retrieval tools not equalizing as per their design due to blockages
- ⊙ Majority of reported incidents ranging in severity from loss of containment to fatality, occur at 6 o'clock
