A-grade RESULT!

Andy Kenning spent eight years restoring it – now it's the best early MGA that we have ever seen

'I had been talking about it for years, and found the perfect project in Scunthorpe in 2007,' says Andy. 'It was a 1956 1500 roadster, an early car just like I wanted, but it wasn't exactly a runner.' When it turned up, Andy pushed it into the garage and shut the doors quickly. 'I knew exactly what the family would say: "Not another car in boxes, surely!"' Andy was a veteran of previous 'in boxes' restorations, a Midget and an MGB V8 – he had a reputation.

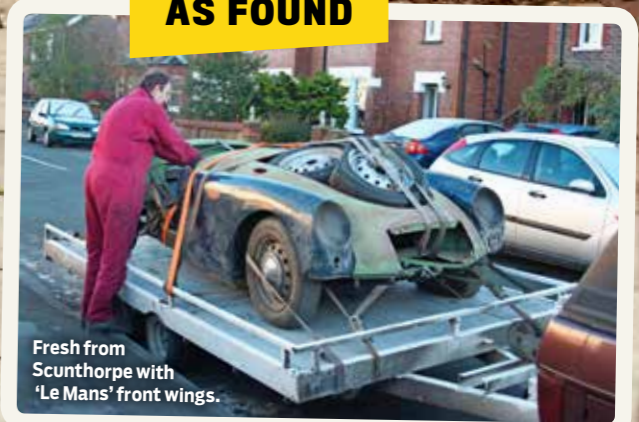
AS FOUND

The MGA had a chassis, a front body tub and a back tub, but nothing in the middle. Both tubs had dissolved from knee height down and what was left had perforations: 'It was a bit like a teabag!' laughs Andy. 'The front wings weren't original and had some sloped headlights, like a Porsche, fitted into them. Apparently, this was called a Le Mans conversion – horrible.

Fresh from Scunthorpe with 'Le Mans' front wings.

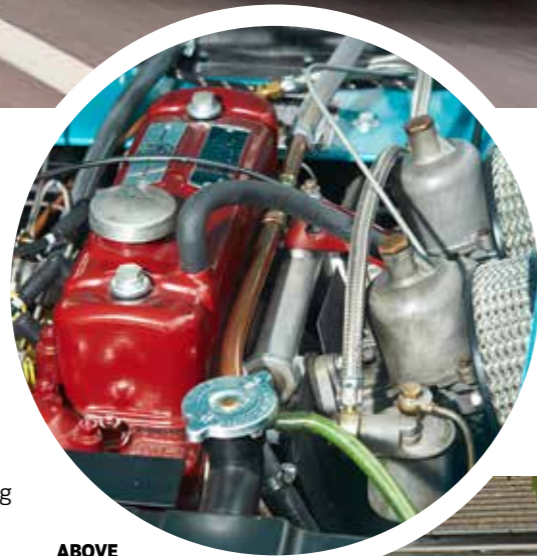
ABOVE Rebuilt B-Series 1500 was re-rebuilt by Andy.

James and Vince at Mini Speed in Brooklands were given the task of prepping and then applying the Glacier Blue paint and did so with an eye on the need to be prompt. During this time, Andy cleaned, stripped and rebuilt the engine. 'It had been professionally rebuilt and, once in bits, I saw it had been nicely machined.' Two of the bearings were scored, probably due to having been stood since 1978 and turned occasionally by hand. As a matter of course, Andy fitted new bearings, thrust washers, core plugs and a replacement water pump.

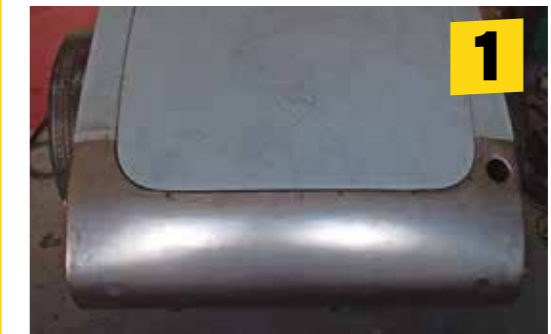
1 FEB 2009 Rear panel

Already, two years of painstaking bodywork have taken place and panels are now being fitted, including this huge rear valance repair panel. Testimony to Andy's fabrication and welding skills... it fitted perfectly.

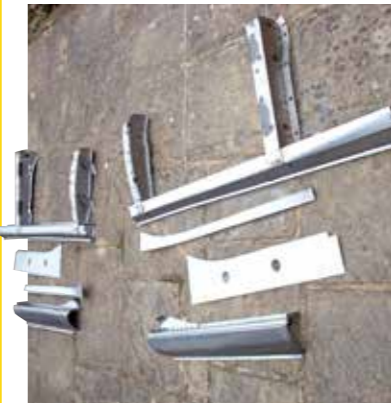
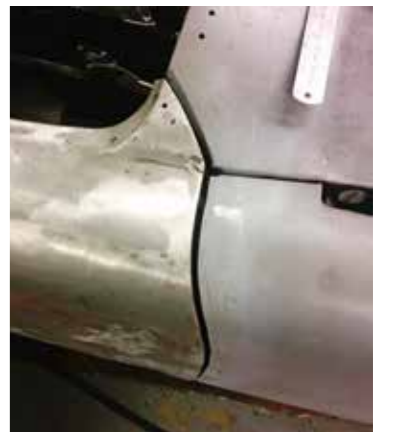
2 OCTOBER 2011 Front to back

By now the chassis has been restored and it is time to think about joining the front body tub to the rear. Here are the sections required – ready!

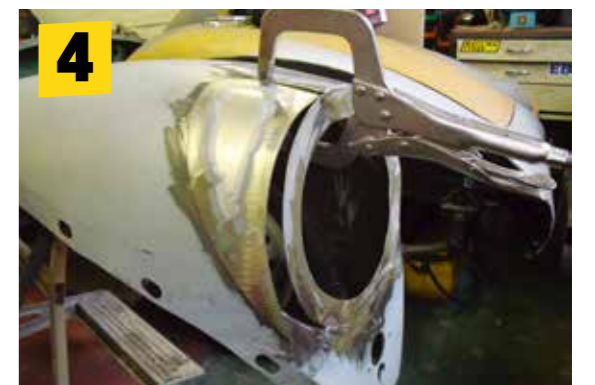
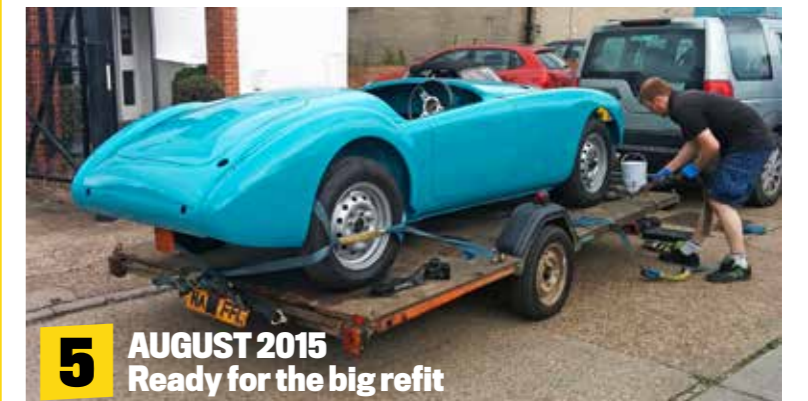
3 NOVEMBER 2014 Proof of quality

It is all coming together and here are the panel gaps. Given the depth of the work, nothing short of miraculous.

Thanks to expensive repair panels, Andy built up a correct headlight mount by using the nearside item as a template and reversing the measurements. Truly expert panelcraft made to look easy.

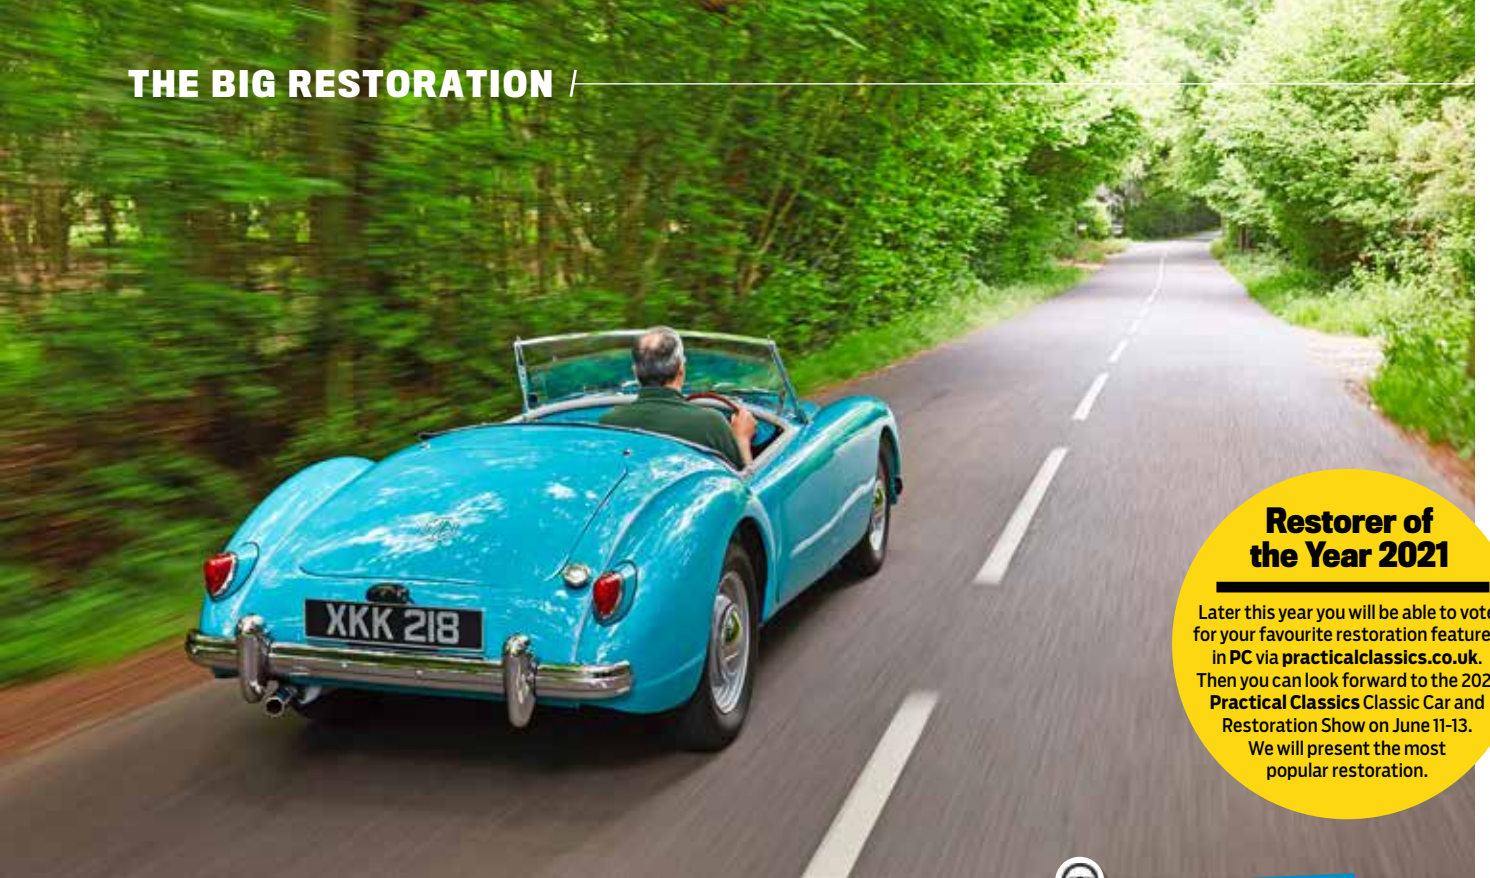
5 AUGUST 2015 Ready for the big refit

After a professional paint job, the MGA's body was fitted back onto the chassis at the paint shop. It went on first time. Testimony to an in-depth restoration well completed.
