MOBS RISER REPAIR KIT

3D designed sleeve to reinforce corroded gas pipes.

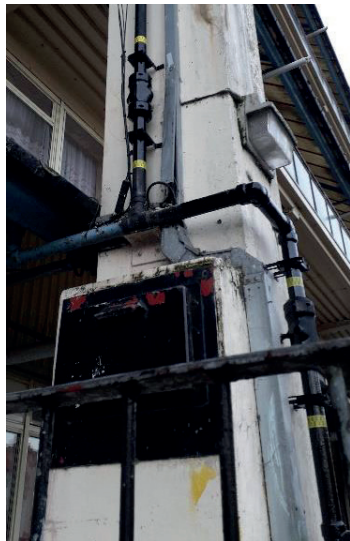
The method utilised a clamp system that reinforces the pipe above and below the corrosion and copes with varieties of configurations. The central sleeve uses a resin that is placed to resist corrosion.

It was established that usually either side of the earthed pipe clips, the sections of pipes were considered strong enough to make a long-term repair.
