EARTH TESTING CASE STUDY

Safearth CS3 Test Prevents HV Outage

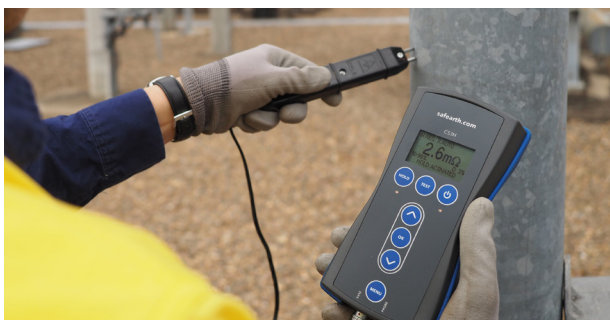
In an earth grid integrity test in Wisconsin, USA, the CS3 identified a set of 3 line voltage transformers that had their main grid bond severely deteriorated or damaged below grade. The VT's were found to be bonded via the screen of the control wiring only. Left unrepaired, this situation may have led to spurious trips on the line, significant equipment damage in the event of a fault or potentially hazardous conditions for workers on the control wiring.

The use of a comparably low 1A test current in the CS3 enabled this serious defect to be identified accurately without causing any negative impacts, whereas a high current test (10A or greater) may have caused damage to the control wiring, likely resulting in an outage.

During routine integrity testing using Safearth's new CS3 continuity meter, engineers identified an inadequate bond that would have led to an outage if tested by other integrity testing equipment. This discovery allowed the client to make a repair before it resulted in major equipment damage or compromised safety.
