WORKING IN THE DUST

Reliably detecting fire in a busy waste transfer station with high levels of airborne contaminants

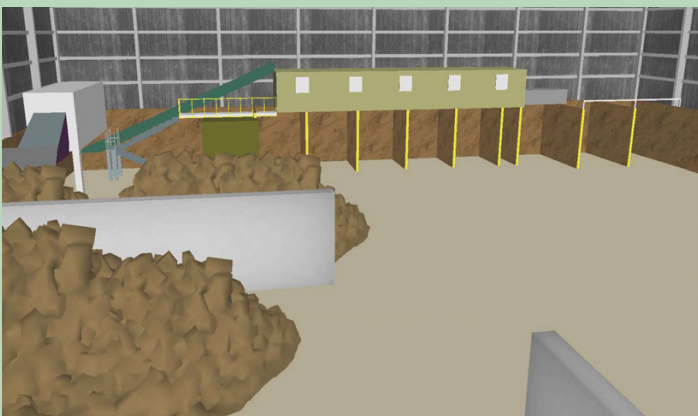
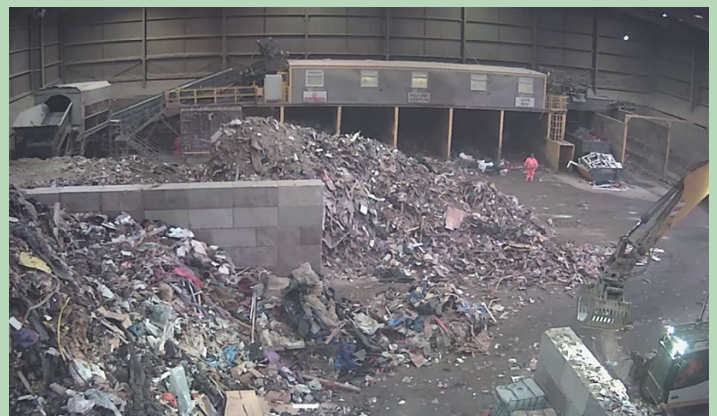
Four XFP video flame detectors and a CORE Control Hub were installed, linked to the site fire system, which is monitored off-site. The system also provides a live video feed from each video detector to the site staff, accessible from their PCs and mobile devices. Below is an example of the 3D model prepared to calculate coverage, compared to the actual view from one of the video detectors. The site are very happy with the system, which is performing well, and the insurer and Environment Agency are both satisfied.
